NASA/TP-2006-213716

# **STS-111 (OV-105 Flight 18) Meteoroid/Orbital Debris Postflight Assessment**

This section details the inspection and analysis conducted in the months following the STS-111 mission. The outer surfaces of OV-105 (the Space Shuttle *Endeavour*) were examined, and samples were collected from sites of potential hypervelocity impact (HVI) damage from meteoroid and orbital debris (M/OD). The surfaces include the Orbiter radiators, windows, payload bay door flexible reusable surface insulation (FRSI), and wing leading edge reinforced carbon-carbon (RCC).

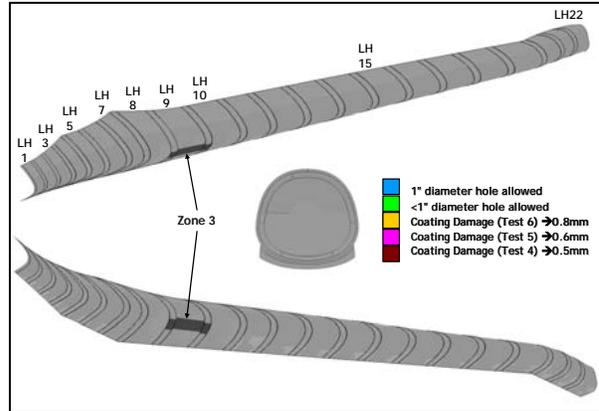
Figure E1. RCC M/OD failure criteria map.

Thirty-two hypervelocity impact sites were observed on Space Shuttle OV-105 surfaces after the STS-111 mission. The largest impact, which occurred on payload bay door radiator panel R3, was caused by a meteoroid particle with an estimated diameter of 0.4 mm. This impact produced a 3.2-mm-diameter hole in the thermal tape and a 0.2-mm-diameter hole in the facesheet. The estimated diameter of the meteoroid impactor that perforated the radiator facesheet approaches the 0.5-mm critical particle diameter of the wing leading edge reinforced carbon-carbon (RCC) panel high-temperature regions (Zone 3, figure E1) that was established during Return to Flight (STS-114) testing of the RCC panels.

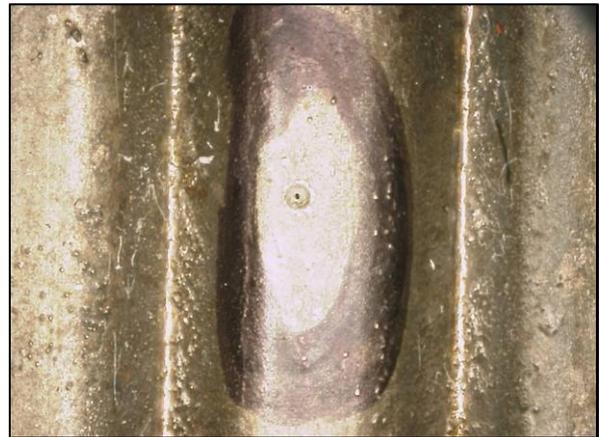
Figure E2. SSME-3 nozzle, tube 358.

A perforation, approximately 3 in. forward of the aft manifold (figure E2), was detected in tube 358 of the SSME-3 [Space Shuttle main engine-3] nozzle hot wall. Impact site features were consistent with the morphology of a hypervelocity impact. The crater lip had a diameter of 0.58 mm, and the bottom of the crater revealed a 0.10-mm pinhole in the stainless-steel material. Although no sample was taken at the impact site, a stainless-steel impactor with an estimated diameter of 0.2 mm would be a reasonable assumption. The engine nozzle was repaired and returned to service for the STS-114 mission.

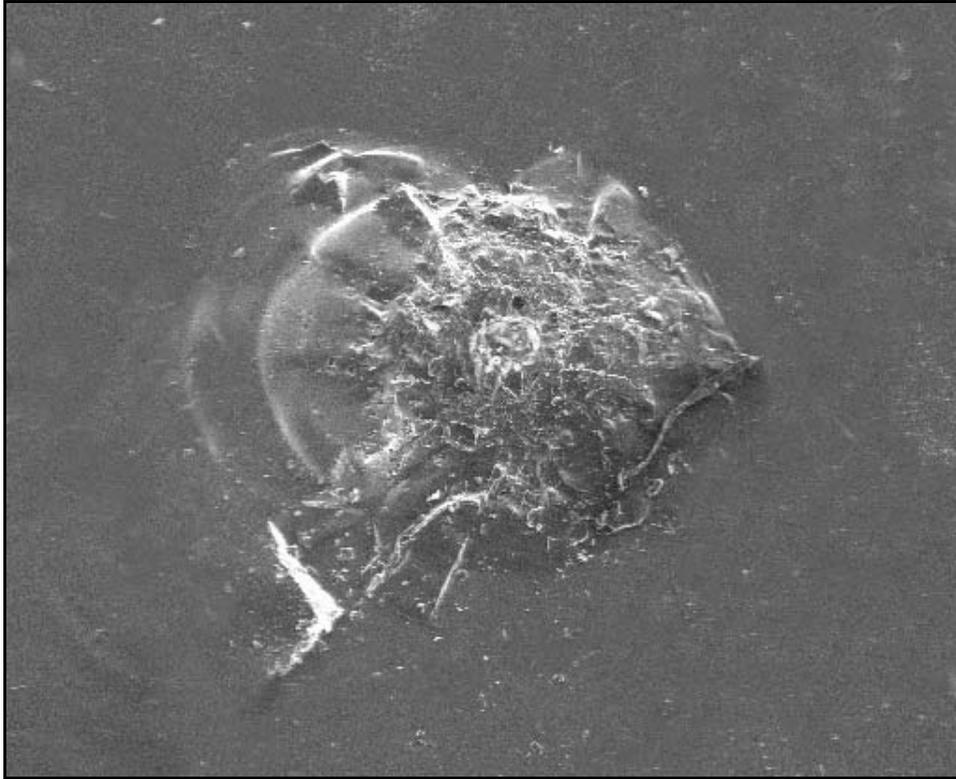
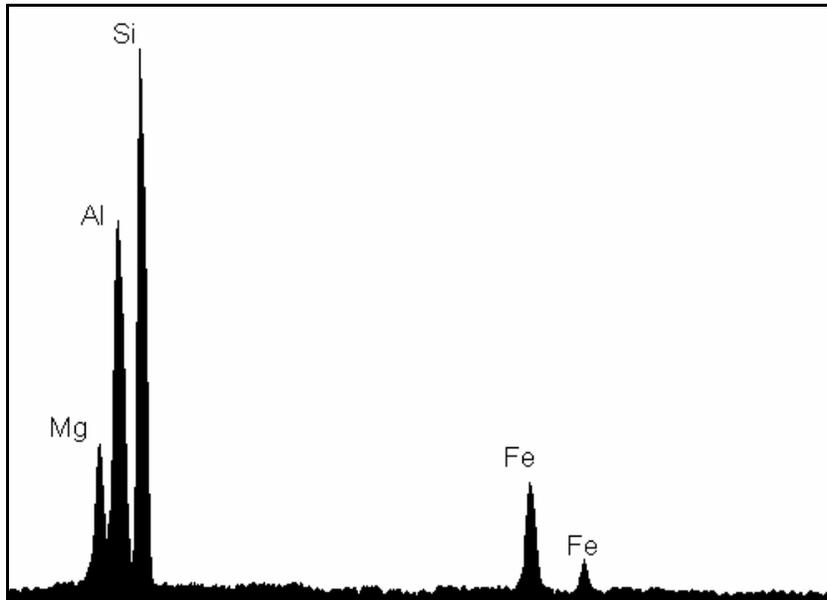
Figure 5. SEM image from the dental mold sample taken at window 2, PR 30.

Figure 6. EDX spectra from the dental mold sample taken at window 2, PR 30.  
This impact was caused by a meteoroid particle.

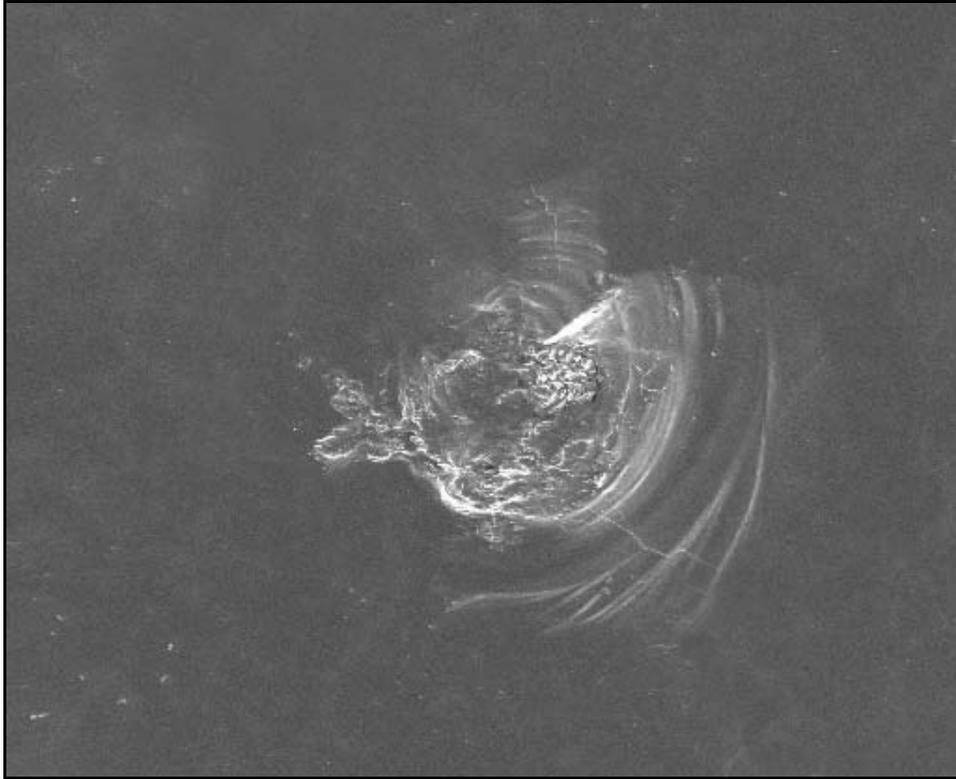
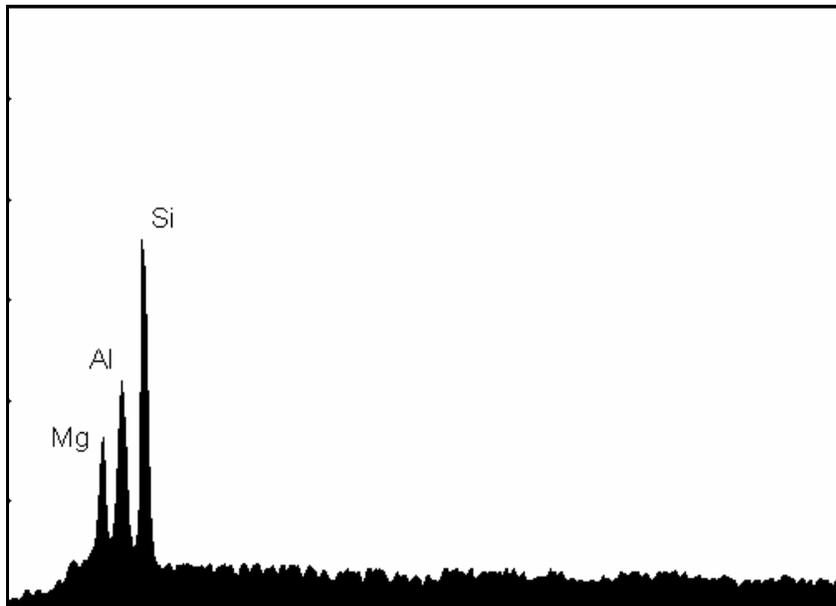
**Figure 7. SEM image from the dental mold sample taken at window 2, PR 36.**

**Figure 8. EDX spectra from the dental mold sample taken at window 2, PR 36.  
This impact was caused by an aluminum orbital debris particle.**

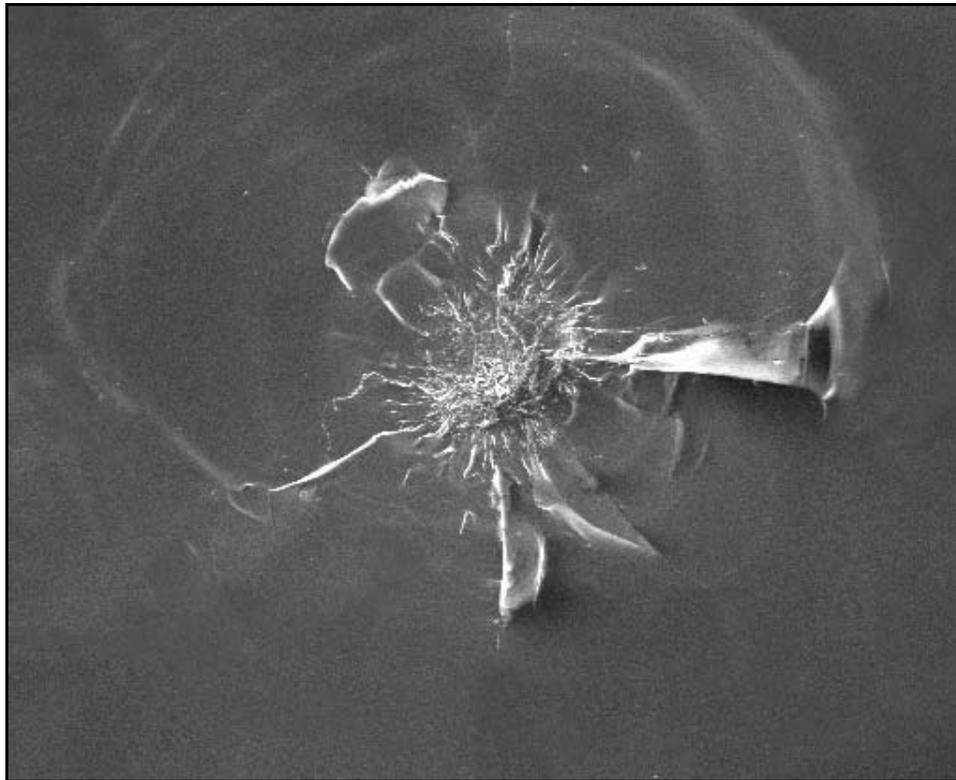
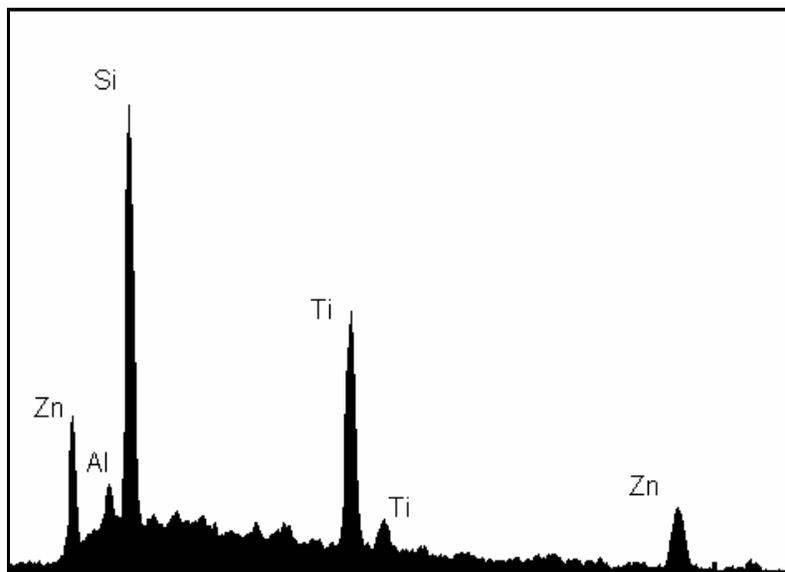
**Figure 9. SEM image from the dental mold sample taken at window 4, PR 144.**

**Figure 10. EDX spectra from the dental mold sample taken at window 4, PR 144.  
This impact was produced by an orbital debris particle of spacecraft paint.**

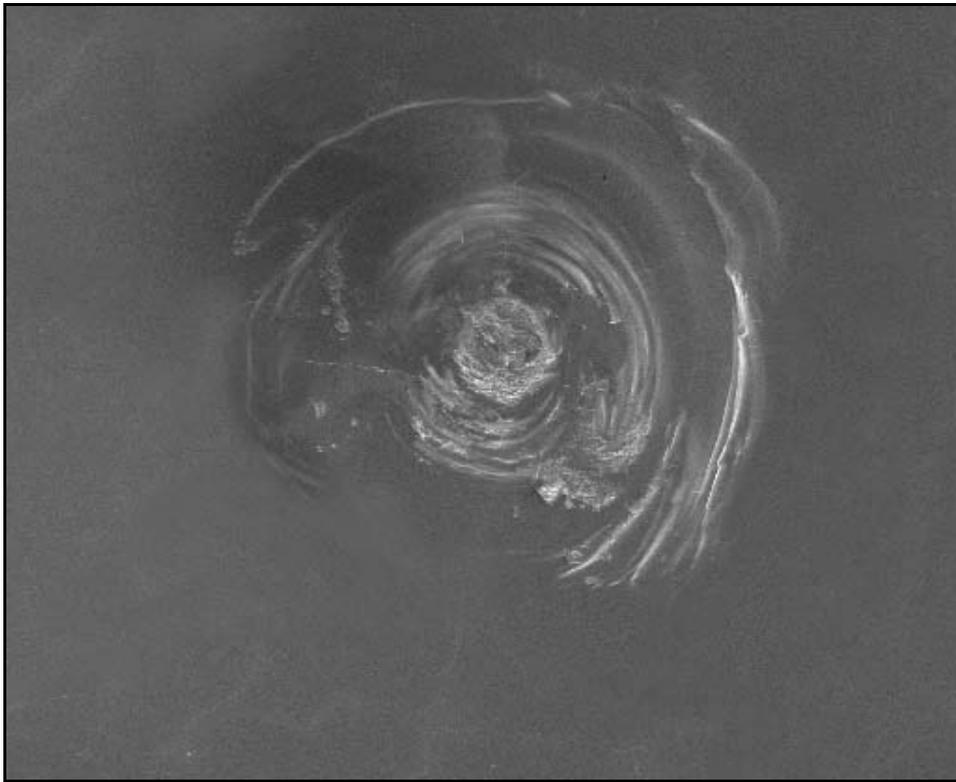
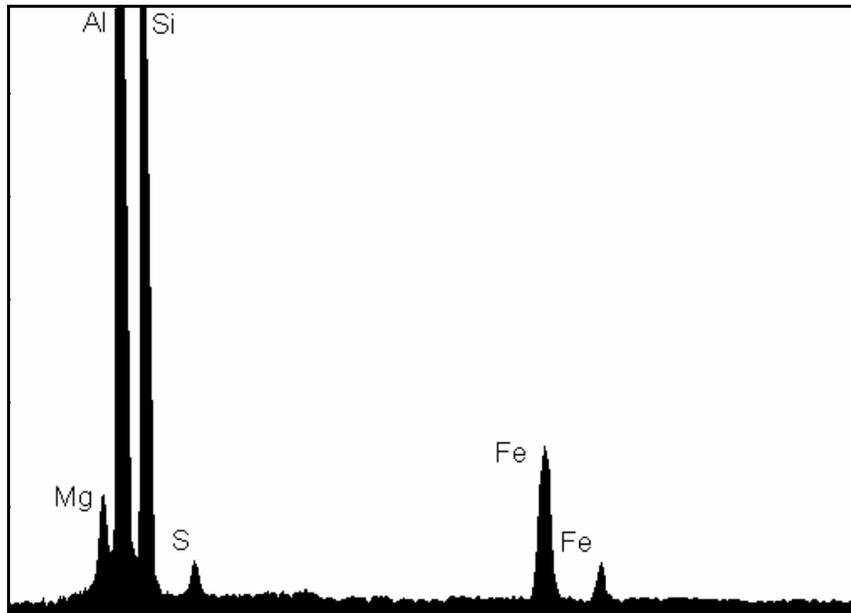
Figure 11. SEM image from the dental mold sample taken at window 5, PR 41.

Figure 12. EDX spectra from the dental mold sample taken at window 5, PR 41.  
This impact was caused by a meteoroid particle.

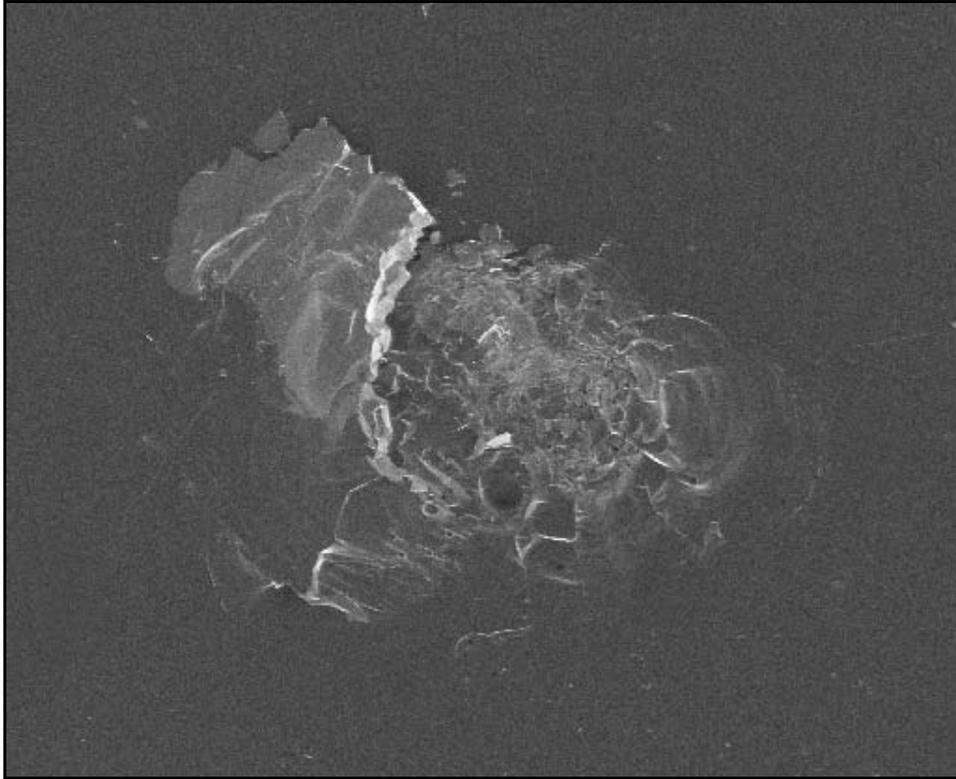
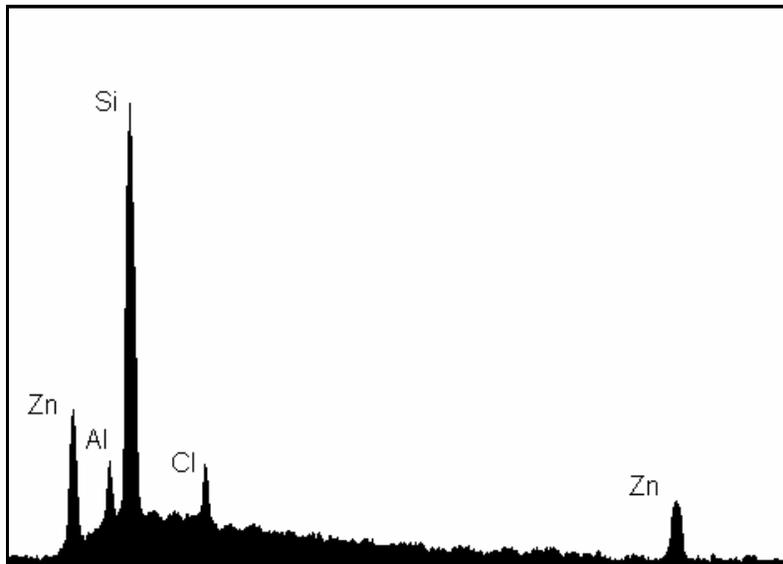
**Figure 13. SEM image from the dental mold sample taken at window 6, PR 2.**

The M/OD damage sustained by the windows on STS-111 is shown in an SEM image taken from a dental mold impression of the damage as well as from EDX spectra in figures 5 through 16. Specifically, figures 5 and 6 provide views of strike damage from a meteorite particle to window 2, problem report (PR) 30. Figures 7 and 8 show damage to window 2, PR 36, caused by an aluminum orbital debris particle. An orbital debris particle of spacecraft paint produced the damage to window 4, PR 144 (figures 9 and 10). Window 5, PR 41, was damaged by a meteorite particle (figures 11 and 12). The damage caused by a particle of spacecraft paint to window 6, PR 2 (figures 13 and 14), was sufficiently severe that it caused the window to be scrapped. Finally, window 8, PR 1, was damaged by a meteorite particle, as in figures 15 and 16; this window, like window 6, also needed to be replaced.

**Figure 14. EDX spectra from the dental mold sample taken at window 6, PR 2. This impact, from a particle of spacecraft paint, caused the window to be scrapped.**

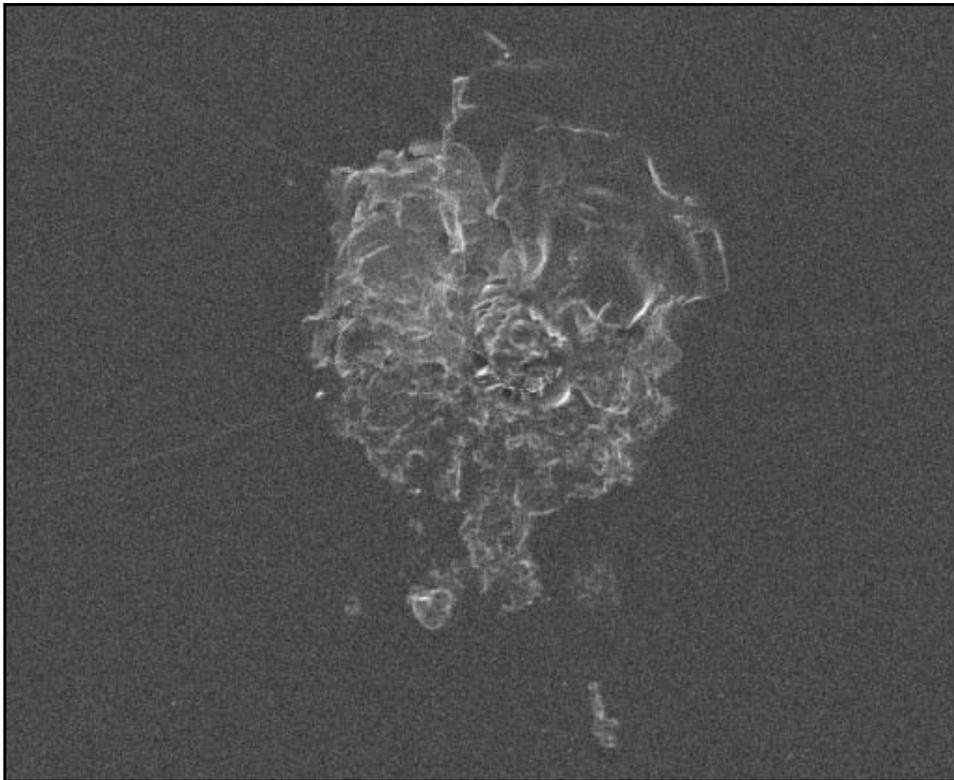
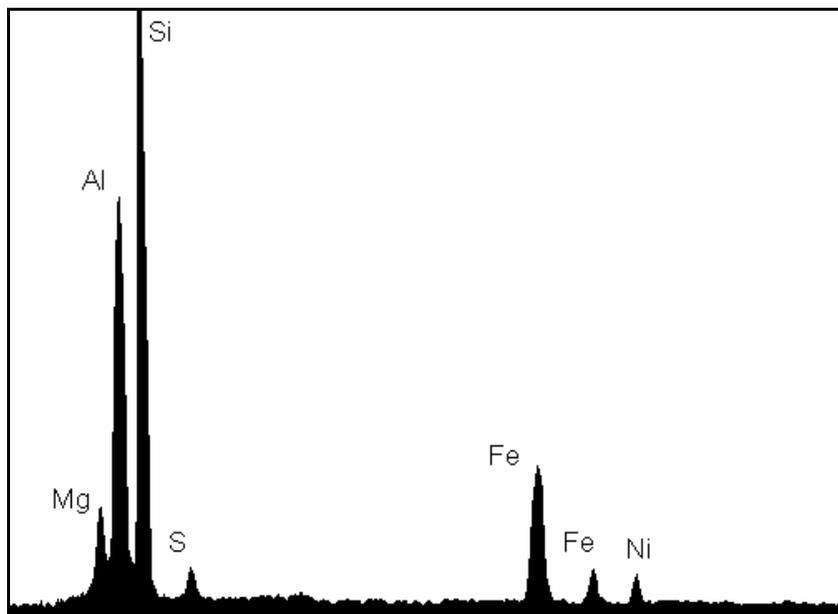
Figure 15. SEM image from the dental mold sample taken at window 8, PR 1.

Figure 16. EDX spectra from the dental mold sample taken at window 8, PR 1.  
A meteoroid particle was the cause of this window replacement.

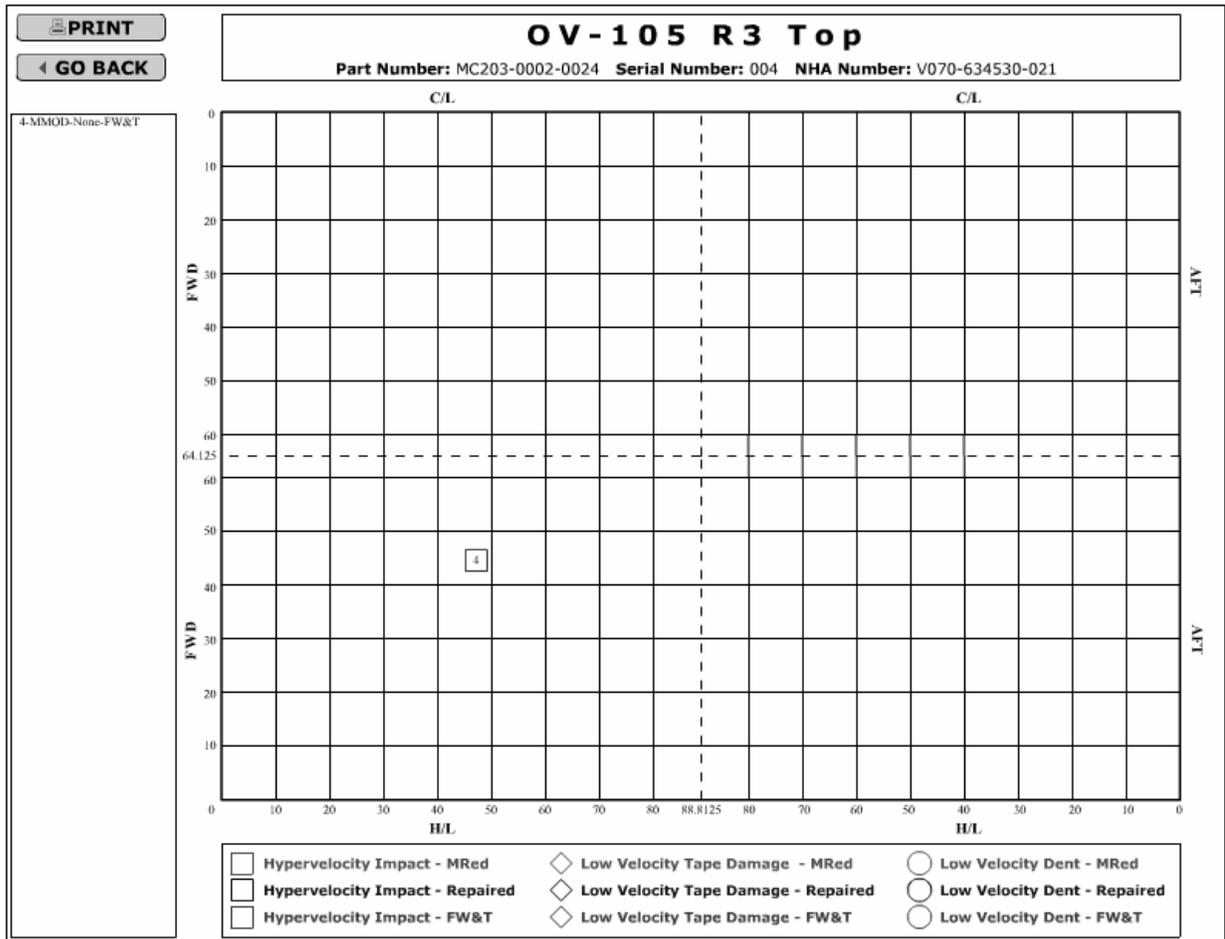
Table 3 also shows all 10 defects reported on OV-105 radiators after STS-111. The figure, which is shown below table 3, indicates the relative location of the single hypervelocity impact that was observed—a perforation of the facesheet in panel R3. The size of the damaged areas was determined initially by KSC inspection personnel and documented in a radiator PR. These damaged areas were confirmed by later measurement when actual samples of the damage became available (either radiator tape or mold impressions). The radiator inspection did not record the distance of the facesheet perforation to the closest doubler.

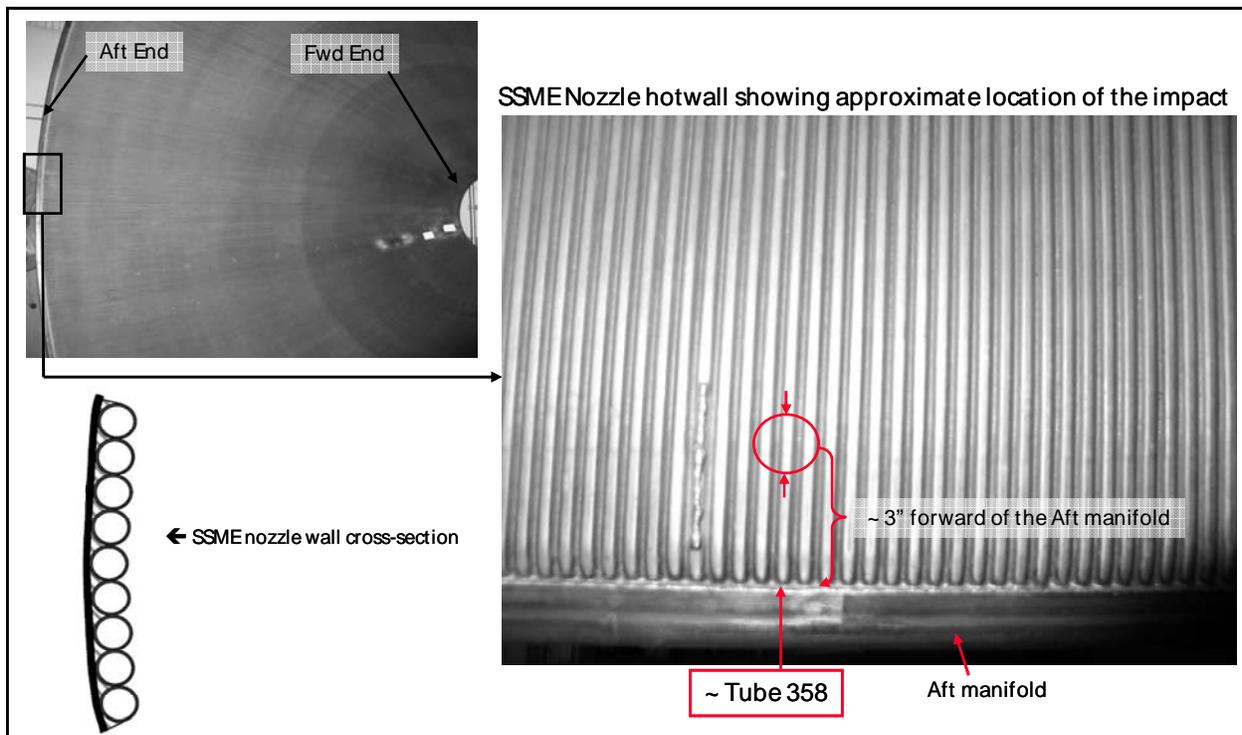
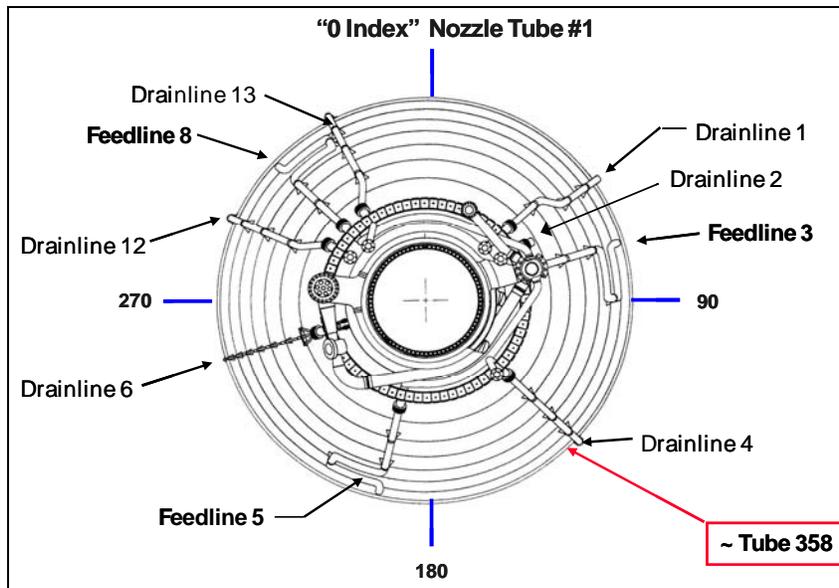
Figure 22. SSME nozzle impact location.

During postflight processing at Stennis Spaceflight Center (SSC), a small hole was observed on Space Shuttle main engine-3 (SSME-3) nozzle 2030 tube 358 (SSC MR #700-3585). Figures 22 and 23 describe the general location of the impact site. The coolant tubes are constructed of nickel-plated A286 stainless-steel material, and have a wall thickness range of 0.010 in. to 0.012 in. in the area where the impact occurred. The crater displayed the distinctive morphology of a hypervelocity impact event, with a raised lip and a smooth bottom. It was located approximately 3 in. forward of the aft manifold. The impact crater measured 0.58 mm (0.023 in.) in diameter, and there was a 0.076-by-0.127-mm (0.003-by-0.005-in.) hole in the bottom of the crater. Figures 24 and 25 provide views of the impact crater.

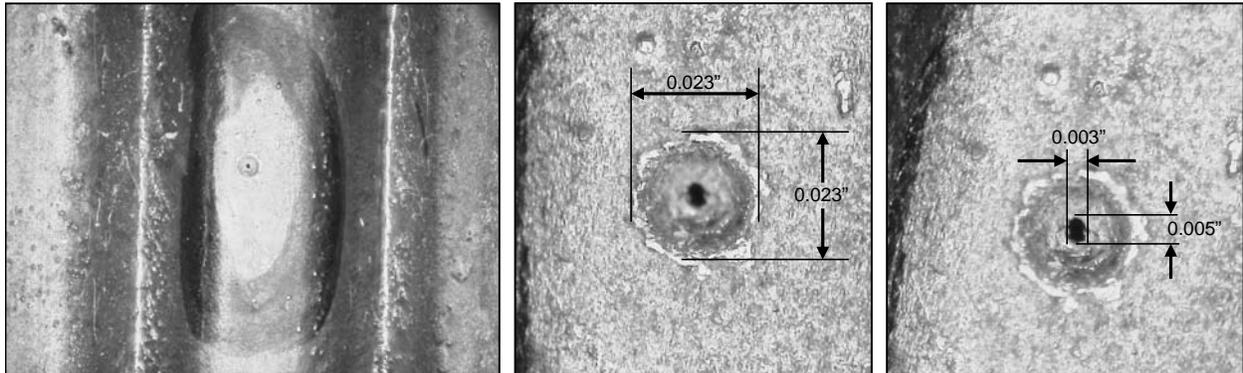
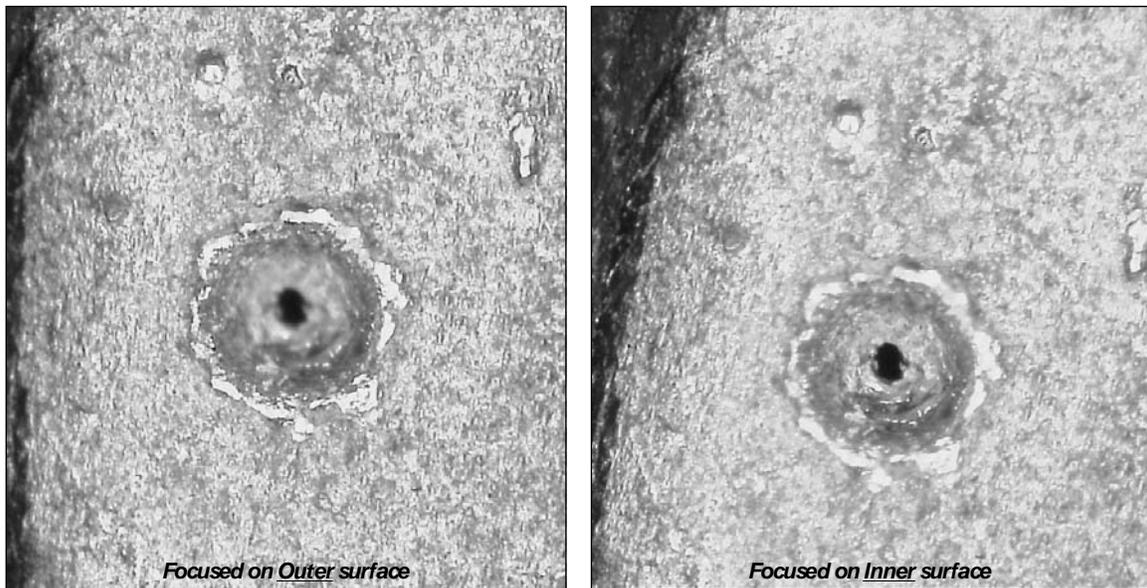
Figure 24. SSME nozzle tube 358 impact details.

Since there were no samples obtained from the impact site, the origin of impact is unknown, but the fact that a perforation occurred in the high-density nozzle tube material suggests that the impactor was not a low-density meteoroid. If the projectile was stainless steel (density = 8 g/cc), impacting with a velocity of 9 km/s and an impact angle of 45 deg, it would have had an estimated equivalent diameter on the order of 0.2 mm. A lower density aluminum particle (2.8 g/cc) at the same impact velocity and angle would have an estimated equivalent diameter on the order of 0.3 mm [Christiansen et al., 1998, equation (13), page 62].
