NASA/TP-2007-213733

Johnson Space Center Material Laboratory Reproduction and Failure Analysis of Cracked Orbiter Reaction Control System Niobium Thruster Injectors

*Willard L. Castner
Jeremy B. Jacobs
Lyndon B. Johnson Space Center
Houston, Texas*

March 2007

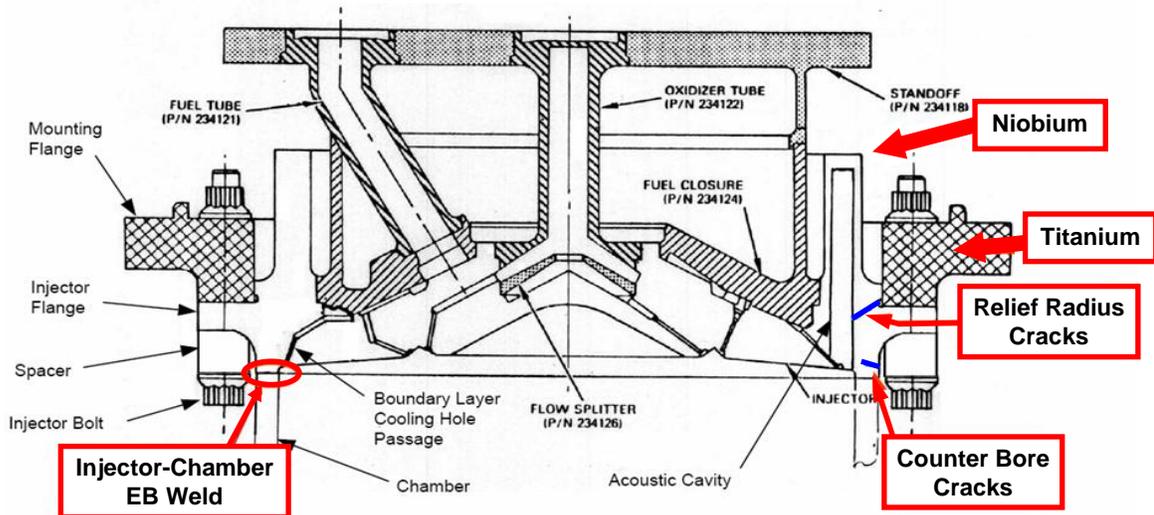
Figure 3 – Cross section of injector showing location of cracks found in S/N 120. (Note: Figure is rotated 90 degrees from Figure 2.)

The cracks in the relief radius were in all cases far more numerous and far more extensive than the counter bore cracks. In some cases, the relief radius cracks extended nearly all the way around the injector. The surface appearance of the cracks is shown in Figure 4 and Figure 5.

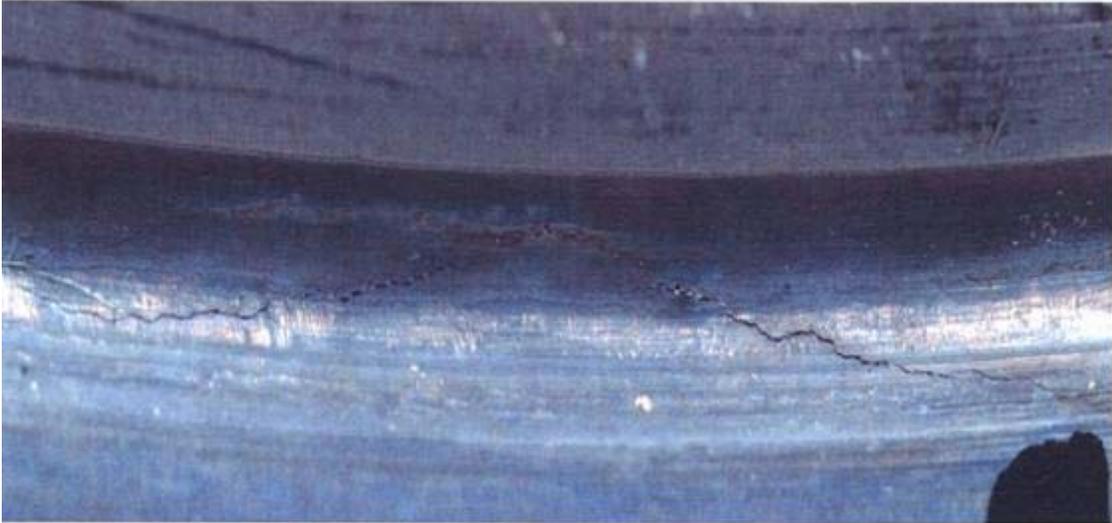
Figure 4 – Cracked relief radius from S/N 120 holes J to K.

The rough-machined surfaces adjacent to the cracks will be the subject of additional discussion later in this report. The cracks in the relief radius initiated in the radius and propagated at approximately 45 degrees towards the acoustic cavities and the combustion chamber. In some cases (in 1979 and 1982), the cracks actually reached the acoustic cavities, which resulted in a leak path from the combustion chamber to the exterior of the injector. A metallurgical cross section through a typical relief radius crack is shown in Figure 6.

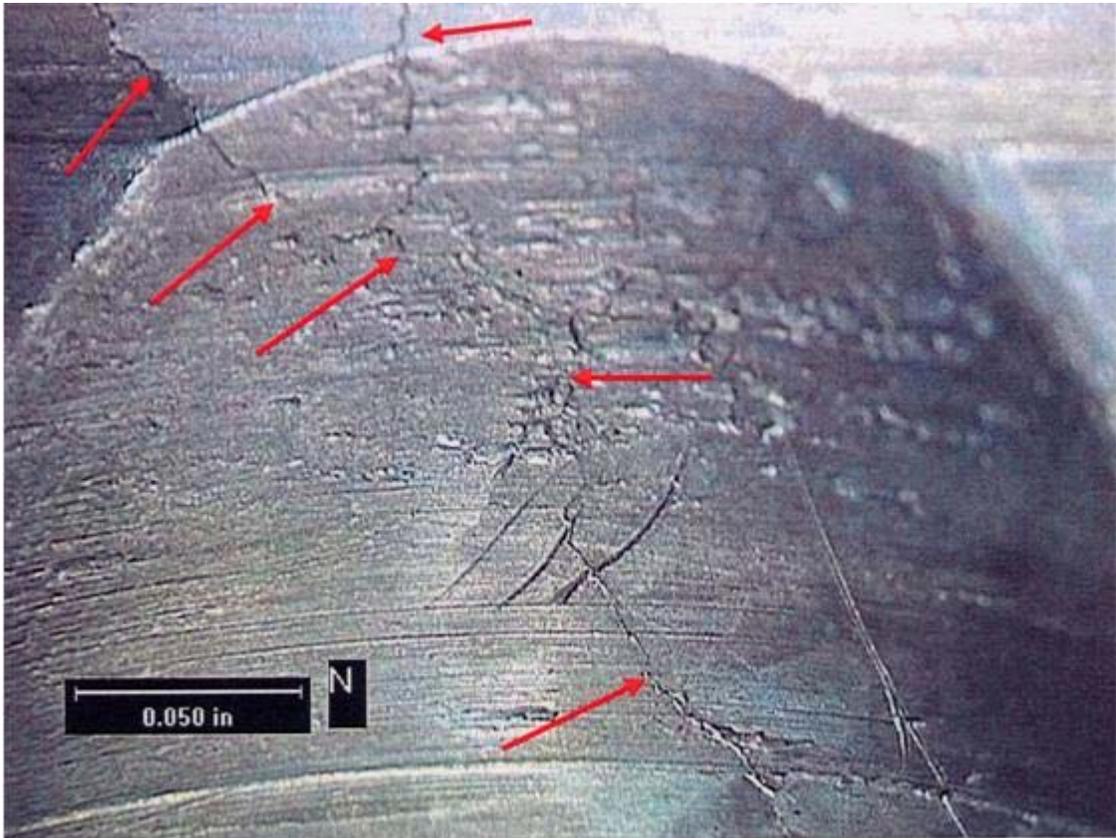
Figure 5 – Cracked counter bore from S/N 120 hole N.

The counter bore cracks are less of a concern than the relief radius cracks due to differences in the expected outcome from a potential burn-through. Burn-through of a through-crack in a counter bore location will result in an exterior leak path that directs the hot combustion gases onto a wire wrap (reference Figure 2 and Figure 3), which results in a system shutdown (the wire wrap was a thruster modification that was added to protect against a burn-through of the combustion chamber). The resulting flow path from burn-through of a relief radius through-crack could result in combustion gas impingement upon surrounding structure and could potentially result in a loss of vehicle.

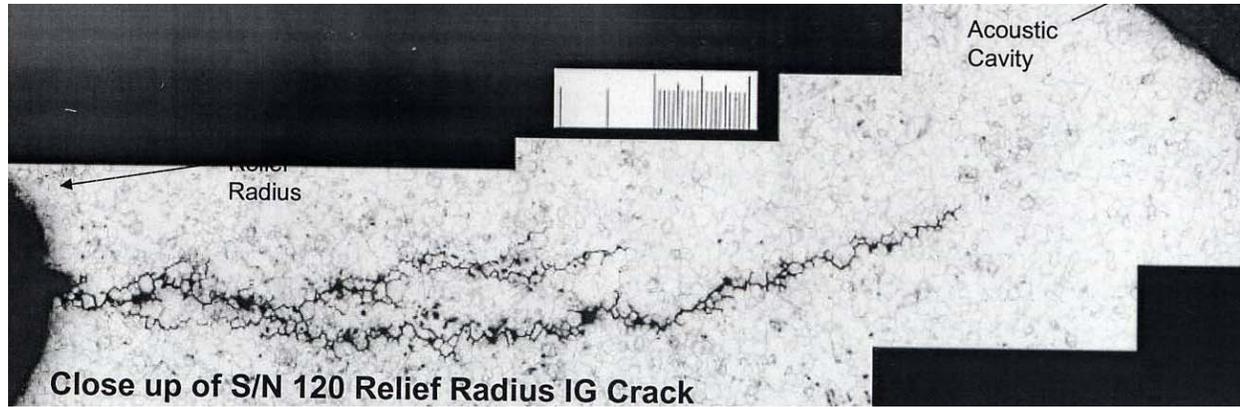
Figure 6 – Shows intergranular nature of S/N 120 relief radius crack.

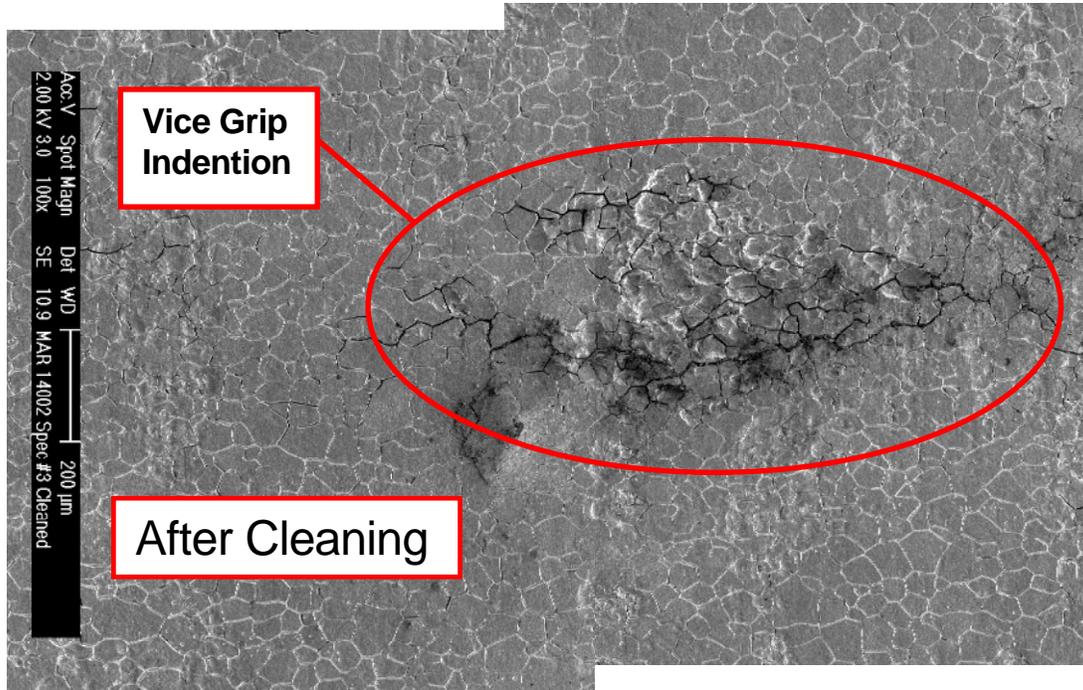
Specimen 3 was the first test specimen in which cracking was successfully produced. The test conditions for Specimen 3 consisted of clamping the titanium and niobium together in the DMA test fixture as in Figure 8, loading the specimen to 40 KSI, and applying a drop of the niobium etch to the titanium/niobium interface and allowing the etch to air dry. The etch was reapplied several times during the day and was allowed to air dry overnight. The following day, the DMA heating apparatus was put in place and the specimen was heated to 600°F for 48 hours. After completing the 48-hour temperature exposure, the specimen was examined in a stereomicroscope and in the SEM. No obvious cracking was noted, but the actual metal surface was completely hidden by the oxide film that was present. After cleaning by a short immersion in the etchant, a patch of intergranular attack was observed on the high stress HF exposed surface. It appeared to be intergranular corrosion rather than a crack. This condition is shown in Figure 11.

Figure 11 – Specimen 3 showing intergranular attack (after cleaning), 100x Magnification. Note that cracking is commensurate with the location of a vice grip indentation.

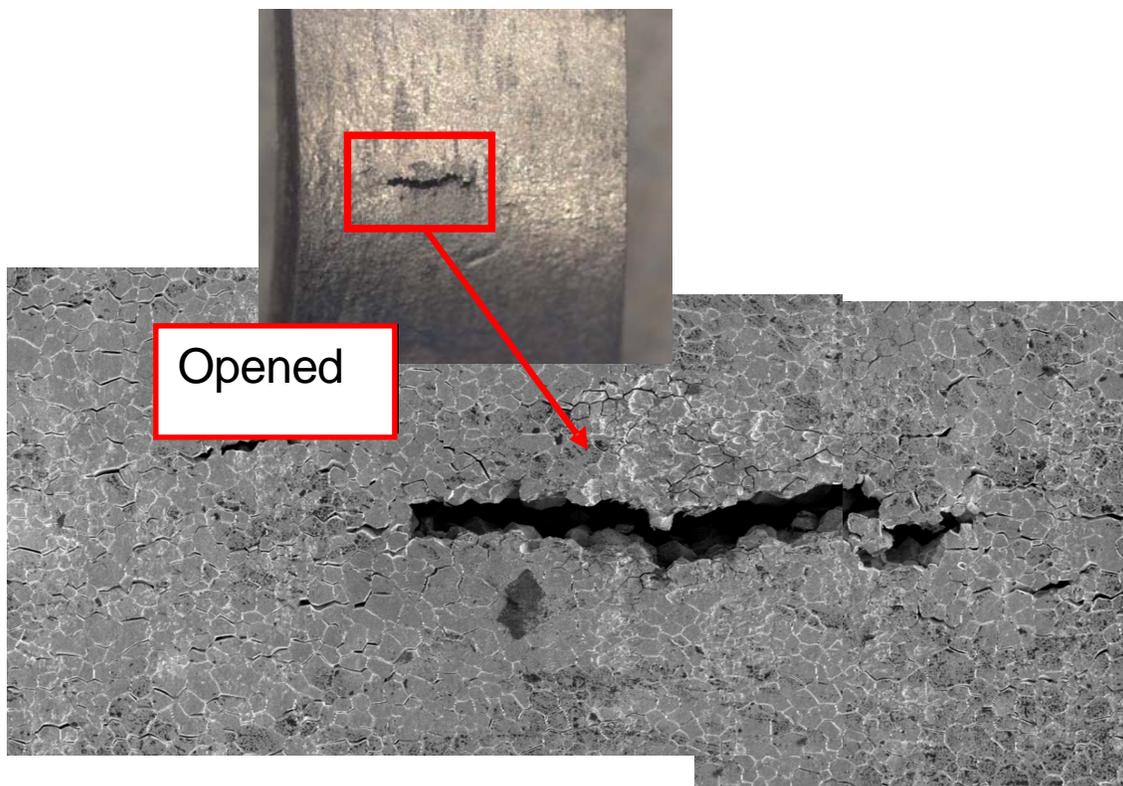
Figure 12 – Specimen 3 after bending.

A crack of significant depth approximately halfway through the thickness of the specimen was opened up. Examination of the fracture surface showed the crack was 100-percent intergranular in nature and had a very distinct blue/purple appearance. These fracture surface features are shown in Figure 13 and Figure 14 and were very similar to the cracks in the thrusters and the Brownfield specimen.

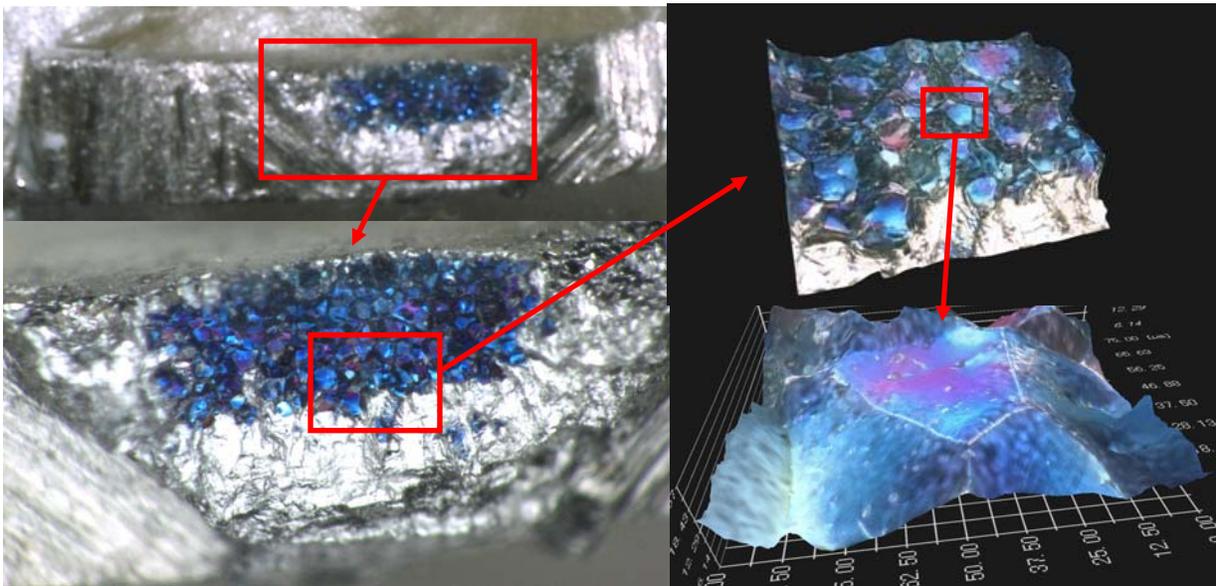
Figure 13 – Specimen 3 Microscopy: Upper (~20x) and Lower (~40x) Left Images – Optical stereomicroscope images of fracture showing intergranular nature/“rock candy” appearance of crack morphology. Upper (~150x) and Lower (~1500x) Right Images – High magnification close-ups via Keyence digital microscope. All images display the vivid blue discoloration of fracture surface (result of oxidation).

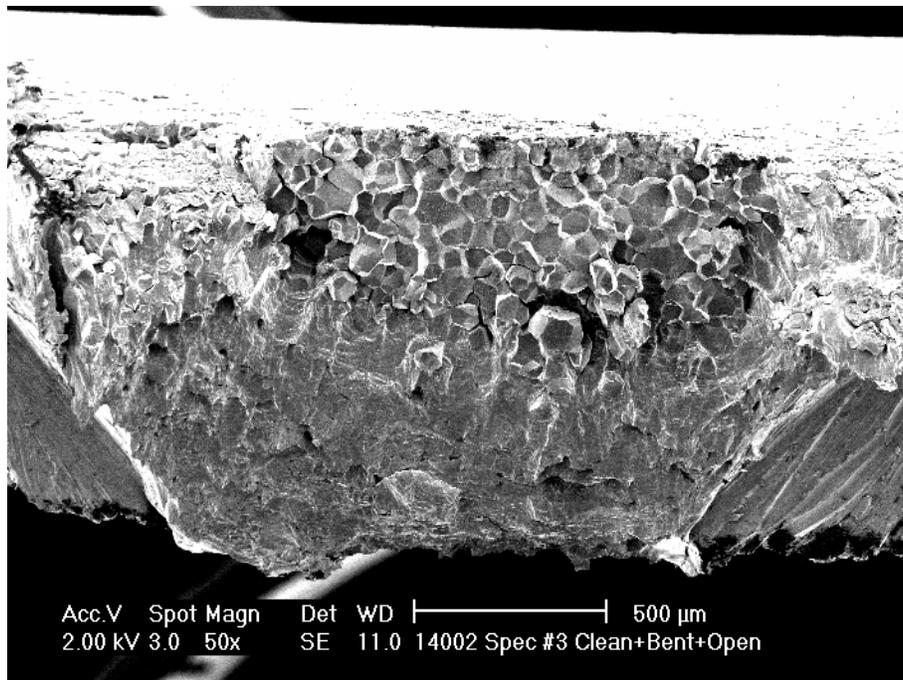
Figure 14 – Specimen 3 fracture surface showing intergranular nature of crack. Magnification: 50x.

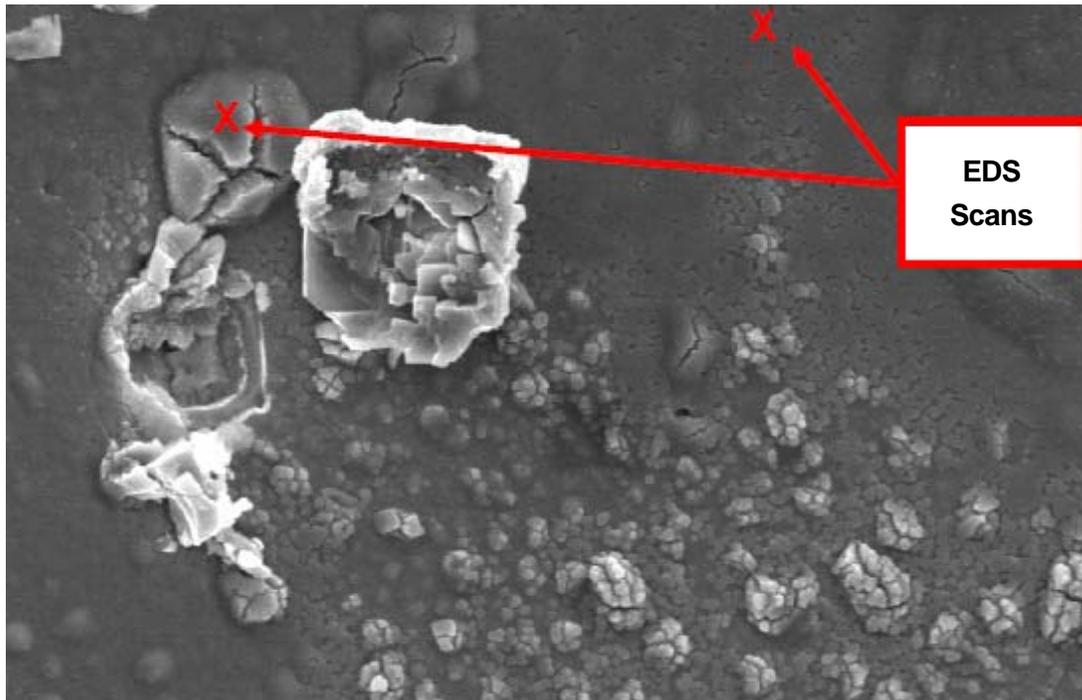
Figure 15 – Specimen 3 fracture surface eruptions in the oxide film referred to as “popcorn.” EDS analyses were performed on the areas noted and are presented in Figure 16 and Figure 17. Magnification: 5000x.

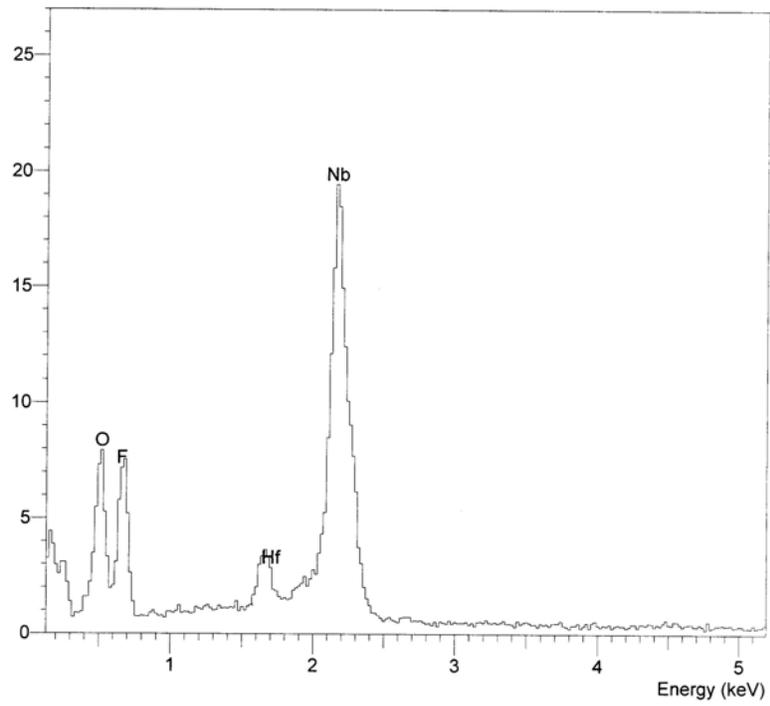
EDS analysis of a popcorn feature and the adjacent surface showed high oxygen and fluorine with the popcorn feature having a significantly higher fluorine content. These analyses are shown in Figure 16 and Figure 17. The similarities between the crack in this specimen and the thruster cracks indicated that a very good reproduction of the thruster cracking had occurred. These similarities included the 100-percent intergranular crack propagation, the blue discoloration, the presence of oxygen and fluorine, and the presence of the popcorn features.

Figure 16 – EDS analysis of popcorn feature in Figure 15. Note high fluorine content and compare to analysis in area adjacent to popcorn feature.

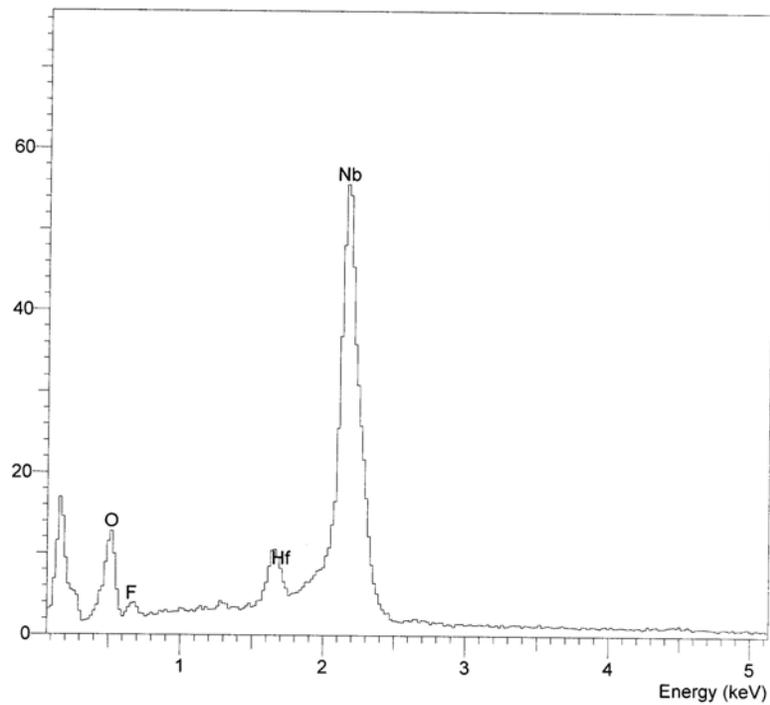
Figure 17 – EDS analysis of area adjacent to popcorn feature showing a much reduced fluorine content.

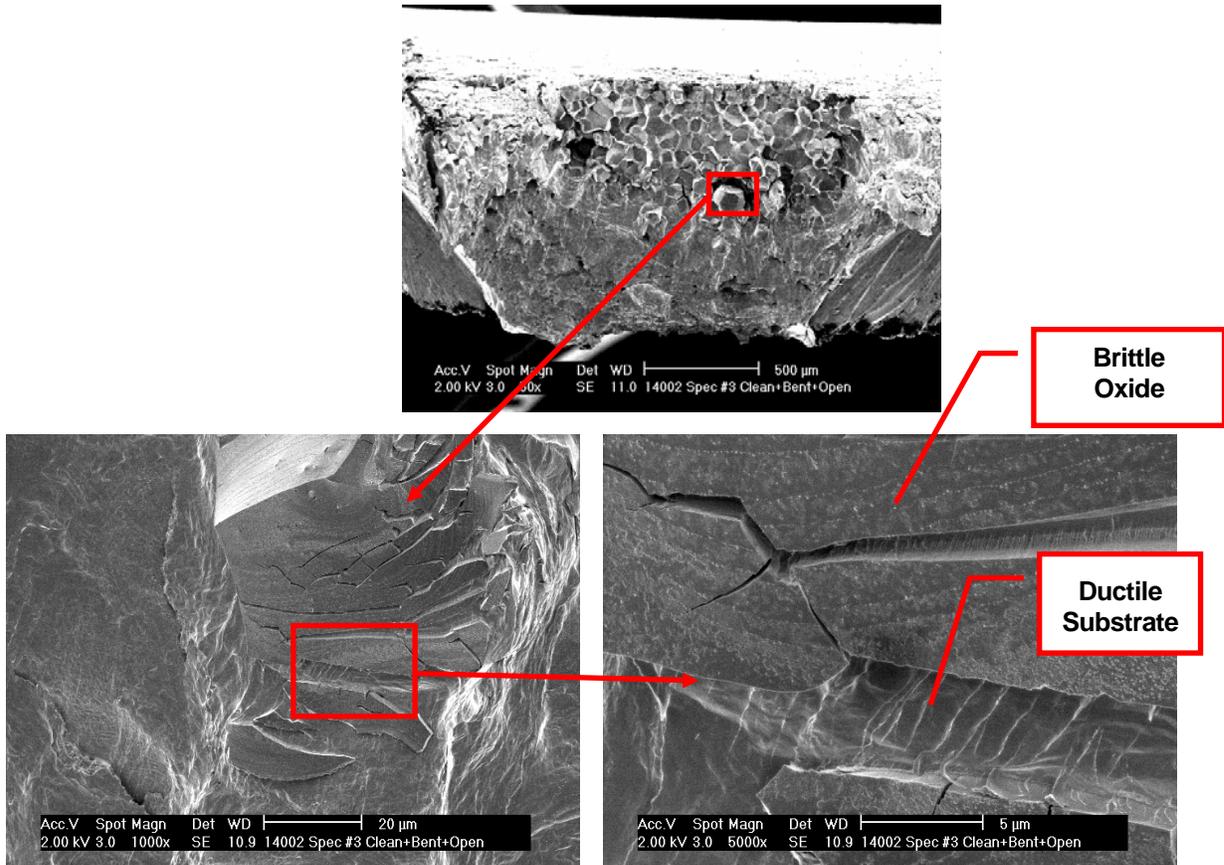
An unusual surface feature that was noted in this specimen and in most of the other specimens was cracks or separations in the oxide film on the grain boundary surfaces. A typical oxide film separation is shown in Figure 18. This feature was only observed at or near the tips of the cracks. It was also noted in the original failure analysis of S/N 128 (Ref. 1) and was referred to as “broken grains.” These separations in the oxide film attest to the very brittle nature of the oxide film and results from the plastic strain the underlying ductile niobium undergoes at the crack tip when the cracks are opened for examination. This condition was another fracture surface feature that was reproduced during these tests.

Figure 18 – Cracking of the brittle intergranular oxide near the intergranular crack tip (as a result of sample overloading to separate fracture surfaces).

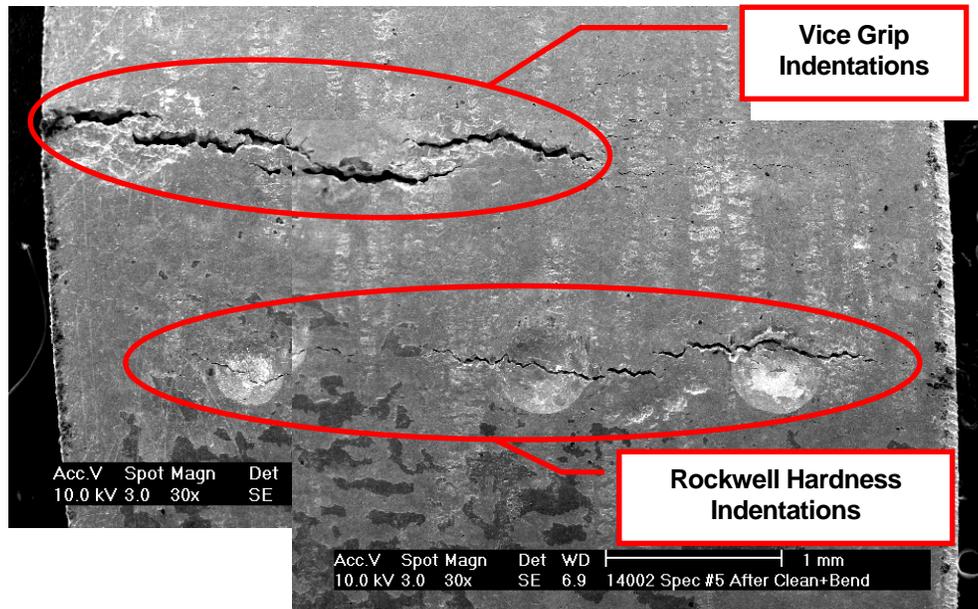
Specimen 5 was a repeat of the test conditions of Specimen 3 to be sure that the cracking could be repeated. The only difference was the addition of the hardness indents. After completing the 600°F temperature exposure and cleaning with the etchant, cracking was evident but obscured by remnants of the oxide film. After bending, the extent of the cracking was very evident as shown in Figure 19.

Figure 19 – Specimen 5 shows cracks extending out of each hardness indent as well as several vise indents. Magnification: 30x.

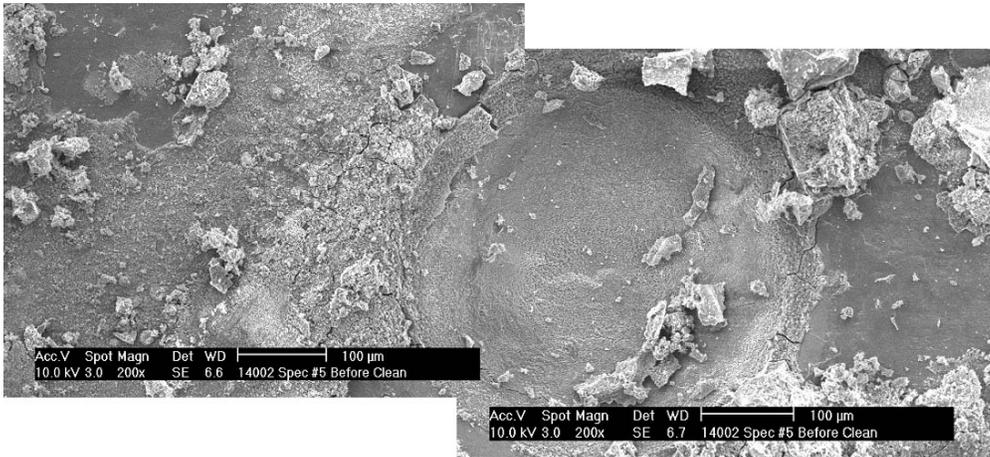
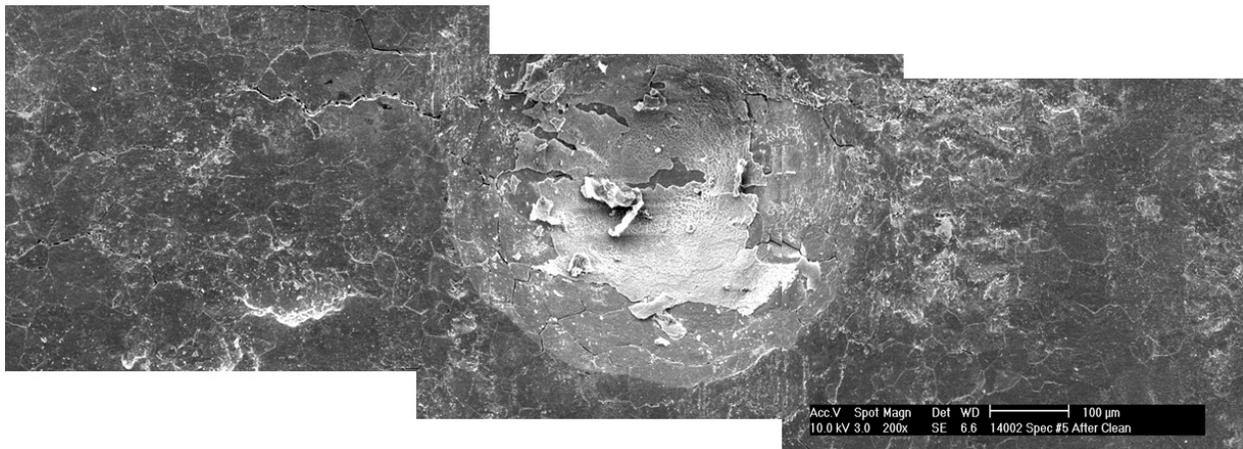
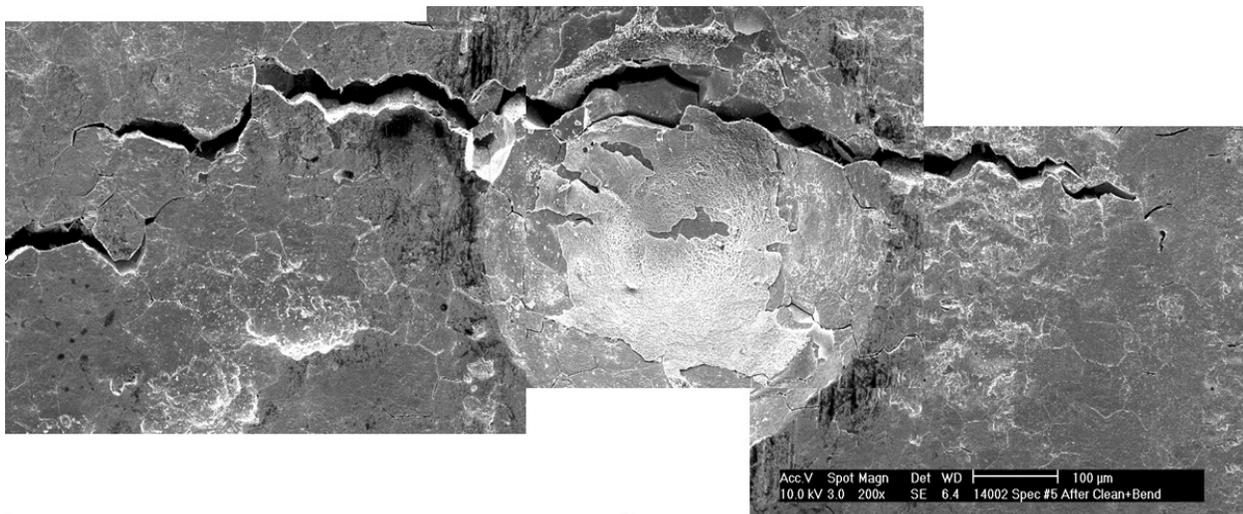
Cracks initiated in and grew out of each of the hardness indents as well as several of the vise indents. The difficulty of seeing the cracks is illustrated in Figure 20 where the same hardness indent is shown in the as-tested, as-cleaned, and as-bent conditions. Because of crack tightness, each specimen had to be bent through the expected crack location to be sure whether cracking had occurred. It is obvious in the as-bent photograph that the cracks had propagated in an intergranular manner.

Figure 20 – Specimen 5 comparing the as-tested, as-cleaned, and as-bent surfaces. The need to clean and bend the specimen to verify the presence of cracks is evident. Magnification: 200x.

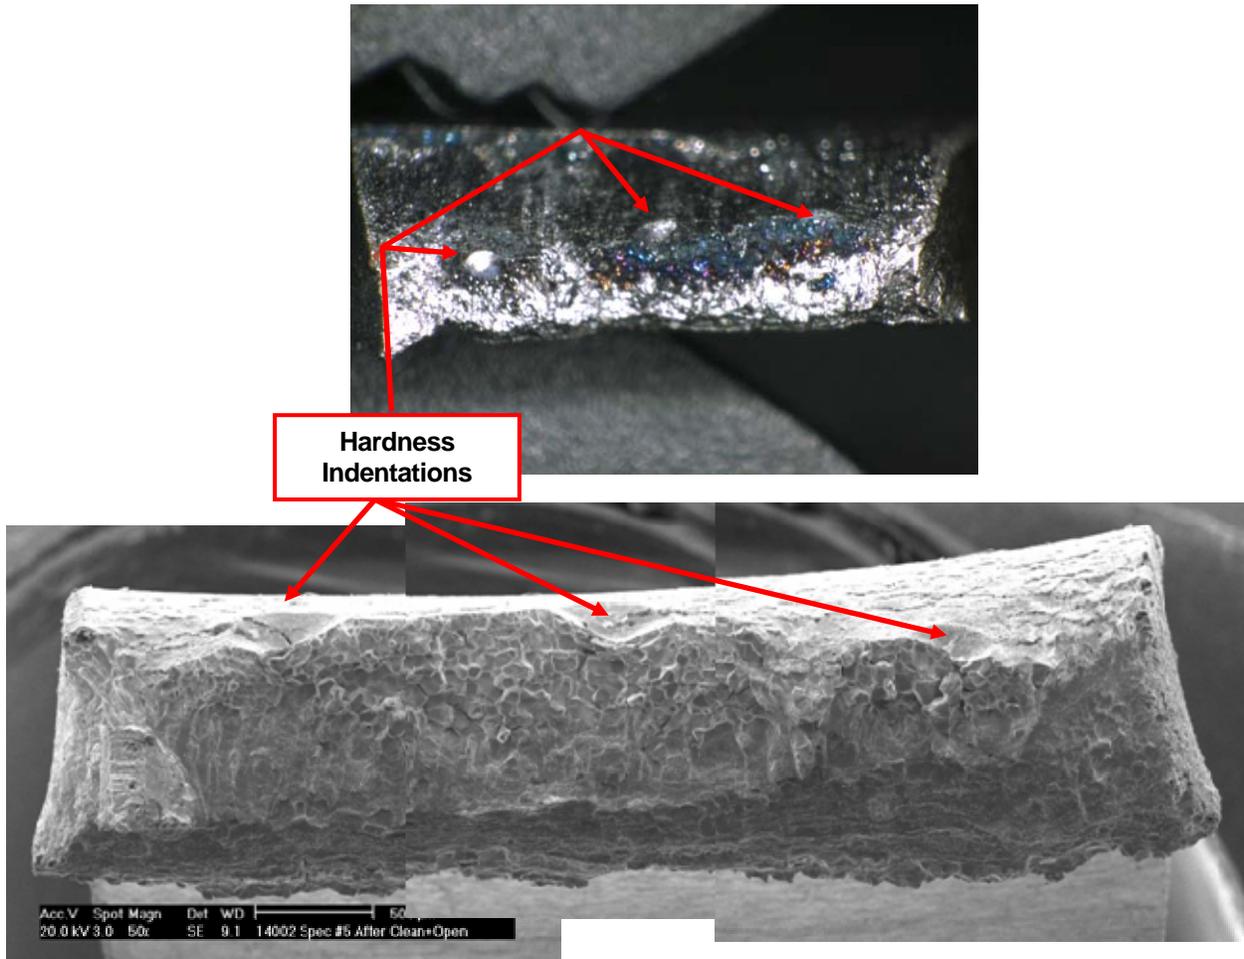
The crack faces were exposed by bending back and forth until separation occurred. The crack surface is shown in Figure 21. Again, the cracks were 100-percent intergranular and had a blue discoloration. At higher magnifications in the SEM, the popcorn features were again present as shown in Figure 22.

Figure 21 – Specimen 5 showing the intergranular nature of the crack surface. Cracking extends about halfway through the thickness. Hardness indents are visible at the specimen surface. Magnification: 50x (lower image).

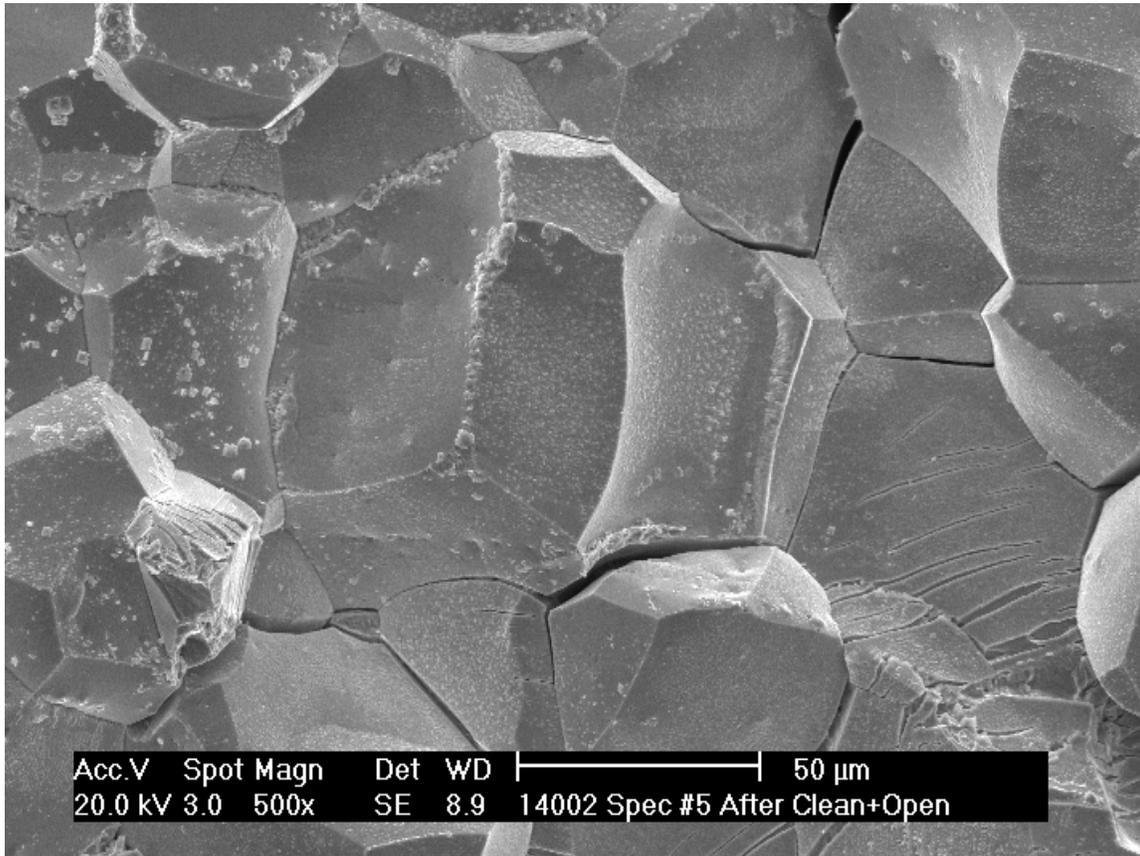
Figure 22 – Specimen 5 showing intergranular facets near crack tip. Popcorn-like features are present on most of the facets. Cracking of the oxide is visible. Magnification: 500x.

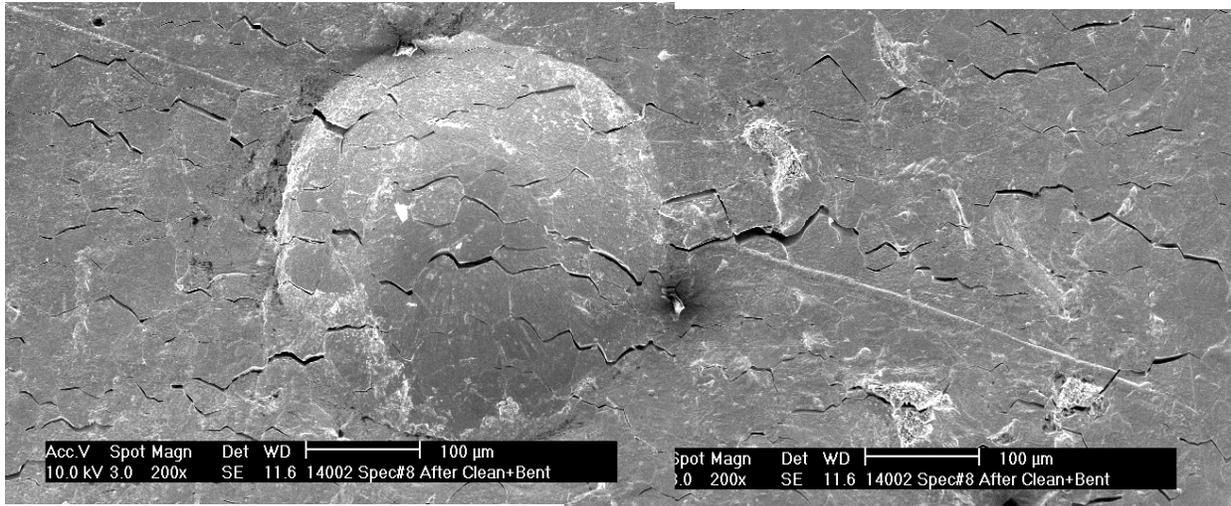
Specimen 8 was tested at 500°F. After exposure, only minor cracking could be found, as shown in Figure 23. Based upon evaluation of the surface via SEM and comparison with other test coupons, it was determined that these cracks were shallow (no attempt was made to open them). The surface appearance indicates that the cracks were intergranular.

Figure 23 – Specimen 8 showing intergranular cracks after 500°F exposure. Magnification: 200x.

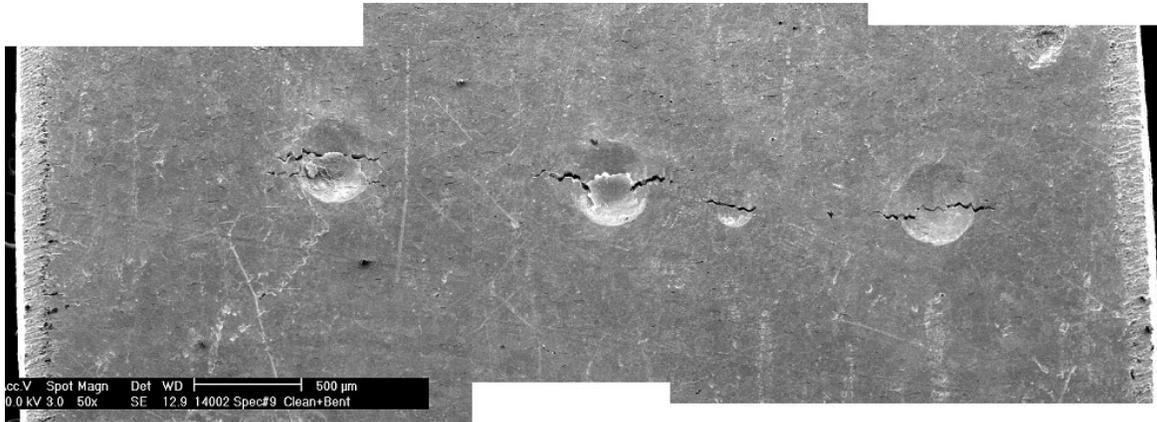
Specimens 9 and 11 were tested at 3 hours and 168 hours, respectively. Both specimens had about the same degree of cracking as shown in Figure 24 (Specimen 9) and Figure 25 (Specimen 11). These results indicate that the cracking process begins early in the exposure. The cracking process under these conditions appears to be self-limiting in some way since the test is a constant load test and the cracking should accelerate as the crack grows. Apparently, the reactive species are used up or depleted early in the temperature exposure cycle, and the cracking is subsequently arrested. If the cracking species were in abundant supply or regenerative in nature, the constant loading of the test would necessarily have grown the cracks to failure (certainly in the 168-hour test).

**Figure 24 – Specimen 9 showing degree of cracking after 3 hours of exposure to HF at 600°F.
Magnification: 50x.**

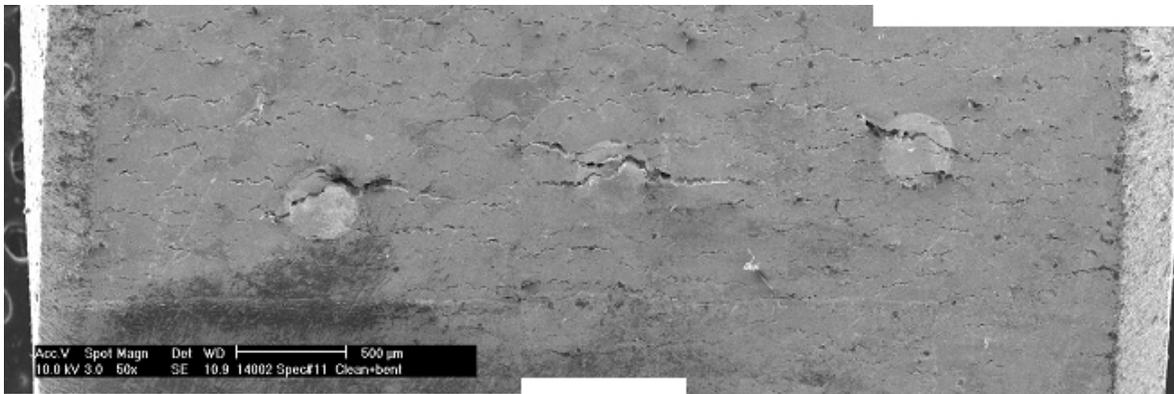
**Figure 25 – Specimen 11 showing degree of cracking after 168 hours of exposure to HF at 600°F.
Magnification: 50x.**

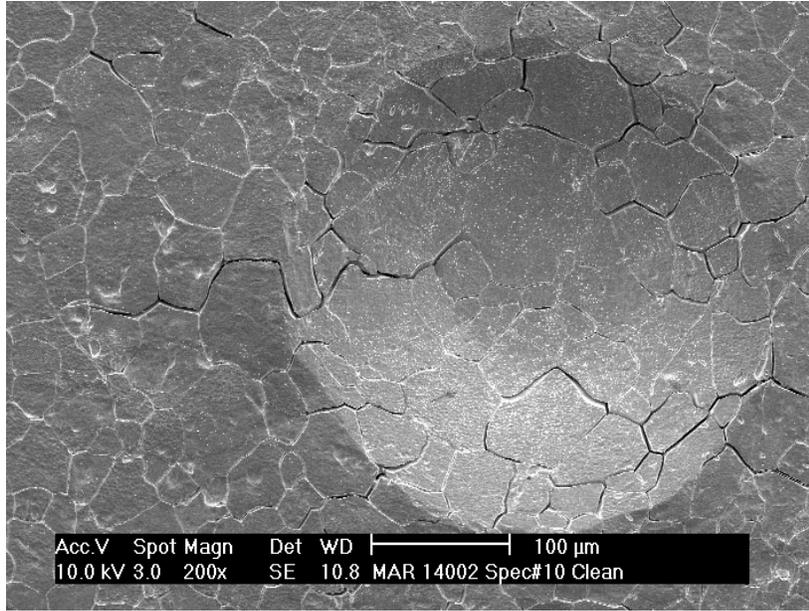
Figure 26 – Specimen 10 showing crack locations after HF, 600°F, 48 hours, and etch cleaning. Compare to Figure 27 after water exposure. Magnification: 200x.

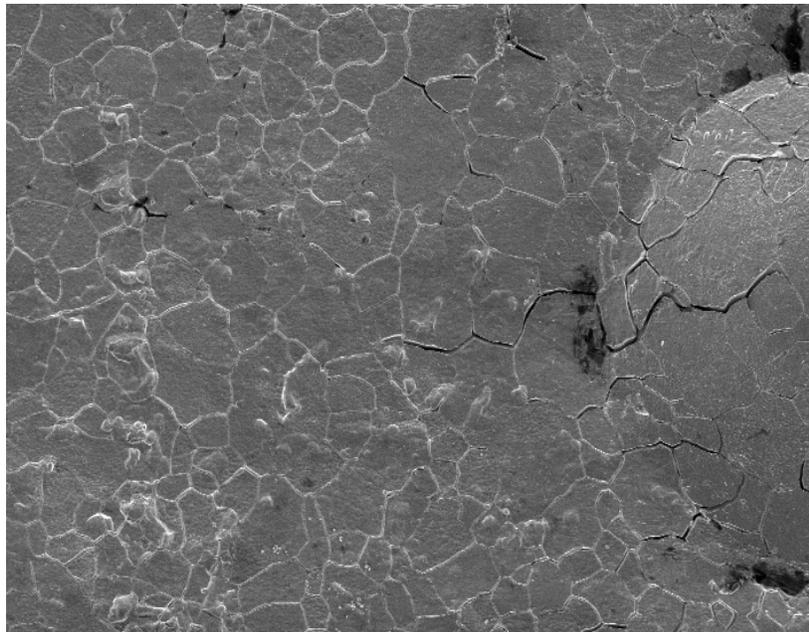
Specimen 10 was tested at 600°F for 48 hours to produce cracking that could subsequently be exposed to water at room temperature to see if the cracks would propagate when exposed to a simulated wet/humid environment. After 48 hours at 600°F, the specimen was etchant-cleaned so that the cracks that were induced could be documented in the SEM. After the cracks were documented, the specimen was placed back in the load fixture and reloaded to 40 KSI with the titanium cover in place. Drops of water were periodically applied to the niobium/titanium interface. This re-wetting occurred several times a day to keep the cracked surface wet. This water exposure was continued for 260 hours. Before and after (water exposure) comparisons at the same magnifications showed no evidence of crack growth. These comparisons are shown in Figure 26 and Figure 27. Although this test was not a standard corrosion test, it was quite sensitive in that deflection of the test article was actively measured in the DMA during testing, and crack growth was subsequently measured in the SEM at high magnification. This look at exposure of these cracks to water shows that short-term exposure to moisture and humidity does not grow the cracks.

Figure 27 – Specimen 10 showing exact same area as Figure 26 after 260 hours exposure to water and 40 KSI constant stress. No change in the apparent crack locations is evident. Magnification: 200x.

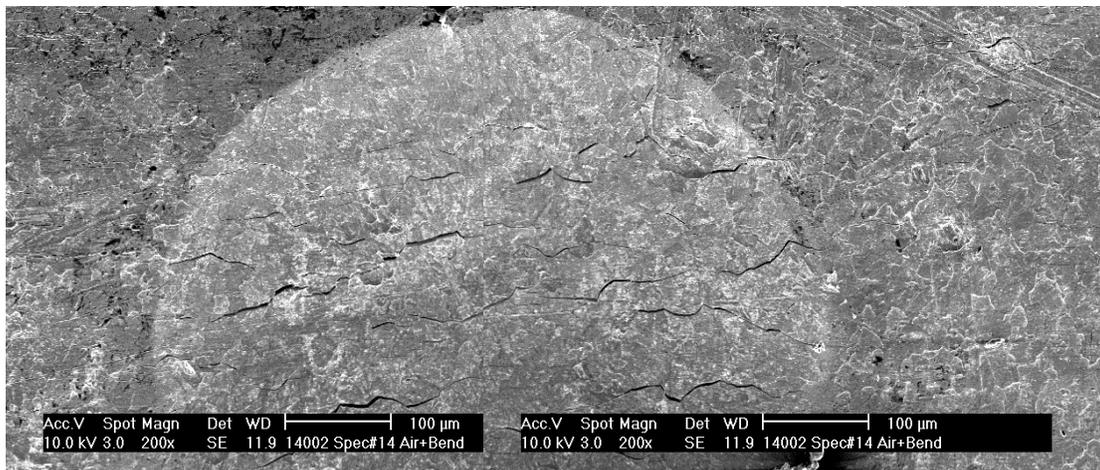
Specimen 14 was a test conducted in air at 600°F for 48 hours to establish a baseline for comparison with the other test specimens. After the 600°F air exposure, this specimen was mildly bent and numerous short shallow cracks were opened up as shown in Figure 28. Apparently, a minor amount of grain boundary oxidation occurs in this alloy when it is exposed to air at 600°F for 48 hours. Upon bending, the oxidized brittle grain boundaries crack.

Figure 28 – Specimen 14 baseline 600°F, 48 hours test in air. Shallow intergranular cracks evident in indent after bending. Only short straight cracks in oxide film evident between indents. Magnification: 200x.

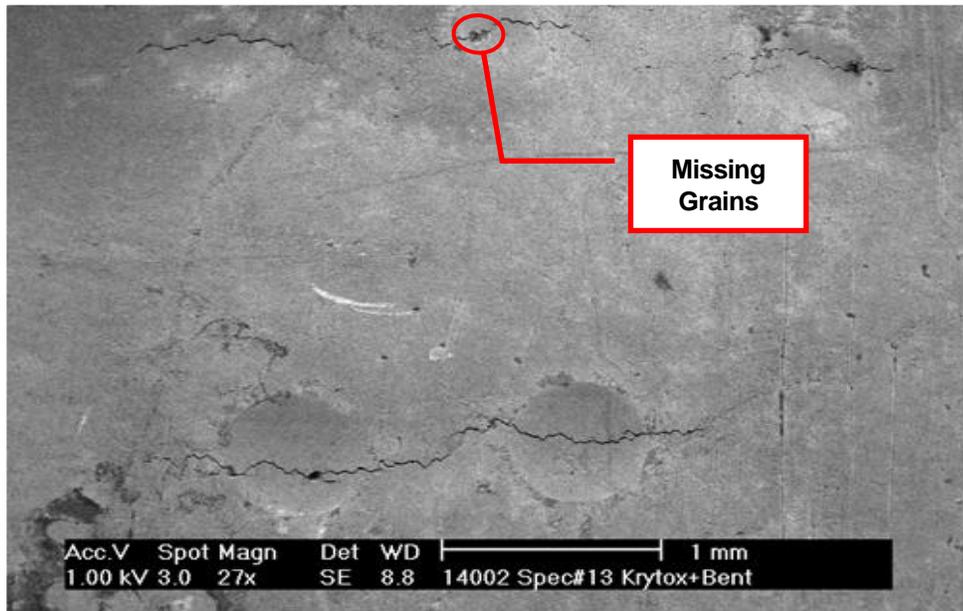
Specimen 13 was clamped in the DMA test fixture with a titanium cover and loaded to 40 KSI. After a drop of Krytox was applied to the titanium/niobium interface, the specimen was heated to 600°F for 48 hours. After completing the exposure, the specimen was examined in the SEM. Cracks were present in all of the hardness indents as shown in Figure 30.

**Figure 30 – Specimen 13 showing cracks in each of the hardness indents.
Test conditions were 40 KSI + Ti cover + Krytox + 600°F + 48 hours.
Magnification: 27x.**

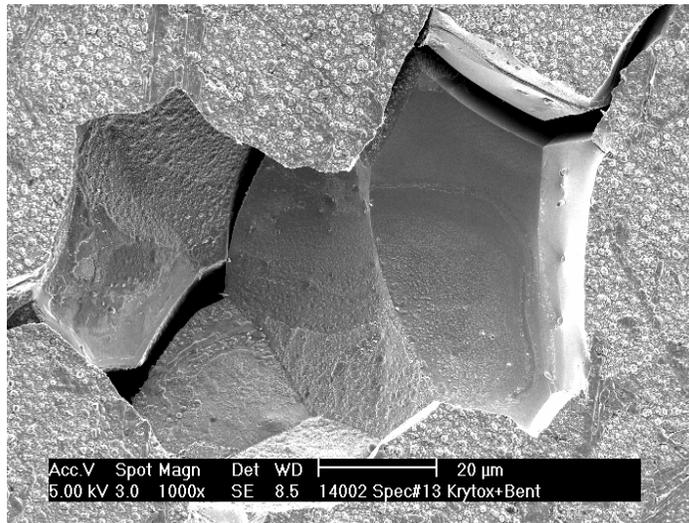
Crack propagation was obviously intergranular in nature as some grains were missing from the crack edges before the crack was even opened. The missing grains are shown in Figure 31. The popcorn features were present on the exterior surface as well as the grain faces as shown in Figure 32.

Figure 31 – Specimen 13 after Krytox exposure showing missing grains. The intergranular nature of the crack is emphasized. This area is macroscopically visible in the upper center indent in Figure 30. Note the thickness of the oxide film in upper right. Magnification: 1000x.

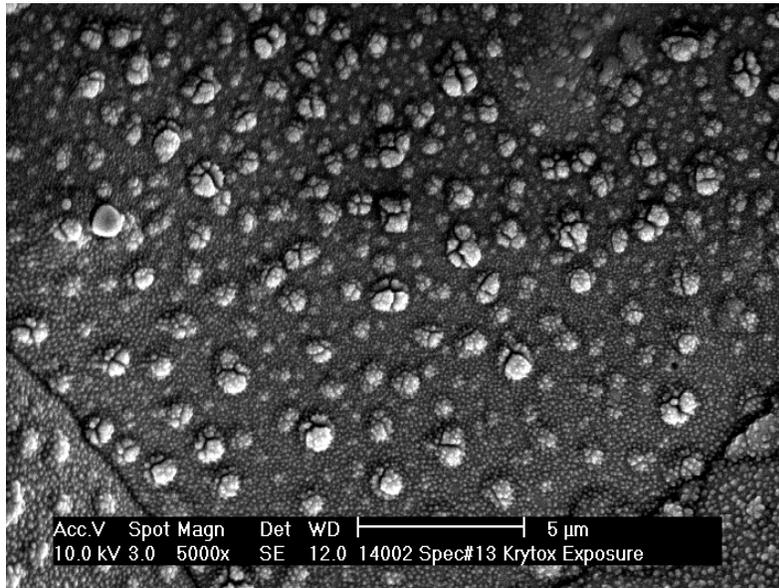
After opening the cracks, the 100-percent intergranular nature of the crack propagation was confirmed. The crack surface was dark gray to dark blue in appearance. An EDS analysis of a typical grain facet showed high oxygen and carbon peaks with a minor fluorine peak. The area analyzed is shown in Figure 33 and the analysis is shown in Figure 34.

Figure 33 – Specimen 13 intergranular facet near crack origin showing popcorn-like features in the oxide film. The EDS analysis of this surface is shown in Figure 34. Magnification: 5000x.

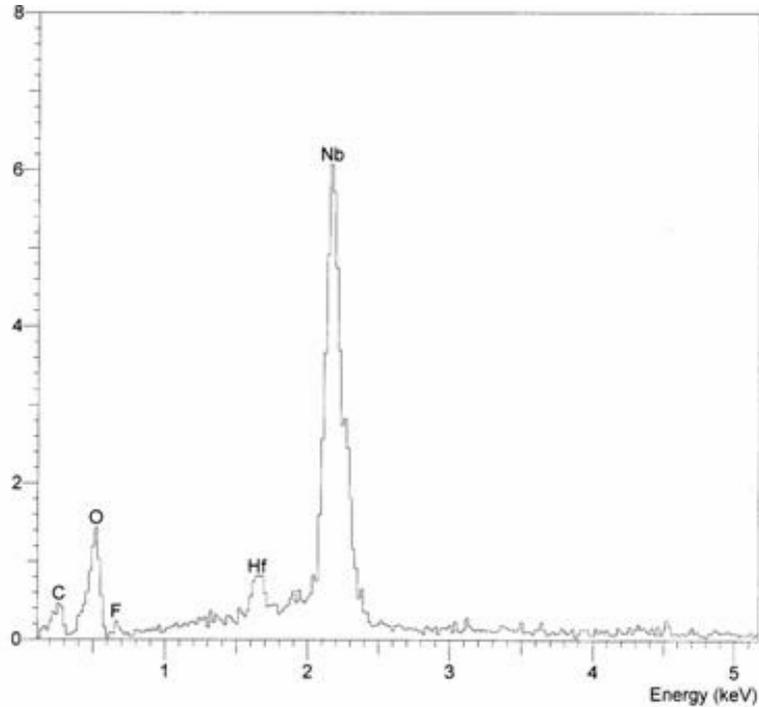
Figure 34 – Specimen 13 EDS analysis of popcorn features and surrounding area shown in Figure 33. Oxygen and carbon peaks are significant, but the fluorine peak is barely discernible.

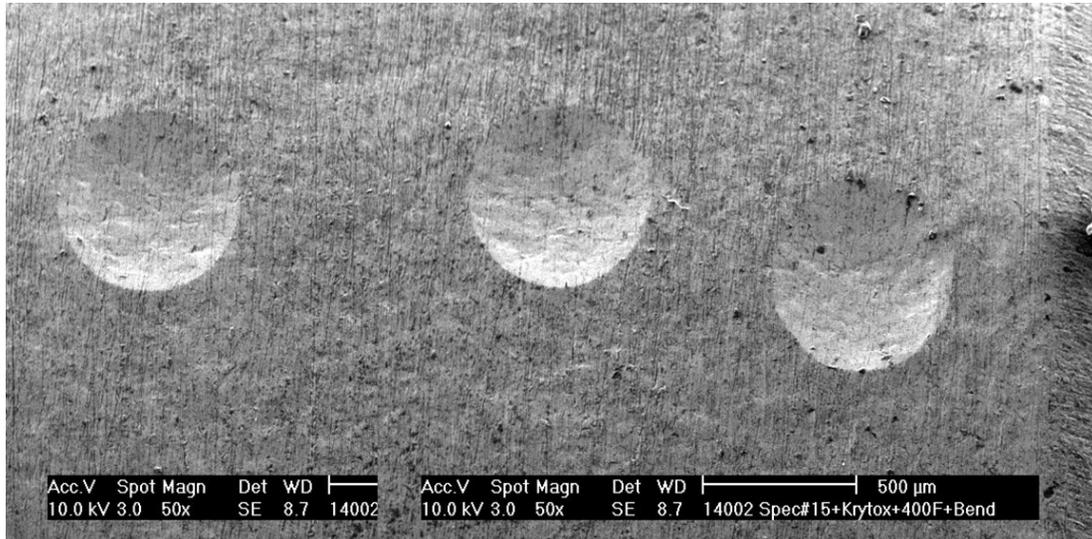
Specimens 15 and 16 were tested at lower temperatures, Specimen 15 at 400°F for 48 hours and Specimen 16 at 500°F for 48 hours. The results were the same as occurred in the HF tests at lower temperatures. No cracking was found in the 400°F test specimen and only minor cracking was found in the 500°F test specimen. The appearance of the surface of the 400°F specimen is shown in Figure 35 and the EDS analysis of the test surface is shown in Figure 36.

Figure 35 – Specimen 15 exposed to Krytox at 400°F for 48 hours showing no cracks are evident after bending. Magnification: 50x.

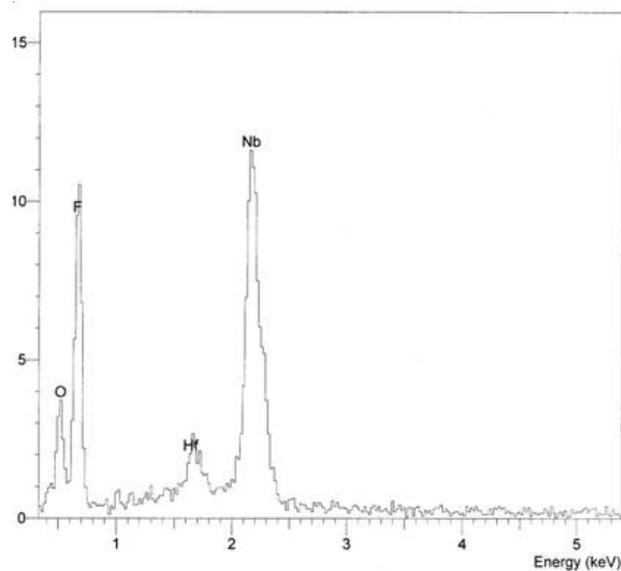
Figure 36 – EDS analysis of Specimen 15 between indents. The fluorine is very high after the 400°F exposure but decreases dramatically after the 600°F exposure as shown in Figure 34. Apparently, the fluorine is reacting and volatilizing in some manner.
