NASA/TP-2007-213733

Johnson Space Center Material Laboratory Reproduction and Failure Analysis of Cracked Orbiter Reaction Control System Niobium Thruster Injectors

*Willard L. Castner
Jeremy B. Jacobs
Lyndon B. Johnson Space Center
Houston, Texas*

March 2007

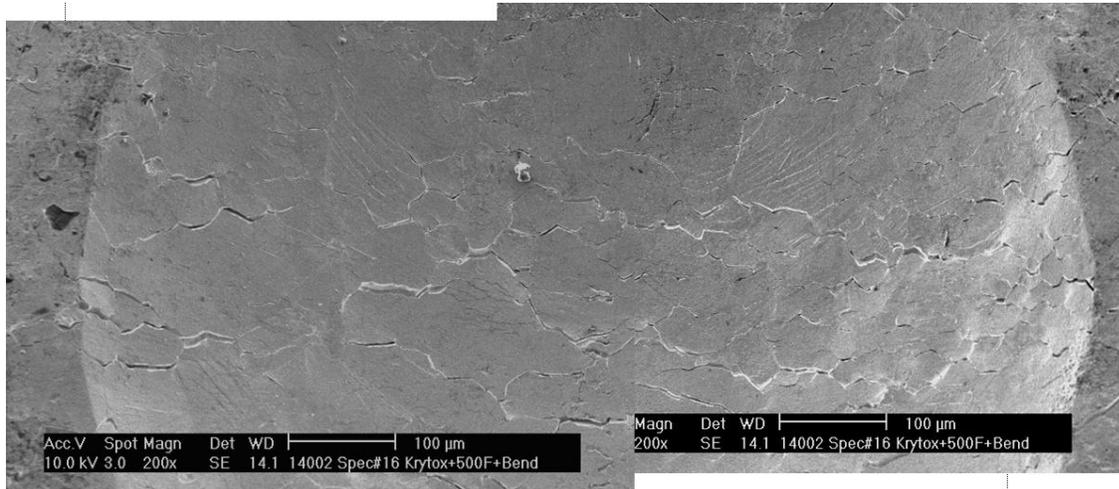
Figure 37 – Specimen 16 showing minor intergranular cracks in the hardness indent after the 500°F exposure and bending to open the cracks. Magnification: 200x.

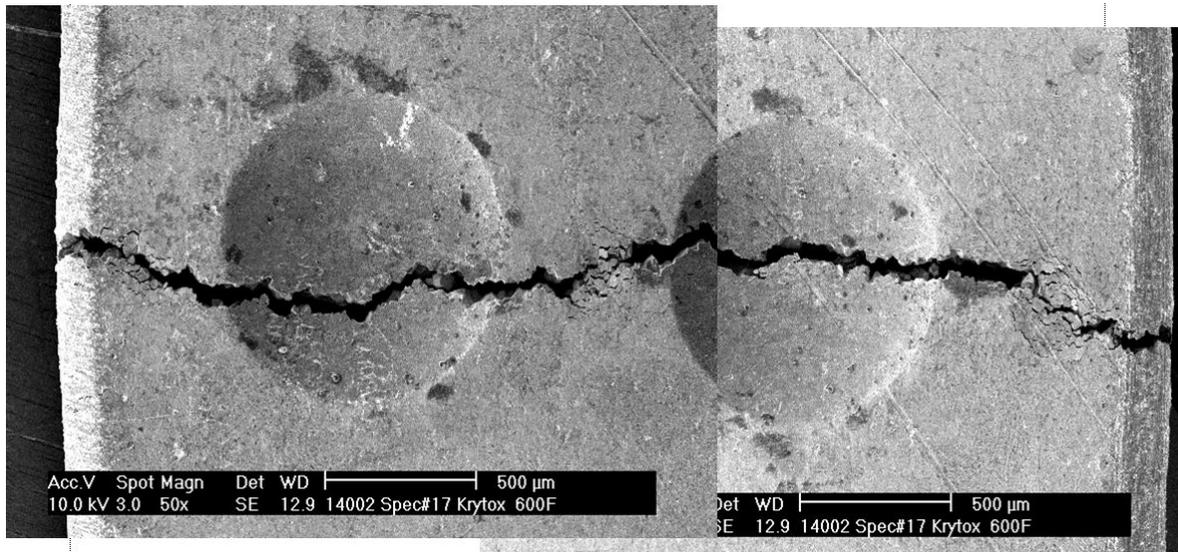
Figure 38 – Specimen 17 showing extensive cracking after 96-hour exposure. Note surface dimpling where crack tips intersected. The crack propagated through the entire thickness in an intergranular manner. Magnification: 50x.

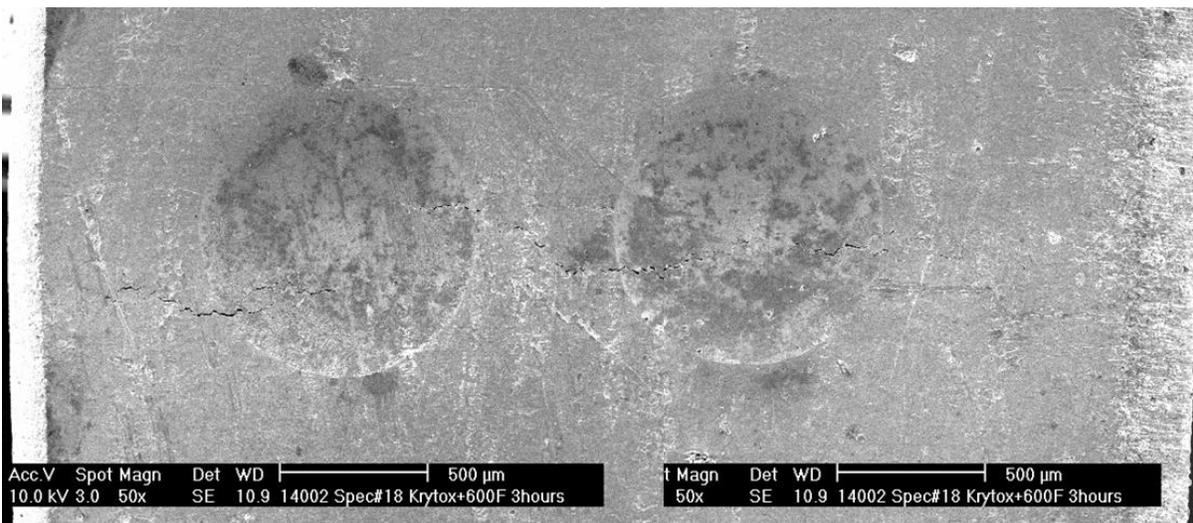
Figure 39 – Specimen 18 showing cracks after exposure to Krytox at 600°F for 3 hours. This illustrates that cracking began early in the exposure. Magnification: 50x.
