NASA/TP—2000–209760

Oxidation of Reinforced Carbon-Carbon Subjected to Hypervelocity Impact

March 2000

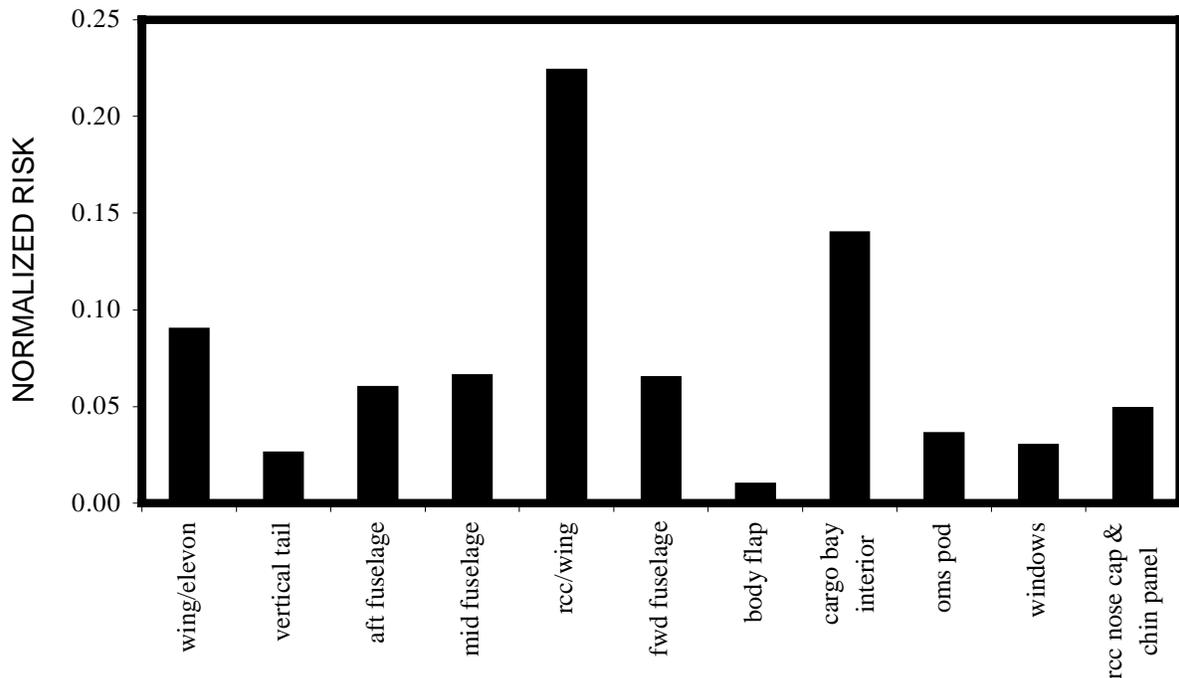
Figure 1. Meteoroid/orbital debris relative risks for various components using omnidirectional flux analysis.

During the early flights of the Space Shuttle, micrometeoroids and orbital debris were not recognized as a significant hazard to the Orbiters. However, more recent models of the space environment suggest that MOD pose a significant threat to the orbital vehicle. The RCC wing leading edge and nose cap are especially vulnerable to this MOD environment and have been identified as areas of the Orbiter that appear to pose the highest risk for critical failure. Figure 1 presents the relative risk of the RCC as compared to the other Orbiter components.

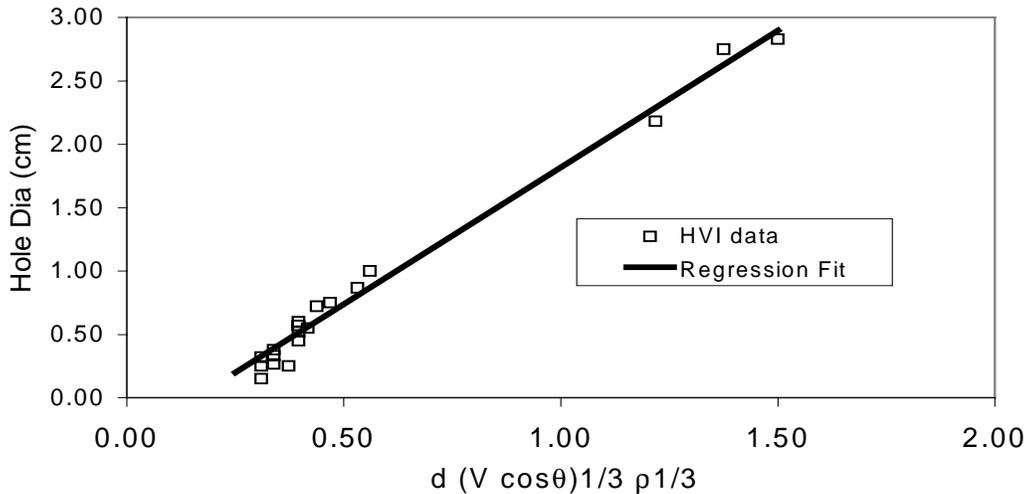
Figure 3. RCC hole size correlation.

Previous hypervelocity impact testing conducted at JSC had established the threshold for several damage modes on coated RCC samples. Equations have been developed relating impact conditions to RCC damage, such as penetration depth and hole size.^{4,5} An equation was developed to predict hole size when complete penetration of RCC occurs. This equation was used to predict the diameter/velocity required to create the three hole sizes used in this investigation. Figure 3 provides a comparison between predicted hole size and HVI data.

$$D_h = 2.20 d \rho_p^{1/3} (V \cos\theta)^{1/3} - 0.36$$

Where: D_h - hole diameter, cm
 d - Impacting particle diameter, cm
 ρ_p - density of impacting particle, g/cm³
 V - particle velocity, km/s
 θ - impact angle, deg

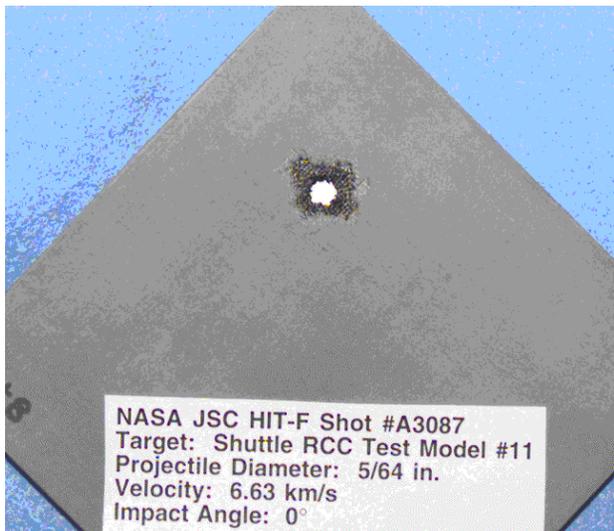
Figure 4. Typical posttest picture of a hypervelocity-impacted 6-in. x 6-in. RCC panel.

Table 1 presents a summary of the impact test results, and figure 4 shows a representative photo of the target damage. Figure 4 shows the result of a 5/64-in.-dia. aluminum sphere impacting the 6-in. x 6-in. RCC sample at 6.63 km/sec normal to the surface. Because the SiC coating is brittle, the coating is damaged in an area around the impact site over 10 times larger than the projectile diameter. The hole through the specimen exposes the RCC substrate over an area 4 times larger than the projectile diameter. The graph in figure 5 illustrates the approximate front and back coating damage diameter as a function of impact energy. The coating on the rear side of the RCC is damaged in a wide area, larger than the front. Internal damage in the RCC substrate can extend significantly beyond the external damage that is readily detected by visual observation. Internal damage in the RCC consists of micro cracks and delaminations.

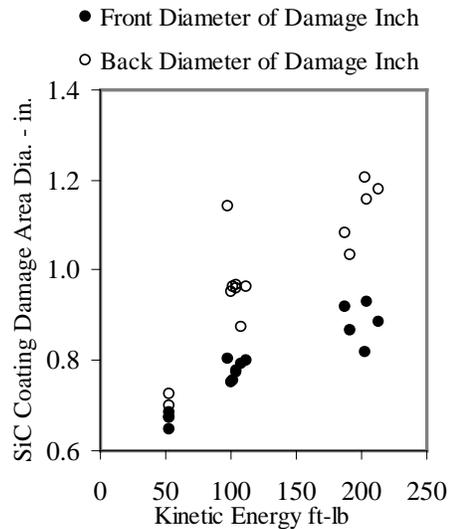
Figure 5. Hypervelocity impact energy vs RCC coating damage area.

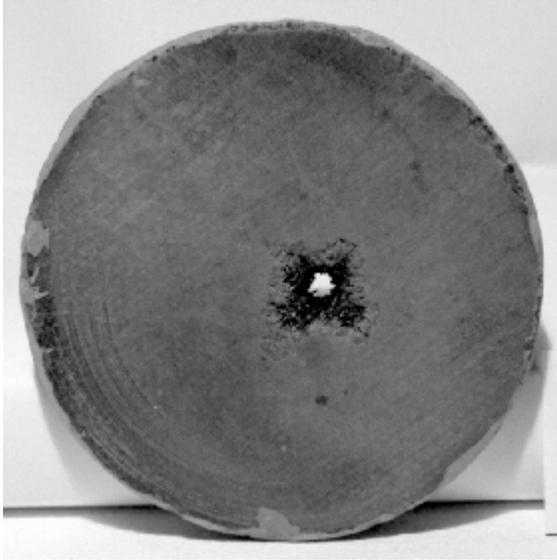
Figure 6. NASA model 1161 front face, pre arc jet test 53 ft-lb impact energy.

The photographs presented in figures 6 and 7 represent the RCC front face impact damage as a result of 53 and 212 ft-lb of impact energy. Figures 8 and 9 show a photograph of the back face damage. These models are presented to illustrate the minimum and maximum energy levels used in the subject test program and the resulting RCC damage.

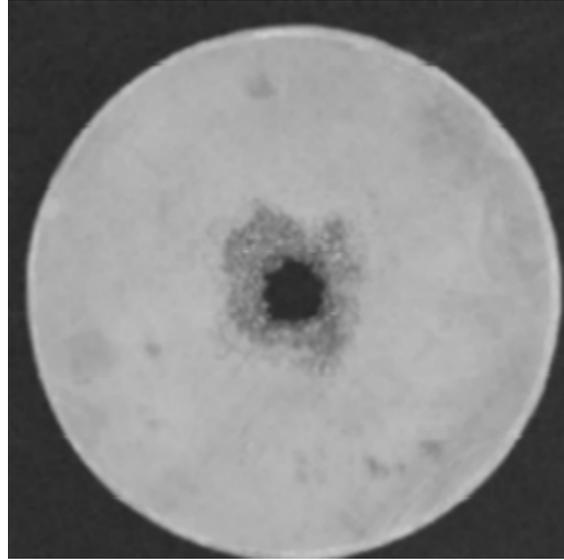
Figure 7. NASA model 1152 front face, pre arc jet test 212 ft-lb impact energy.

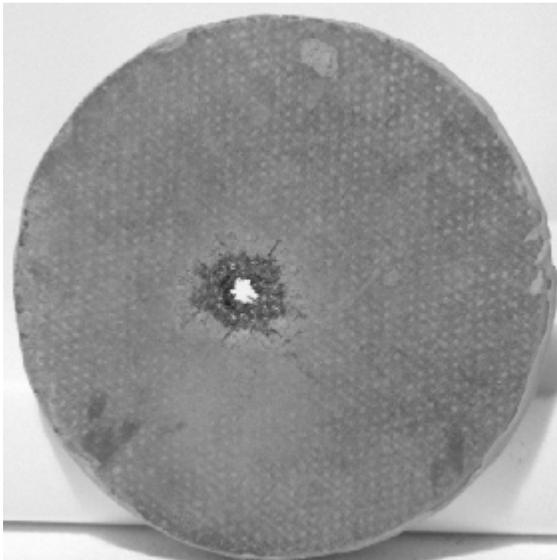
Figure 8. NASA model 1161 back face, pre arc jet test 53 ft-lb impact energy.

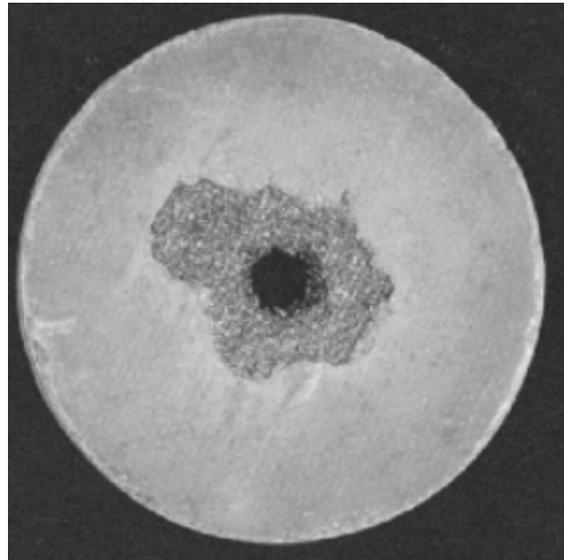
Figure 9. NASA model 1152 back face, pre arc jet test 212 ft-lb impact energy.

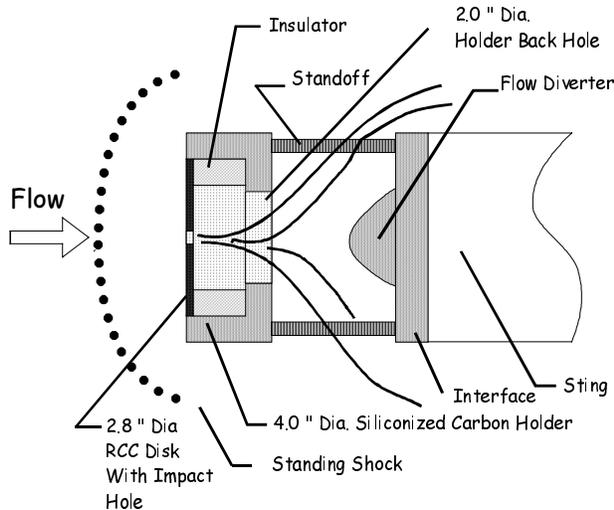
Figure 10. Test specimen holder test configuration.

A sketch of the test specimen holder used during these tests is shown in figure 10. This figure shows the 2.0-in.-diameter hole through which gases ingested through the impact holes can pass without restriction. Ceramic rods support the holder such that a water-cooled conical interface block may smoothly divert the flow. The outlet slot between the holder and interface block has an area that is over 15 times that of the largest posttest impact hole area. Since the pressure just outside the slot is less than 0.6 psf, sonic conditions are maintained at the impact hole with large margin. In addition the stagnation pressure measurement at the forward end of the conical flow diverter indicated that sonic conditions existed at the impact holes.

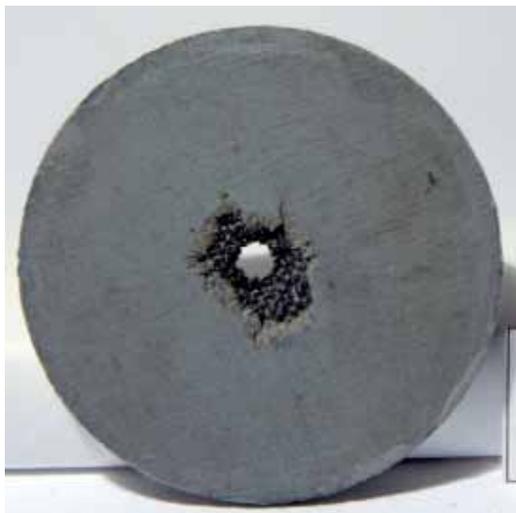
View 12A. Frontside pre arc jet.

Figure 12. Hypervelocity impact damage pre and post arc jet test 2500°F / 50 psf model # 1159.

Figures 12A and 12B present the front and back pre arc jet exposure test photographs of specimen NASA #1159, typical test specimen. It can be noted of the coating damage, which resulted from the hypervelocity impact and penetration, that the backside damage has a larger spalled coating area than the front face coating spallation area. The specimen NASA #1159 was exposed to 2500°F, 50 psf for 450 sec.

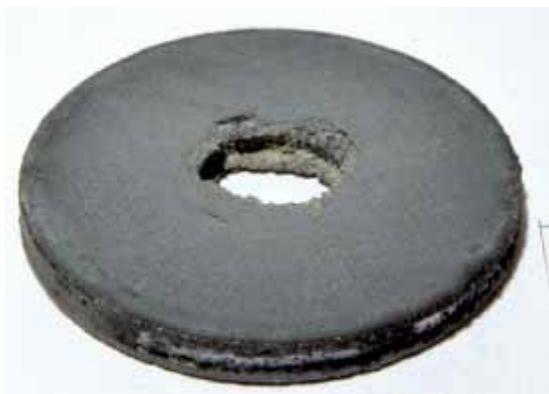
View 12E. Post arc jet test oblique.

Figure 12E presents an oblique view of NASA specimen #1159, where it can be seen that there was additional substrate loss that formed a dishing out of the carbon sandwiched between the SiC front and back coating.

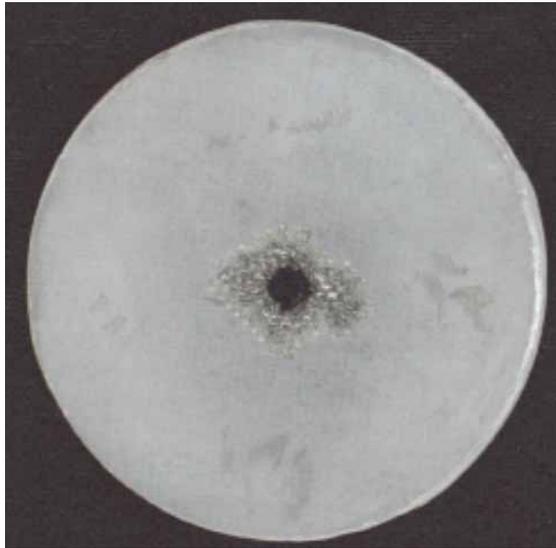
View 13A. Frontside.

Figure 13A and 13B present the pre arc jet exposure test photograph of specimen NASA #1151 that can be compared with the post arc jet exposure photograph shown in views 13C and 13D. For this test condition (2800°F and 100 psf) there was significant front face coating erosion. In general, the front face of the damaged region grew faster than the backside of the specimen giving the hole a conical shape that is typical of all the 2800°F tests.

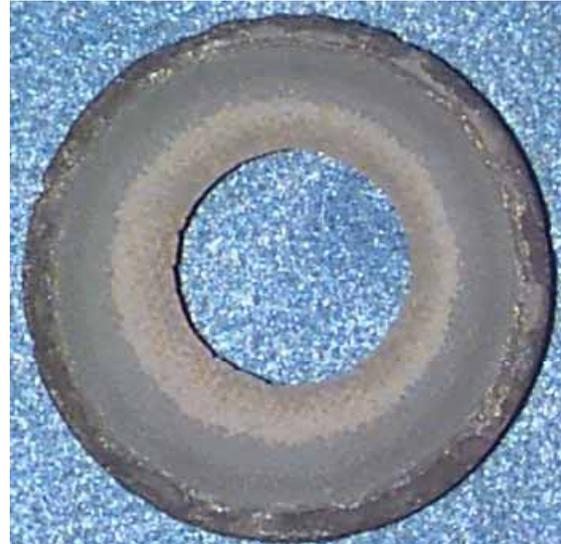
View 13D. Backside.

Figure 13. NASA/JSC model #1151 pre and post arc jet exposure 2800°F/100 psf.

Test data from the 2800°F series showed that the characteristics of the holes are quite different from the 2500°F series. The holes from the 2500°F test are irregular in shape but keep a shape similar to one resulting from the impact test (figure 12). The holes from 2800°F are large, round shapes with a significant difference in size between the front hole and back hole diameters (figure 13).

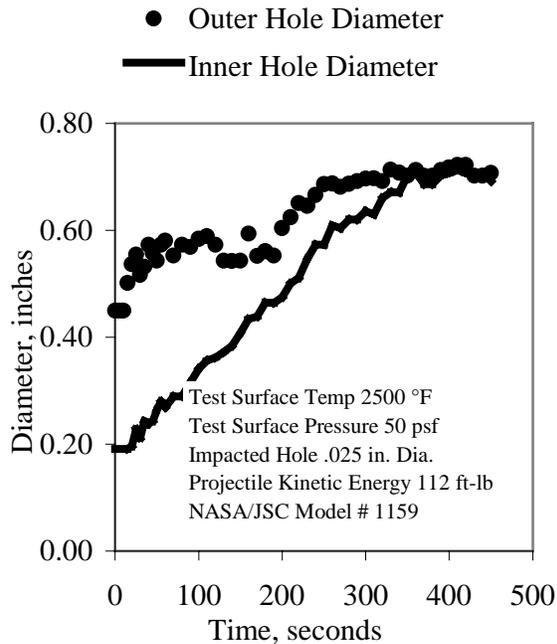
Figure 14. Video hole growth data for a 2500°F/0.25-in.-dia. impacted hole.

The JSC Image Science and Analysis Group (IS&AG) used videotapes of each test to make an assessment of the hole growth (Appendix A).⁶ Dimensional measurements of the diameters of both the larger front face of each hole (called the outer hole) and the back face of the each hole (called the inner hole) were made for 14 tests. Appendix A contains photographs for time cuts that are typical for the videotape images used by the IS&AG group to determine the raw data inner and outer hole growths. The minimum uncertainty in the diameter measurements is estimated to be 0.01 in. The minimum uncertainty applies only when the hole edge is well defined, focus is good, and there is no residual SiC to interfere with the edge identification, generally true for inner hole edge only. Outer edge uncertainty is .03 to .05 in. because of the appearance of new oxidizing (burning) rings of SiC. As these new rings glow brightly their edge blurs the image, giving a false image width. Typical hole diameter measurements as a function of time that the JSC IS&AG made for the 14 test articles are shown in figures 14 (2500°F) and 15 (2800°F).

Hole growths for the 2500°F tests showed only loss of the RCC substrate and no visible SiC coating loss; thus the 2500°F hole growth was circular on the exposed substrate with virtually no difference in the outer and inner diameter.

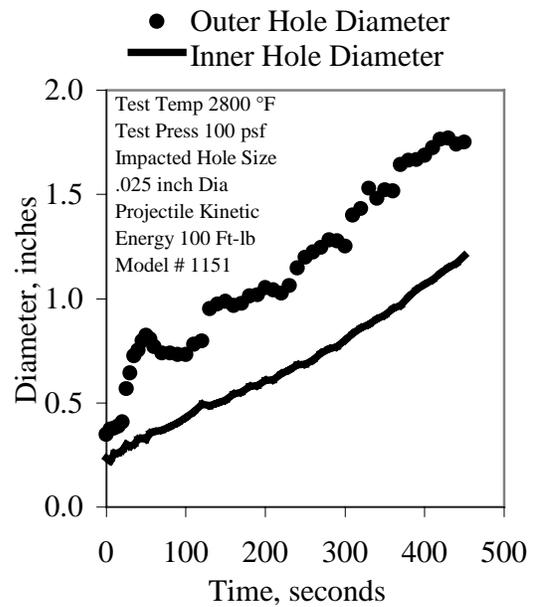
Figure 15. Video hole growth data for a 2800°F/0.25-in.-dia. impacted hole.

Hole growths of the 2800°F test specimens developed a conical shape when viewed in cross section. The widest hole cone was formed by the 100-psf test cases, and the narrowest cone slopes were formed by the test cases tested at 180 psf. The conical hole shape phenomena is illustrated in figure 16. The test data are grouped to show the conical shape (outer ring diameter minus inner ring diameter).

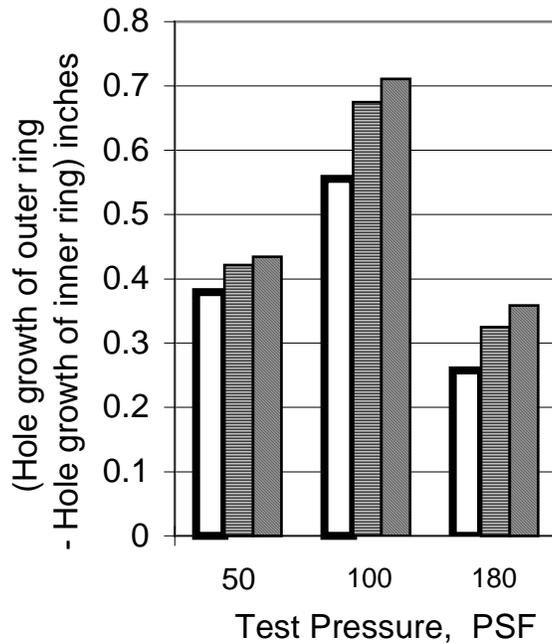
Figure 16. Conical shape of hole growth at 2800°F.

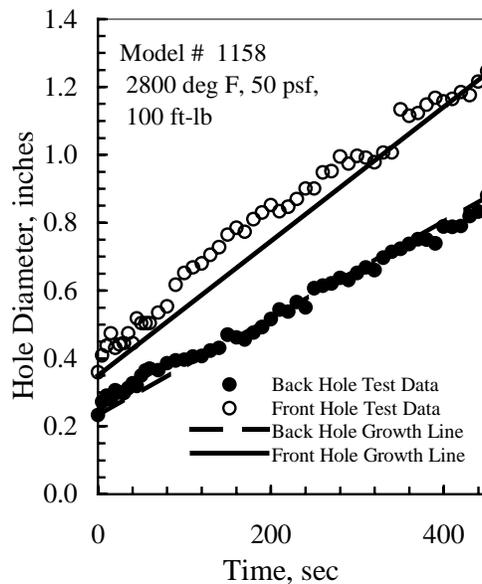
Figure 17. Front and back hole growth rate comparison.

The 2800°F test series included three different levels of impact energy and three different pressure environments. Based on these test data, correlations of an impacted RCC hole growth as a function of the level of impact energy and pressure were developed. The correlations assumed a constant hole growth rate with respect to time. Plots of the test data and the constant hole growth rate line are shown in Appendix B. Since the front and back hole growth rates are different, the development of the correlations for the front and back hole growths were performed separately. A typical plot of the test data and the assumed constant hole growth rate is shown in figure 17.

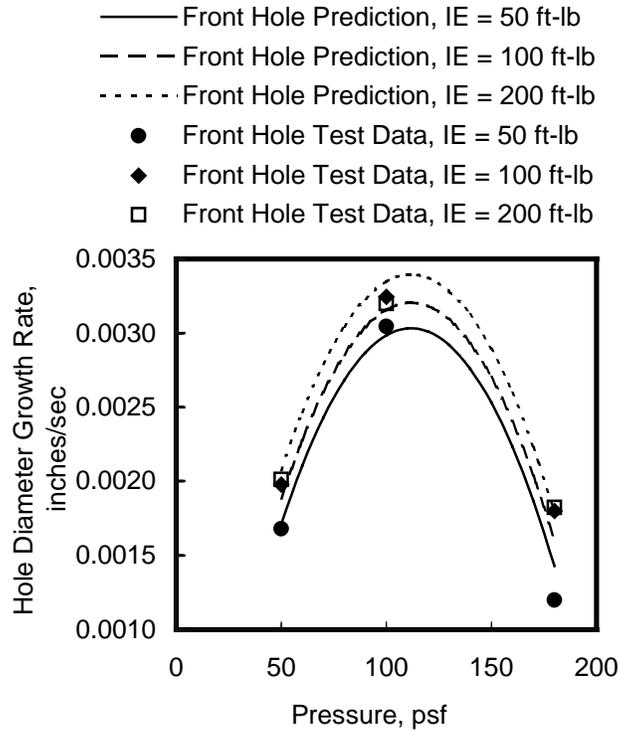
Figure 18. Comparison of test data and predictions for front hole growth rate (pressure).

Figures 18 to 21 show a comparison of the test data and predictions, using the correlations, for both front and back coating hole growth rates, and illustrate the effects of impact energy and pressure on hole growth. As expected with increasing impact energy, the hole growth rate increases as a result of coating and substrate damage. As the arc jet test pressure was increased from 50 to 180 lb/ft², hole growth increased as the pressure change from 50 to 100 lb/ft², but then decreased at a pressure

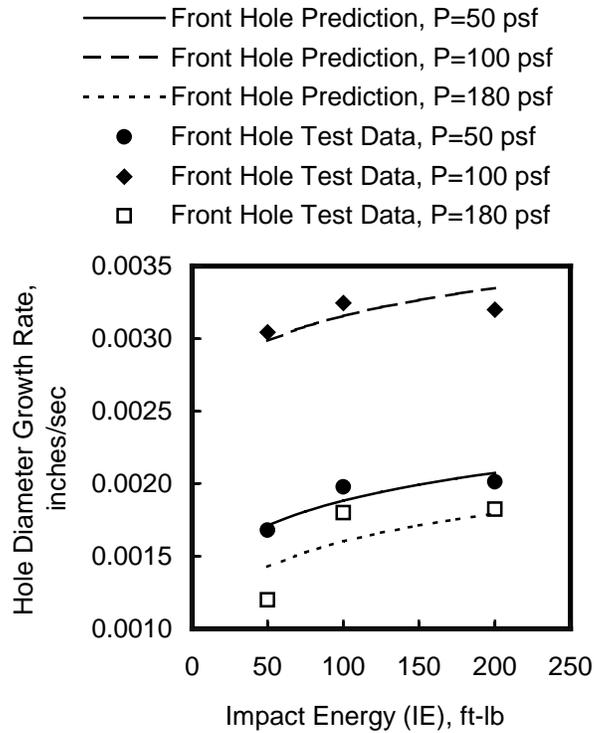
Figure 19. Comparison of test data and predictions for front hole growth rate (impact energy).

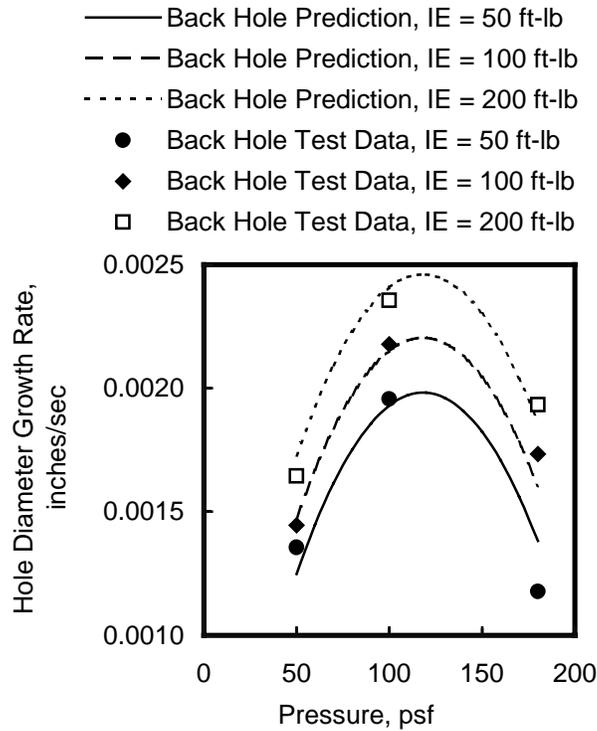
Figure 20. Comparison of test data and predictions for back hole growth rate (pressure).

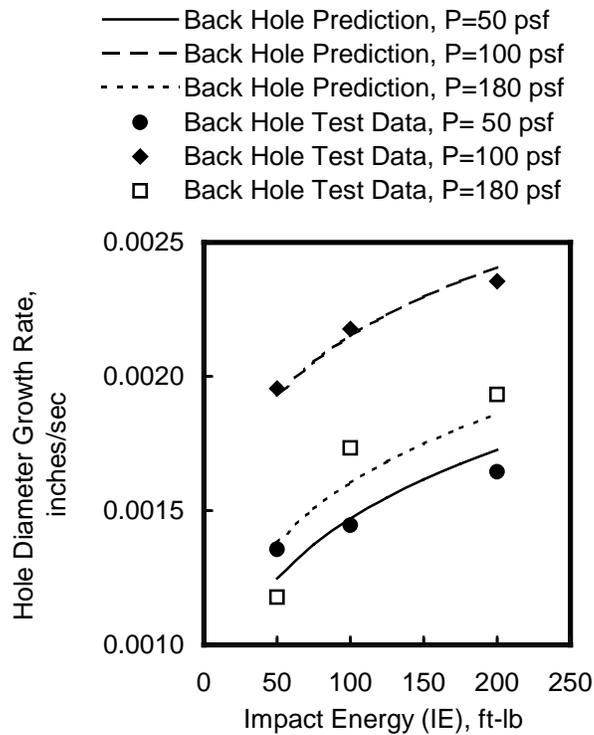
Figure 21. Comparison of test data and predictions for back hole growth rate (impact energy).

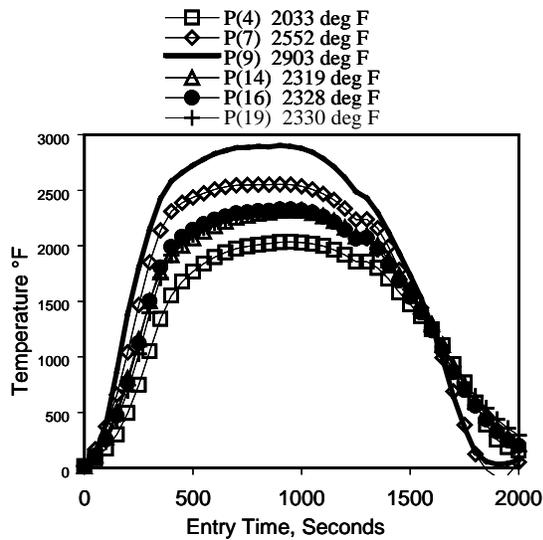
Figure 22. Temperature histories for the stagnation area of the wing leading edge panels 4, 7, 9, 14, 16, and 19 for the ISS mission case R 233K, 57-deg inclination entry trajectory.

Assessment of an entry environment using the methodology developed begins with a thermal entry analysis for the entire RCC leading edge subsystem. A typical International Space Station (ISS) Shuttle mission trajectory case R, 233K forward cg with 57 deg inclination was chosen. Figure 22 presents the temperature histories that represent the entire wing leading edge. For this assessment of the RCC wing leading edge areas where temperatures are predicted to be below 2800°F, the hole growth is not expected to expand beyond the coating damage surrounding the impacted hole. An examination of RCC temperatures reveal that only panels 8, 9, and 10 stagnation area would experience entry temperatures above 2800°F where major coating erosion would be predicted. The entry environment for panel 9 stagnation area is presented in figure 23.

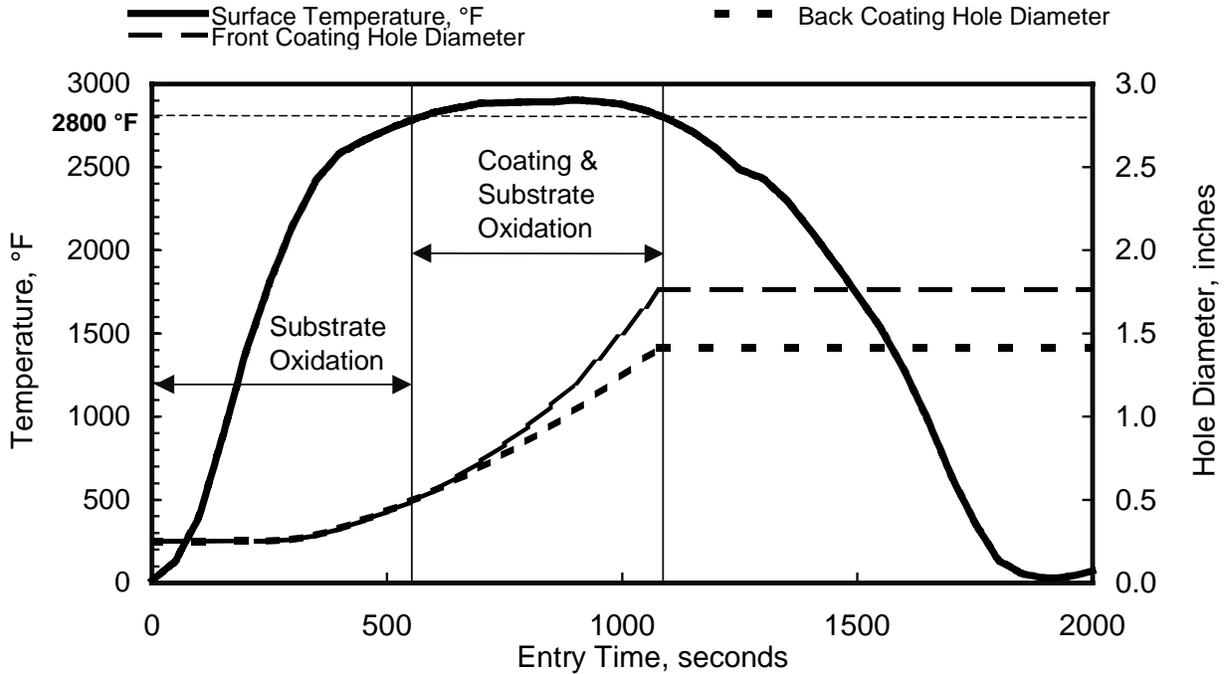
Figure 24. RCC hole growth history for ISS case R, entry trajectory.

The assessment of the impact damage area of the wing leading edge panel requires the prediction of the expected hole growth history. This hole growth history is used to evaluate the consequences of the potential damage effects to the Orbiter structure. For this example a 0.25-in.-dia. hole resulting from MOD impact was assumed. Figure 24 presents the predicted hole growth history for the ISS Case R trajectory. The back hole growth rate is used to calculate the hot gas influx into the wing leading edge cavity for assessing wing spar insulation and structural damage. Final hole diameter of 1.76 and 1.415 in., respectively, for the front and back surfaces is predicted.

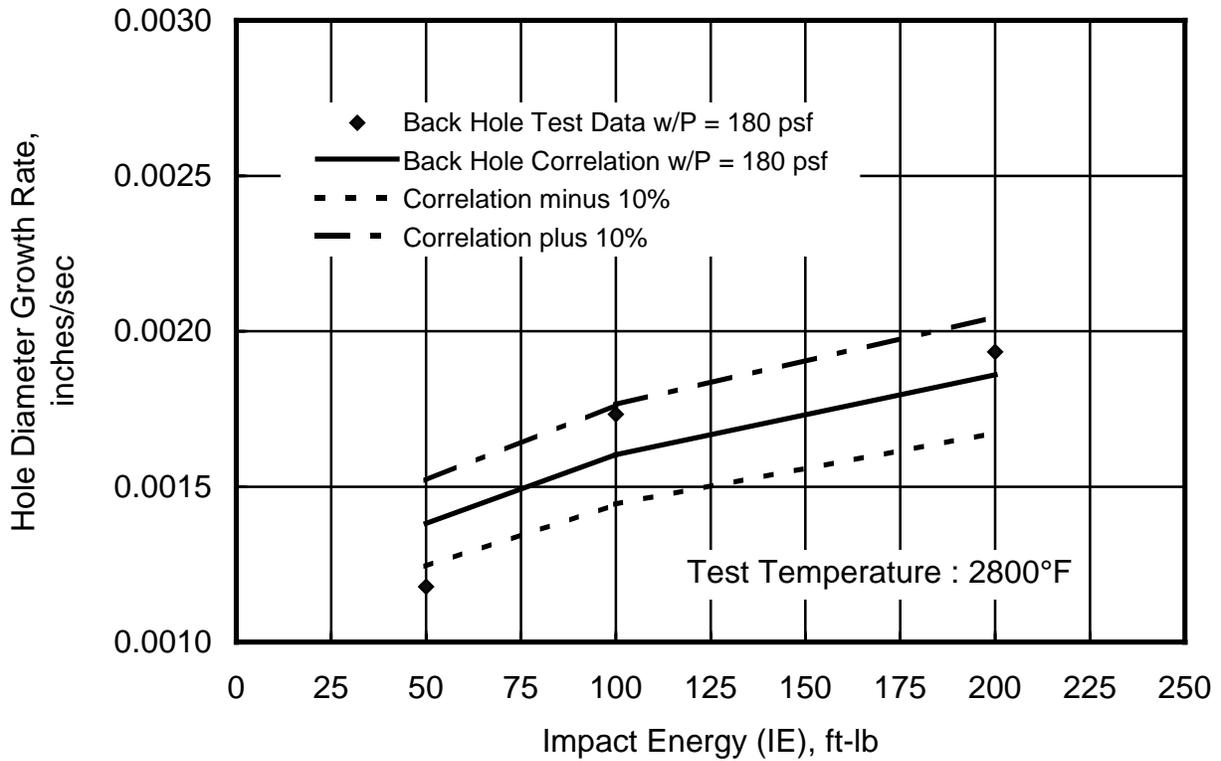
Figure C-7 An Impacted RCC Back Hole Growth

To eliminate the time dependency of the hole growth rate, test data were translated from hole diameter growth history to hole diameter growth rate assuming an average constant growth rate for each test condition. Because a significant difference appeared between the front and the back hole growth rates, separated correlations were developed for the front and back hole growth. Comparisons of the regression lines with test data along with $\pm 10\%$ error bands are shown in figures C-2 through C-7. These test data are in excellent agreement with the regression lines, except two data points for the front hole growth rate (figure C-4) and one point for the back hole growth rate are out of 10% error band (figure C-7).
