NASA/TP-2012-217360

Desert Research and Technology Studies (DRATS) 2009: A 14-Day Evaluation of the Space Exploration Vehicle Prototype in a Lunar Analog Environment

May 2012

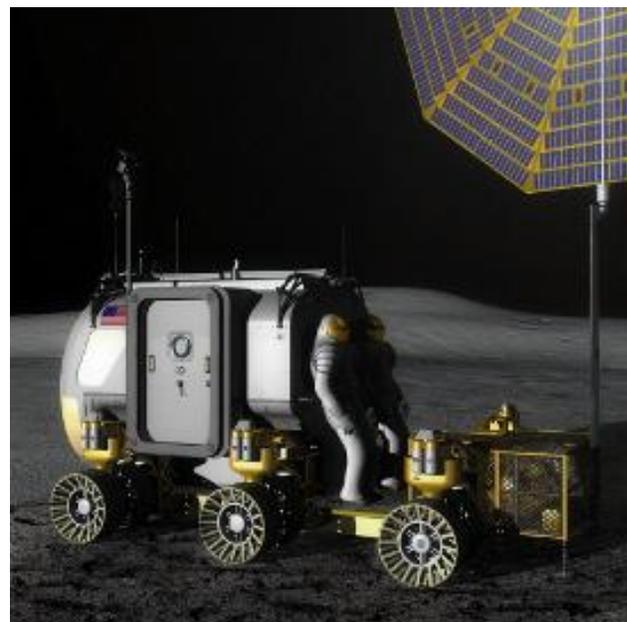
Figure 5. SEV and PUP concepts.

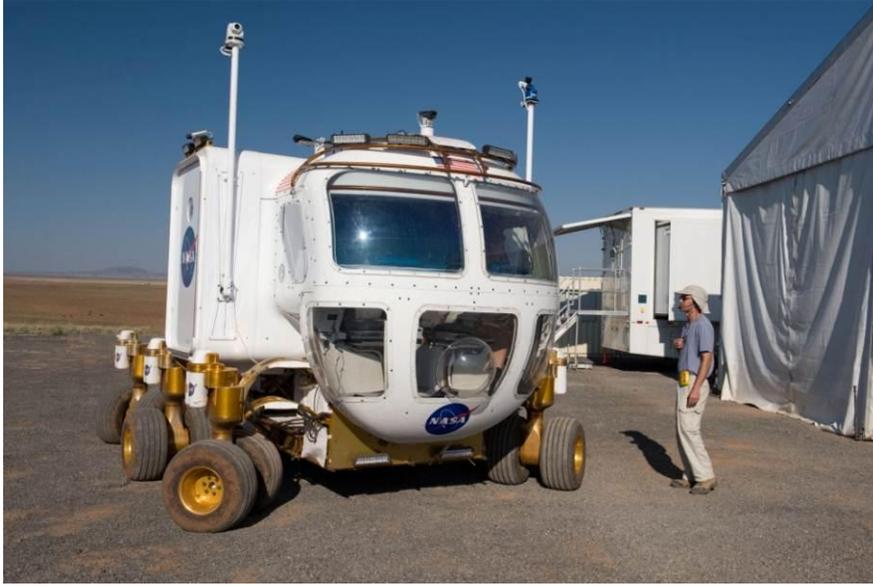
Figure 8. Space Exploration Vehicle Cabin 1B integrated with Chariot chassis.

The SEV Cabin 1B used in this study was developed as a collaborative effort of JSC, Langley Research Center, Ames Research Center, and Glenn Research Center. The cabin is not pressurized but incorporates functional electromechanical suit ports including alignment guides and clamping mechanisms, includes all necessary crew accommodations to support a 14-day traverse, and is fully integrated with the Chariot chassis, consistent with the lunar architecture assumptions (Figure 8). The SEV cabin also incorporates interior cameras and microphones that were used by the JSC Usability, Testing and Analysis Facility (UTAF) in the collection of human factors data throughout the study.

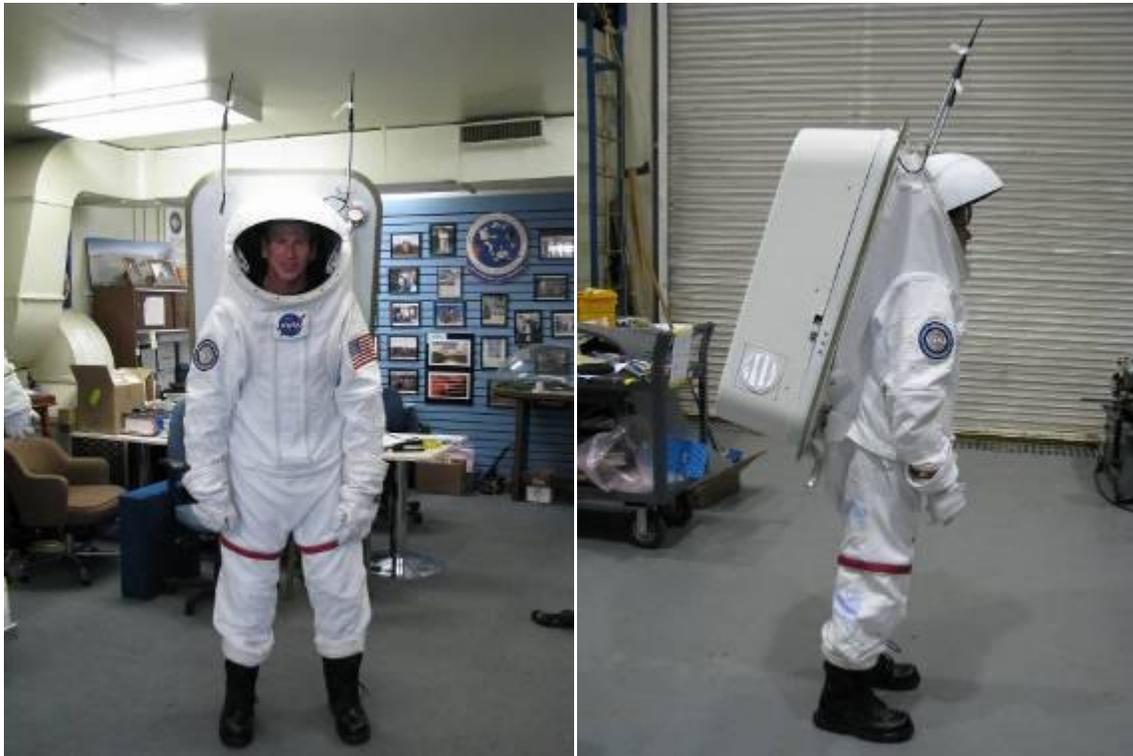
Figure 9. Lightweight EVA suit mock-ups.

The lightweight suits (Figure 9) were used with the electromechanical suit ports and SEV aft deck systems. They are unpressurized and have an open-air helmet. The major components are the interface plate to the suit port (with brackets to make the bottom of the plate sit about 9 degrees off of the person, alignment guide pins for suit port docking, shoulder and waist harnesses, and neck ring with half of a representative helmet bubble), a PLSS shell that includes a removable electronics package, and a lightweight garment that includes representative gloves and boots. The lightweight garment is made of Ortho-Fabric and Spandex, and is modular. For subject comfort, the arms can be removed at the shoulders, the lower torso can be removed at the waist, and the front panel can be unzipped, leaving behind a “vest” that allows more airflow for thermal comfort. These suits have integrated audio systems (speakers and microphones). The total suit weight is approximately 34 kg (~75 lbs), which is about 9 kg (~20 lbs) lighter than the Mark III mock-up suits used in 2008.

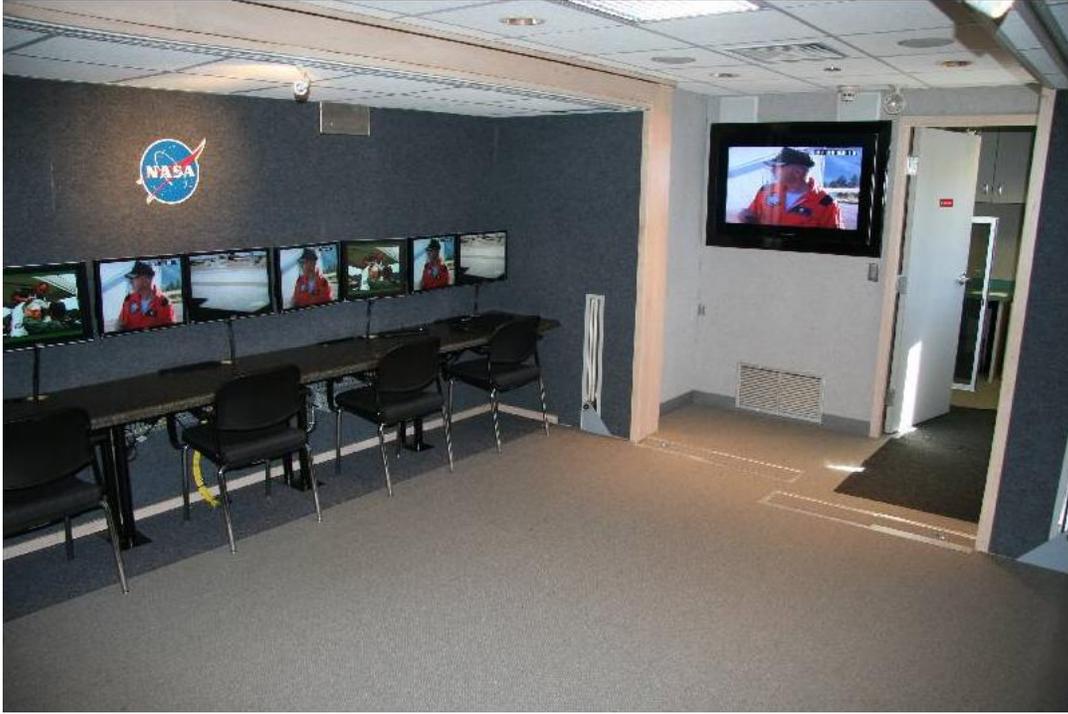
Figure 12. Interior of MMCC.

In addition to the communications and networking infrastructure described above, the ITCD at KSC provided an MMCC, which accommodated test support personnel including the Science Backroom Team, CAPCOM/test director, and data collection personnel. The MMCC is shown in Figure 12 and Figure 13.

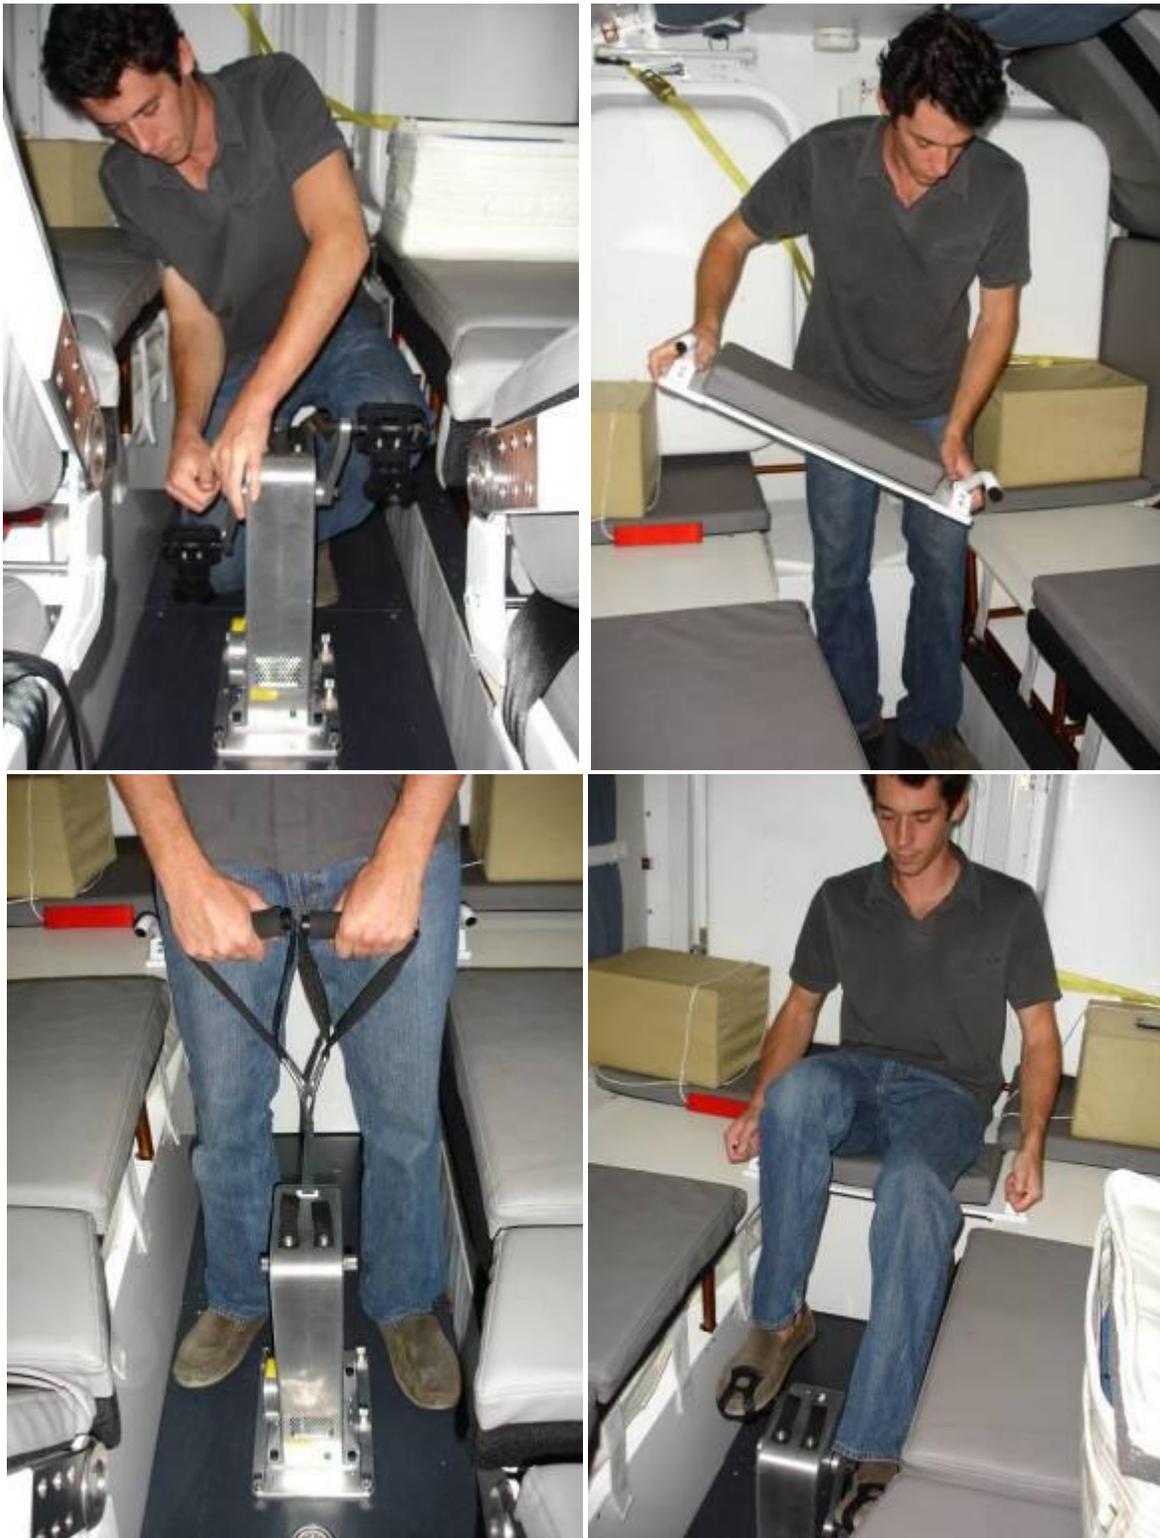
Figure 16. Photographs demonstrating the setup and use of the SEV exercise device. Clockwise, from top left: attaching pedals; placing seat across aisle; cycling; using resistive exercise handle attachments.

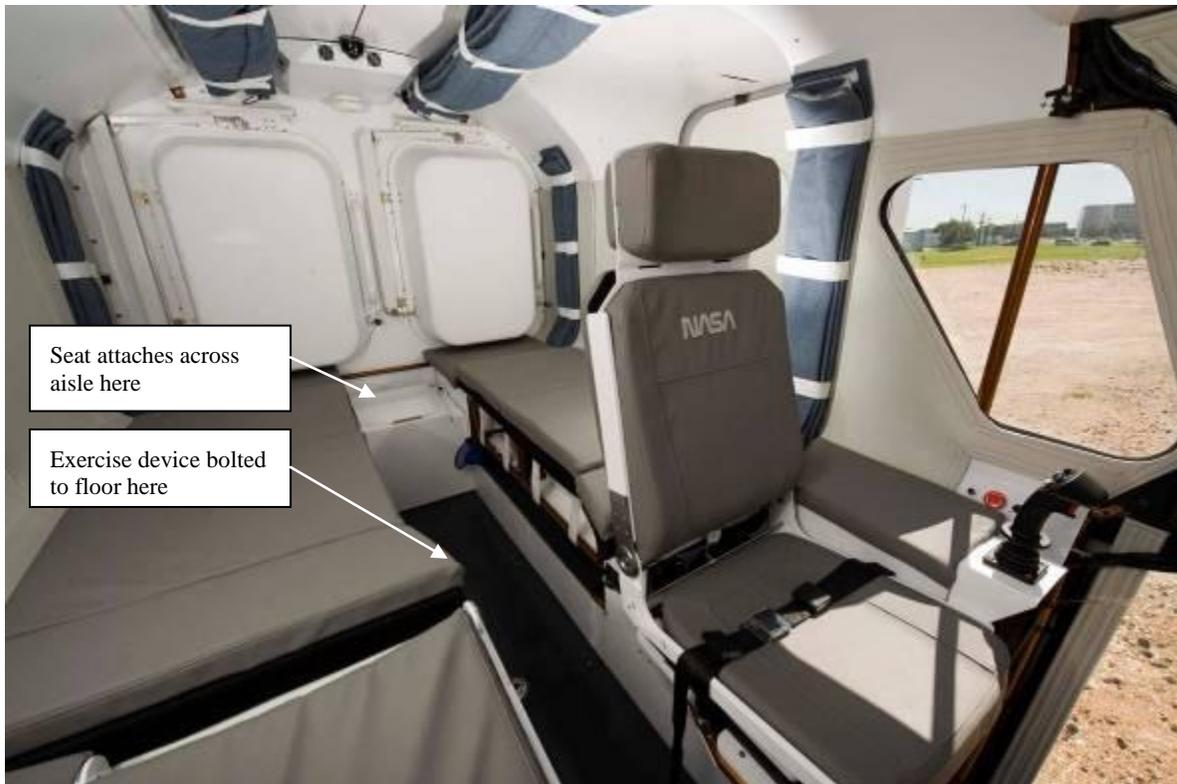
Figure 17. Location of exercise device in SEV cabin.

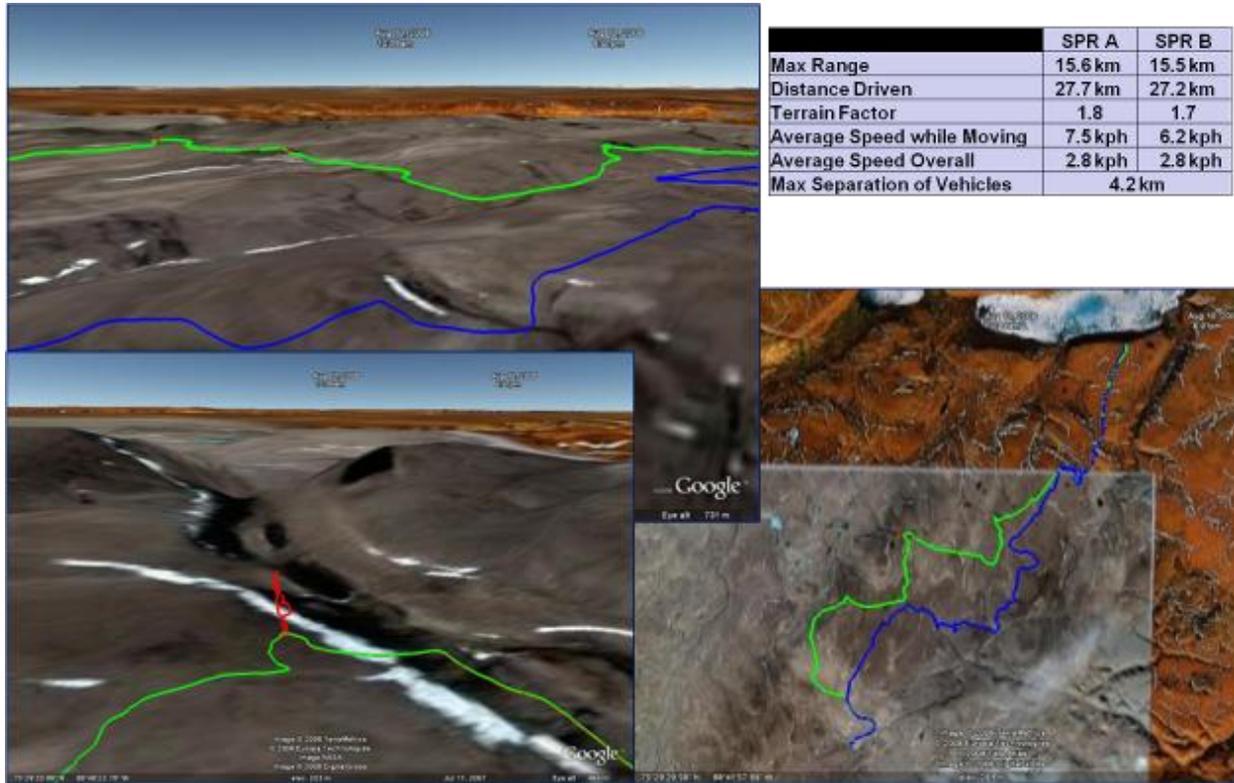
Figure 22. Example of GPS-derived performance data collected during Haughton-Mars Project-2008 field test.

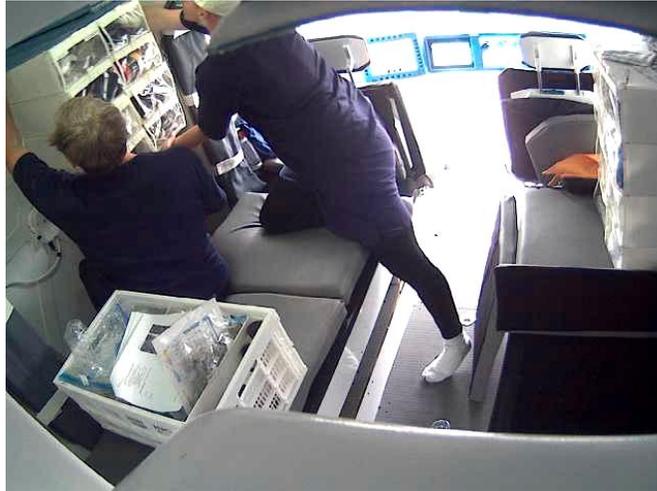
Seven elements were considered borderline by the crew and one – odor of waste/trash stowage – was considered totally unacceptable (Table 10). Access to food stowage became difficult when the crew had reconfigured the aft cabin for an EVA (Figure 28); moving stowage lockers out of one of the side-hatches prior to EVA was necessary to ensure that crewmembers could ingress the vehicle via the side-hatch in the event that both suit ports malfunctioned.

Figure 28. The crew consistently had to reconfigure the aft cabin before and after EVAs.

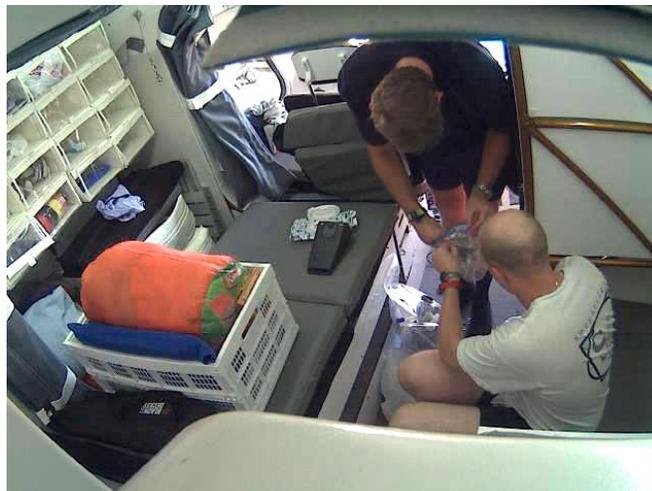
As in the 2008 field test,⁷ having a dedicated stowage area, trash management system, and odor control became the issues, with odor control being rated totally unacceptable (mean = 8.5). Like other systems in the SEV, the trash management system was redesigned to help correct these issues. The new system was to take the daily trash, put it into a medium-sized Space Bag[®], and vacuum seal the bag at the end of each day (Figure 29). After collecting 3 days' worth of trash, the crew would transfer the three medium Space Bags[®] into one large Space Bag[®] and vacuum seal the bag and transfer it out using the SPTM. The first issue occurred when the crew ended up putting 3 days of trash in one medium Space Bag[®]. This caused one bag to break, and the crew repaired it by using 2-inch duct tape. They also noted the Space Bag[®] did not control odor well and was heavy when it contained 3 days of trash.

Figure 29. Crewmembers doing trash operations using a Space Bag[®].

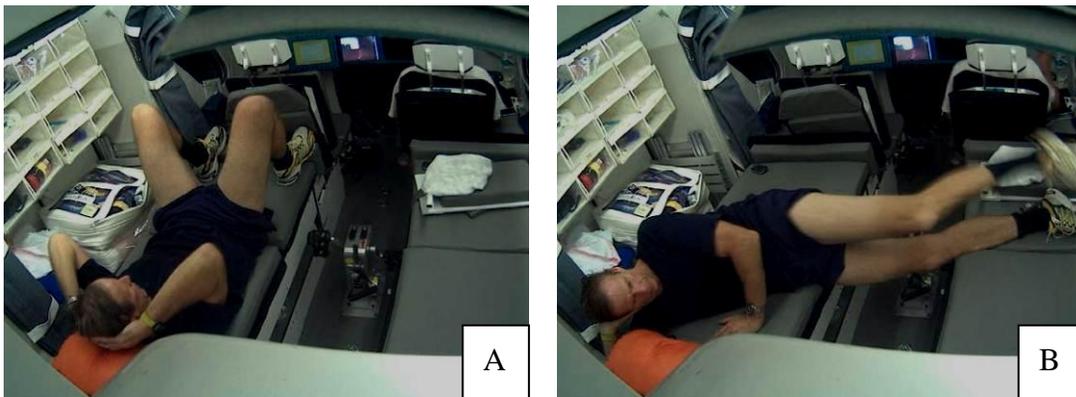
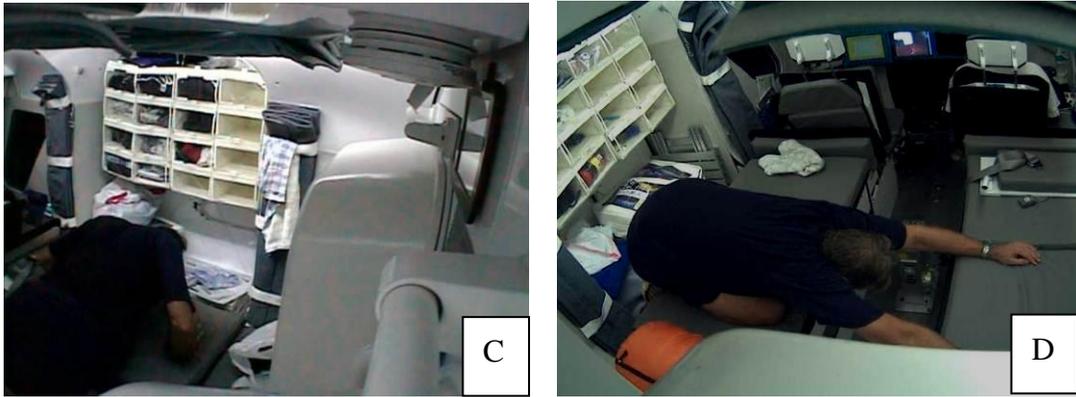
The crew also rated the overall ability to exercise in the SEV as acceptable. They came up with several ways to exercise in the vehicle in conjunction with using the ergometer. The SEV provided plenty of space for doing such exercises as leg lunges, push-ups, bench press with bands, and tricep dips (Figure 32). The interior volume gave the crew the ability to use a variety of exercise elements during their hour-long session.

Figure 32. Crewmember doing sit-ups (A), leg lifts (B), push-ups (C), and stretches (D) using the benches in the aft section of the SEV.

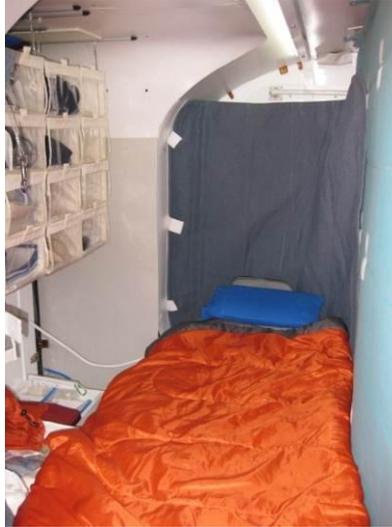
Generally, the crew rated the SEV sleep stations acceptable. Of the 13 elements, the crew rated 5 – volume of station, layout, privacy, within-station light quality, and personal item access – as totally acceptable (Table 13). They noted that the high ceiling height and having the two soft lockers hanging in the side hatch gave them the perception of a spacious volume in the station (Figure 33)

Figure 33. Fully deployed crewmember's sleep station in the SEV. Note the high ceiling and access to the personal soft stowage lockers.

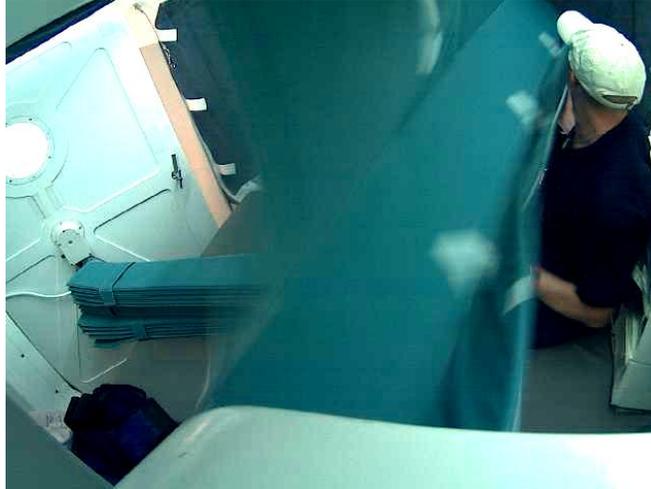
Ease of ingress, stowage of the curtain by a single crewmember (Figure 34), and seat reconfiguration were rated "borderline" by the crew. They noted there was too much Velcro[®] in the new design. Getting into and out of the SEV was not easy without taking most of the curtains apart. Curtain stowage by a single crewmember still remains an issue, especially for the large main curtain. Though the crew stated it was possible to accomplish, the task was not easy due to the weight and curtain support straps. Finally, the front seat reconfiguration received the highest rating by the crew ($GM = 4.8$). This was because it was necessary to adjust the seat with two hands. Access to the adjusting tabs was difficult and getting the seats in the correct lateral placement was not optimal. As for the overall design of the sleep station, the crew rated it acceptable. Though it needed some minor tweaking, the crew stated it was a huge part of the successful habitability of the SEV for the 2-week mission.

Figure 34. Crewmember trying to stow large sleep station side curtain.

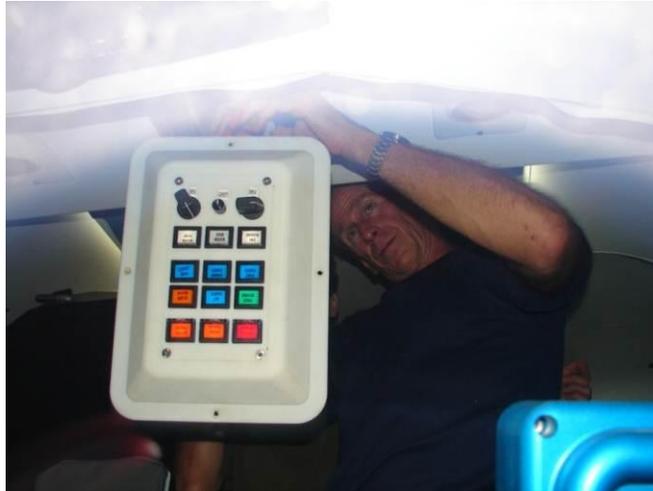
New to the field tests this year were both IVA and EVA maintenance. IVA maintenance was mainly directed toward the AC issues in the vehicle (Figure 37). Over the 14 days, the crew conducted numerous AC filter changes to unclog the drainage lines. Maintenance tasks performed during EVA consisted of cleaning the SEV windows and cleaning the two mast cameras. Originally, eight maintenance factors were to be examined; however, data were collected for only four because of the immaturity of current SEV maintenance procedures (Table 17). Workspace to perform maintenance in the SEV was rated acceptable with minor improvement desired. The only comment the crew made was that some areas could be tight to fit into if maintenance was required.

Figure 37. Crewmember performing a filter change on the SEV AC unit.

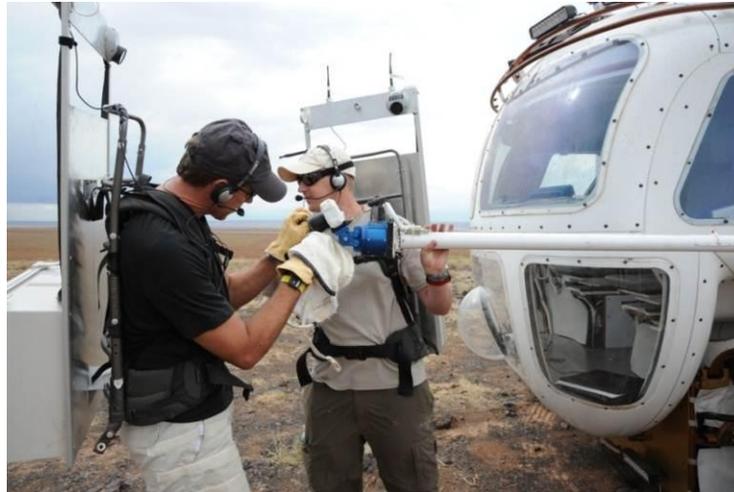
Areas that needed maintenance, especially in EVA window-cleaning operations, were reported to be too hard to reach with the currently designed tools. According to human factors field notes, the crew noted that the pole and frame for cleaning the windows did not make good surface contact to properly clean the window. The crewmembers suggested adding more foam padding to the EVA mitt in front on the wire frame assembly. Stepping the mast (lowering the mast) to clean the cameras was not considered an issue for the crew (Figure 38); however, more testing using pressurized suits will be needed.

Figure 38. Crewmembers stepped the masts to clean the camera lenses.

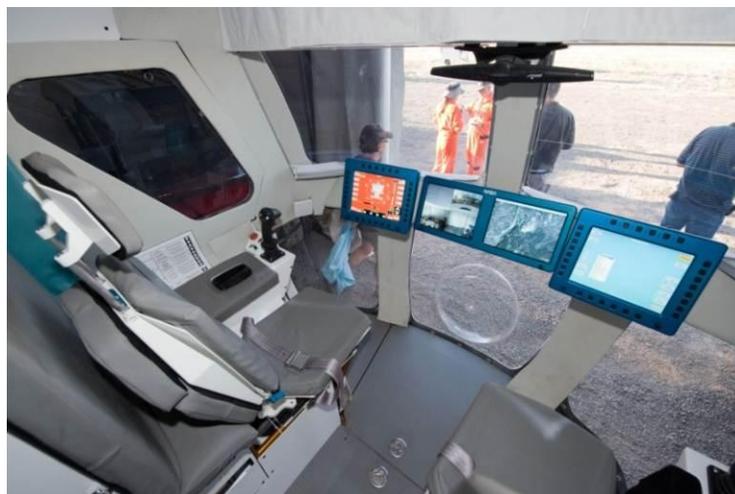
Figure 40. Newly redesigned SEV cockpit with video monitors as SA aids for crew and vehicle alignment.

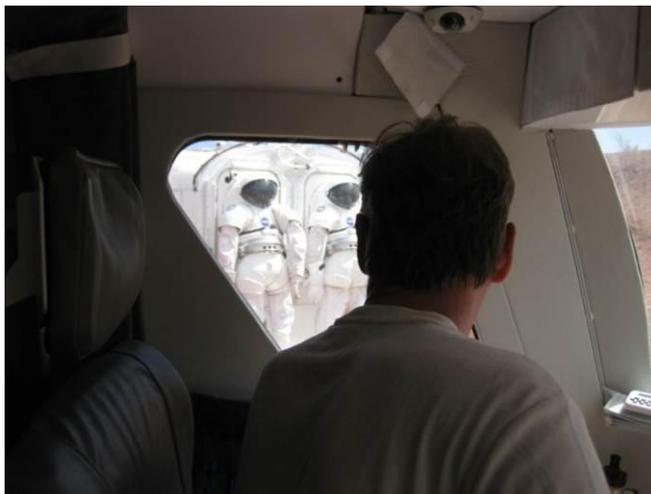
As with the driving, the crew did make comments about several areas of visibility in and around the SEV Cabin 1B vehicle. Side window visibility was still an issue, especially with docking/mating operations. However, during some actual docking tasks, such as docking with another vehicle, the crew used the side windows extensively because of frustration associated with the docking displays (Figure 41). Vehicle body alignment SA was still an issue with the crew during this test as it was during the 2008 desert test.⁷ They commented they could not physically see the SEV’s wheels even though external camera views of the vehicle did provide some SA. The crew also suggested that a portion of the vehicle needs to be incorporated into the side camera views. This would help the crew judge the distance between docking devices and the SEV. As for the aft camera view, the crew indicated this was a great help for the aft SA of the vehicle. However, a design issue with the cabana cover partially blocked this aft view and the crew suggested having this issued corrected on the next-generation vehicle. The center top camera improved the crew’s SA for both tele-operations with the TRI-ATHLETE and geologic observation. They thought this view was extremely important for scientific observational work but suggested replacing the current lens with a gyro-stabilized lens to reduce image jitter while driving. Having this camera unit with pan, tilt, and zoom functions was a joy for the crew to work with during the mission. An interesting note to this year’s test is that the visibility of the front window panels was reduced by about 0.1 to 0.2 m (~4 to 6 in.)

Figure 41. Crewmember using the side window to assist in docking with another SEV.

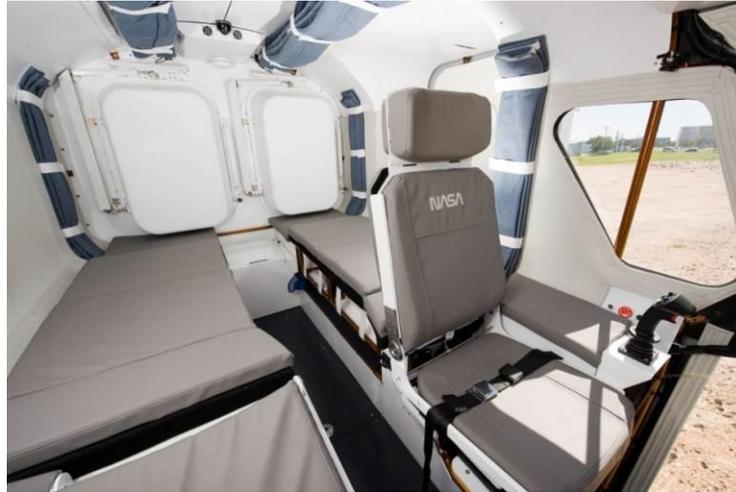
During the 2008 field test, the crew indicated that adjustability of the seats was extremely important for reconfiguration time, stability, and flexibility for the operator. The crew also reported that the space between the two seats needed to be wider to better accommodate a crewmember ingressing into the front lower bubble for scientific observation (Figure 44).⁷

Figure 44. Cabin 1A cockpit seat design.

A redesign of the SEV seat was undertaken, with these considerations in mind, to improve the width of the seat pan to improve crewmember comfort in getting to the lower front observational bubble, to decrease reconfiguration time, and to add robustness to the adjustability of the seat mechanisms. (Figure 45.) Ten different elements for cockpit seating were studied using the same subjective characteristics as in 2008. The crew rated stability of the seat while driving, height of seat, depth of seat pan, usability of seat (activities including driving, navigating, report writing, eating, etc.), and space between the seats for lower bubble access as acceptable, with minor improvements desired.

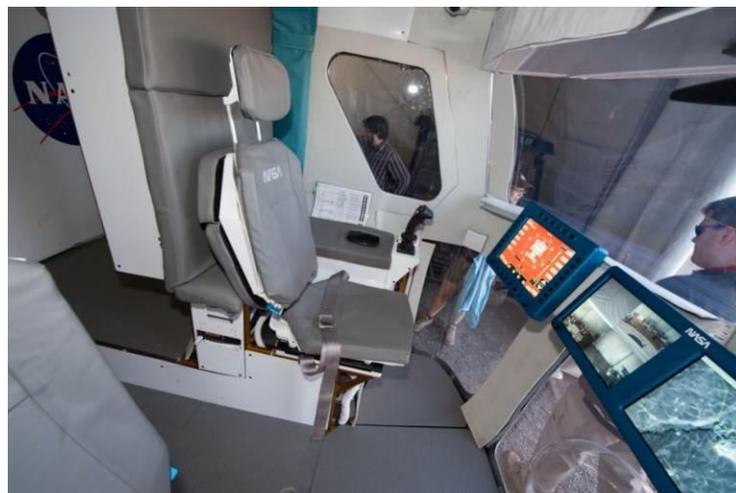
Figure 45. Cabin 1B new cockpit seat design.

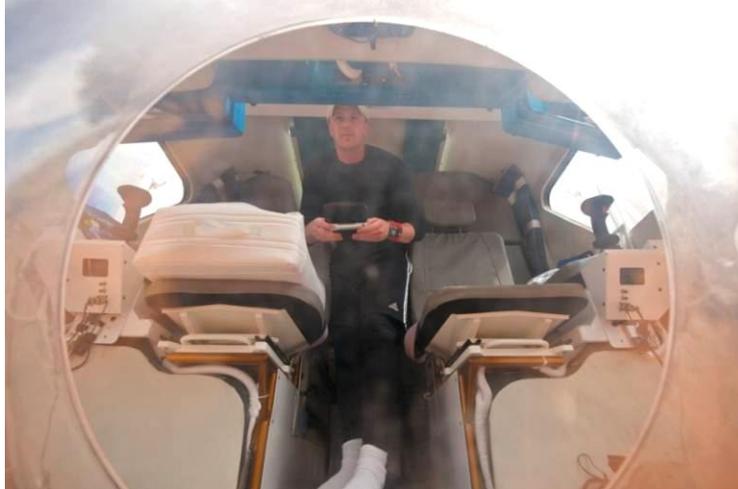
Figure 46. The crew had better bubble access because of the narrower seat pan design.

The width of the seat pan for the Cabin 1B seats was decreased to increase the space between the two cockpit seats for easier accessibility to the lower front bubble (Figure 46). The crew noted that this increase in space did make it easier to access the lower bubble; however, they thought the seat pan was too narrow. As with the comfort element, the newer cushions presented problems for the seat width rating. The crew reported the new cushions were not wide enough in the seat pan to give enough support while crabbing the vehicle down a slope. It was observed that crewmembers tended to slide off the seat pan, even while restrained, during these operations. This was not observed in Cabin 1A during the 2008 field test. However, when the Cabin 1A cushions were used, the crew reported they had more support with the bigger cushions.

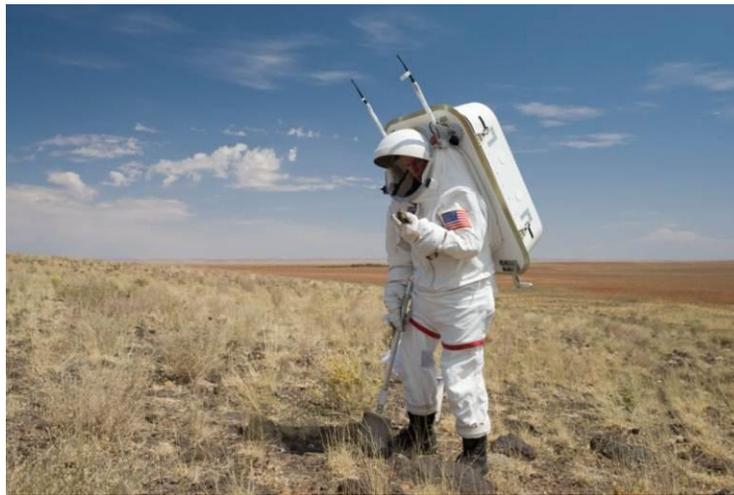
Figure 48. Crewmember wearing the lightweight EVA suit mock-up during the field test.

During the 14-day field test, two types of EVA mock-ups were used by the crew for all aft station operations. Conditions for each suit mock-up type were the same over the 14-day mission. For days 1-4 and 12-14, the crew used the lightweight (LW) EVA suits (Figure 48). These mock-up suits were designed to be lighter weight than the Global Effect suits, which were used during the 2008 field test. On days 5-11, the crew used the relatively lighter-weight and non-constricting EVA Back Pack mock-up (Figure 49). The Apollo Program used a similar type of mock-up during their testing of the Lunar Roving Vehicle in the late 1960s and early '70s (Figure 50). Fatigue and workload data were collected for both suit mock-up types for 7 days each. An overall EVA fatigue and workload assessment for the 14-day mission was also calculated.

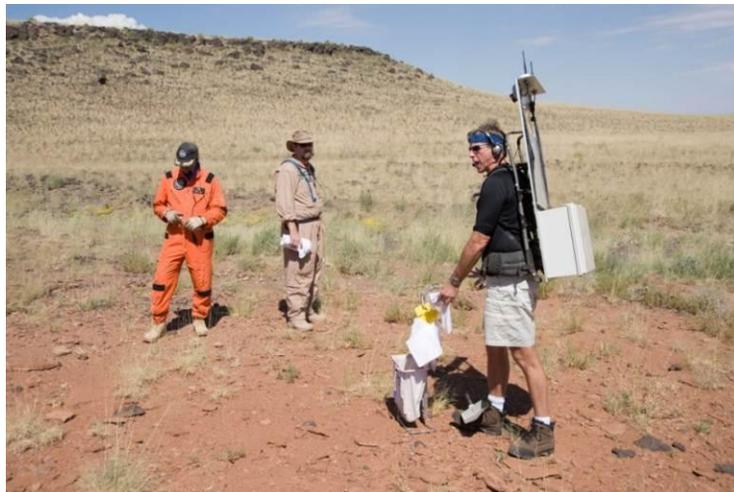
Figure 49. Crewmember wearing the EVA Back Pack mock-up during the field test.

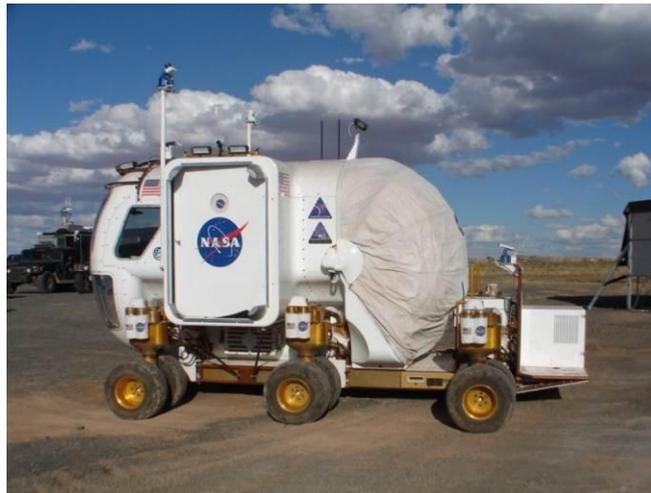
Figure 57. The SEV cabana protects the EVA suits from dust and was a new addition to the vehicle aft deck.

New to the vehicle aft deck was the suit environmental enclosure called the cabana. Being a soft-covered shell over five aluminum ribs, the cabana was designed to protect the suits from dust during the field test (Figure 57). This design resulted from the finding on the 3-day mission that dust accumulation was significant over the whole suit.⁷ The team investigated 11 factors of the cabana during the 14-day mission. Of these 11 factors, the crew reported that most were acceptable, including the cabana interior volume, operations software, elevator operations, hand placement, external hand holds, tool accessibility, and translation off the vehicle. (Table 24.)

The crew noted three elements as being somewhat problematic. It was difficult for crewmembers to open or close the cabana in a manual override mode while suited; thus, the crew gave a borderline rating with improvements warranted ($M = 6.0$). They indicated that when the cabana rose it would not lock into place. For the crew to accomplish the task, one crewmember had to hold the cabana up while the second crewmember translated onto the vehicle and into the suit port. Once this was accomplished, the crewmember in the cabana held it open while the first crewmember climbed into their suit port. A recommendation for redesign is to have an extension pole that the crew could attach to the last cabana rib to support the cabana while they translate into the suit port area. Another observation noted by the crew about this task was the mobility of the EVA suit. They reported that this task would be very difficult to do in a pressure suit. Lastly, the crew indicated that some minor improvements needed to be considered for translation back onto the SEV. When the cabana was added, the external handhold poles were redesigned so the crew still had some assistance in getting back onto the vehicle. However, field observations indicated the crew tended to use the aft station control arm and battery box for climbing back onto the vehicle instead of using the redesigned handholds (Figure 58). On the other hand, the field test was conducted in a 1-G environment with mock-up suits, instead of in the partial gravity that would be expected on another planetary body; therefore, climbing aboard the aft deck remained cumbersome for the suited crew as the mission continued.

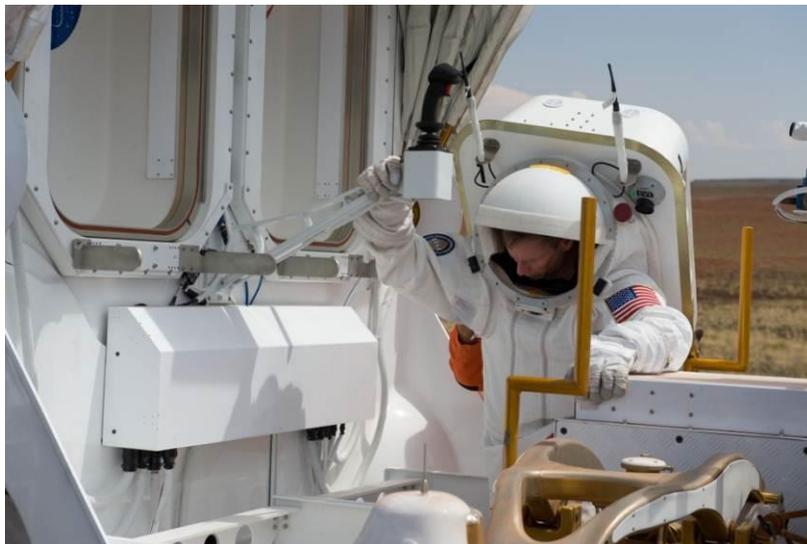
Figure 58. Suited crewmember translating back onto the aft deck of the SEV. Note his hand placement on the aft station control arm and battery box. The “L” shaped gold poles are the redesigned handhold poles.

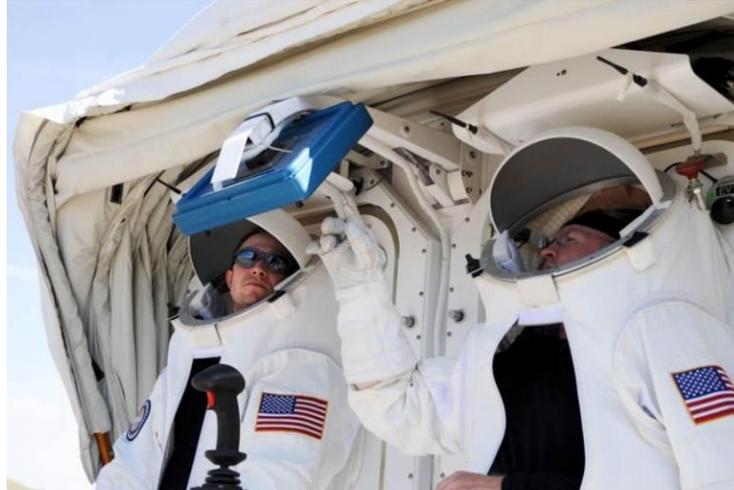
Figure 60. Crew sharing the aft display screen during a two-person EVA.

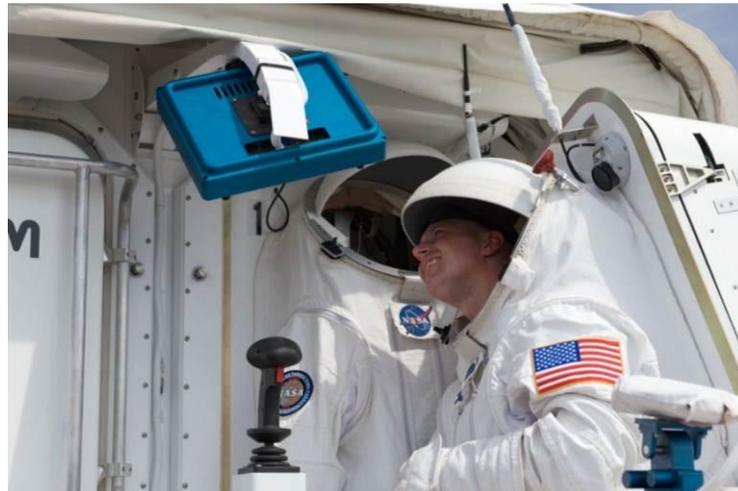
Figure 61. Crewmember trying to see aft display screen during an SPTM operational event.

Readability of the display screen was not an issue when nominal suit port operations, such as an EVA, were performed. On the other hand, the crew reported difficulty with readability when doing SPTM operations. They indicated the display screen needed to have the ability to swivel 180° when the SPTM is docked into the suit port so that they could access the SPTM operational procedures.

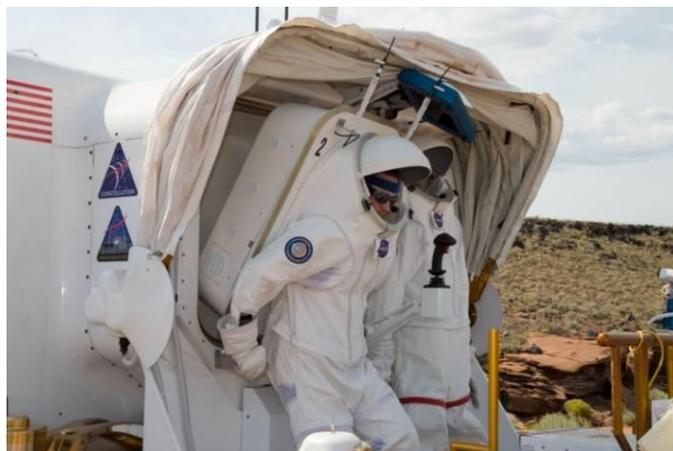
Figure 63. Crewmember using suit port alignment guides to assist in orienting the PLSS.

The crew rated the suit port with the new electromechanical mechanisms for the hatches as totally acceptable. They indicated that practice in docking the PLSS to the suit port before testing in the desert was beneficial to understanding one’s posture when using the alignment guides and backing into the suit port. The crew did note that some work was needed on the manual override system.

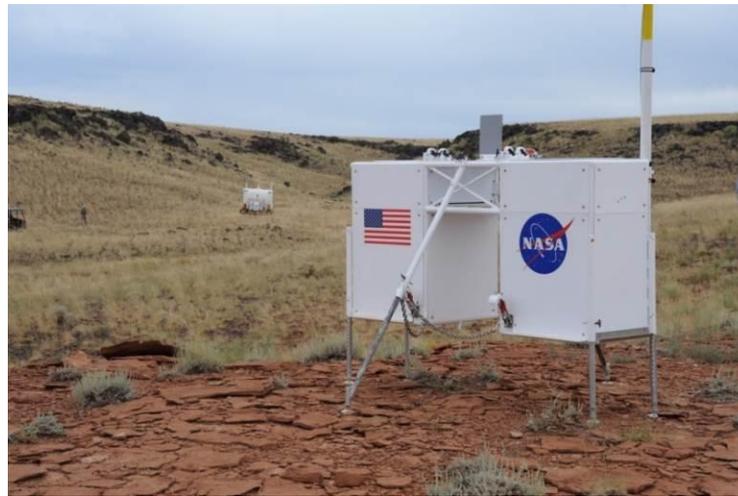
Figure 64. The PUP standing alone after the SEV had de-mated from it earlier.

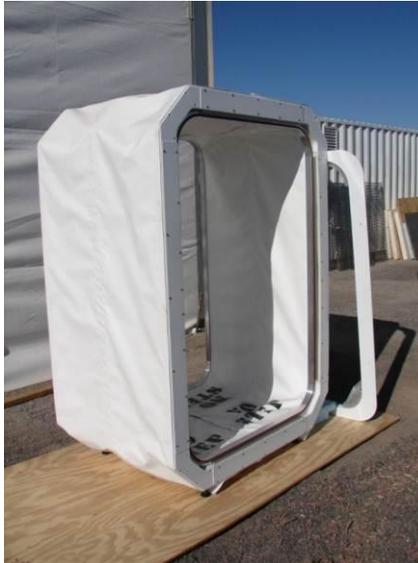
Figure 65. The AAMA used on the SEV for docking with another SEV and a habitat during the field tests.

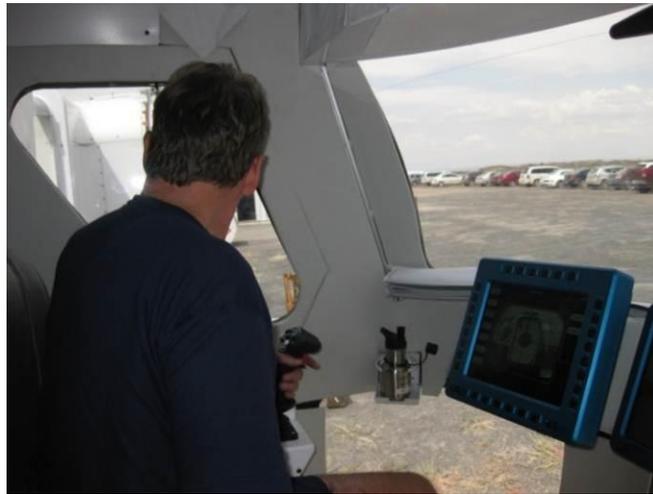
Figure 66. Crewmember “flying” a visual approach docking pattern with Cabin 1A using the side window.

passive compliance and alignment cues for distance. However, the visibility of docking from the SEV side window needs only minor improvement. The crew indicated that their SA from the cockpit seat was not bad and noted it was better to “fly” visually out the window instead of using the cameras.

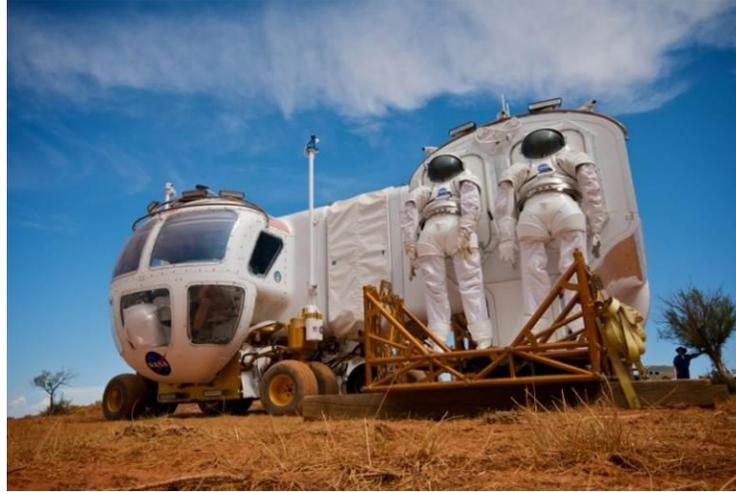
Figure 68. Two SEVs docked using the AAMA. EVA suits for Cabin 1A are shown.

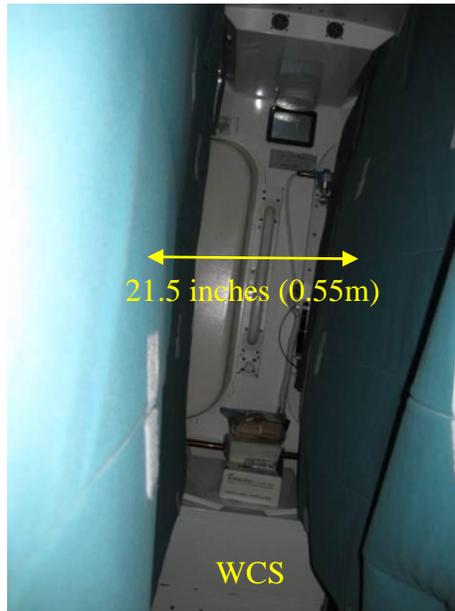
Figure 71. Photo taken by Crew B showing deployed sleep stations. Note the WCS in lower center of photo. Space for using the WCS was reported tight.

However, during WCS operations, the crews noted some issues. First, the crew noted that if all four crewmembers were sleeping, there would not be any room to deploy the WCS, thereby suggesting the crew might have to develop another type of sleep plan if the need arose. Second, the volume was somewhat tight with four crewmembers (see Figure 71). However, the crew was able to perform this task with three crewmembers in the cockpit – two in the seats and one on the floor. With this arrangement, the privacy curtains could still be closed for the fourth crewmember using the WCS. As for quality of sleep with four crewmembers in the vehicle, both crews reported the “two working and two resting” plan was good as long as the crew working was somewhat quiet.

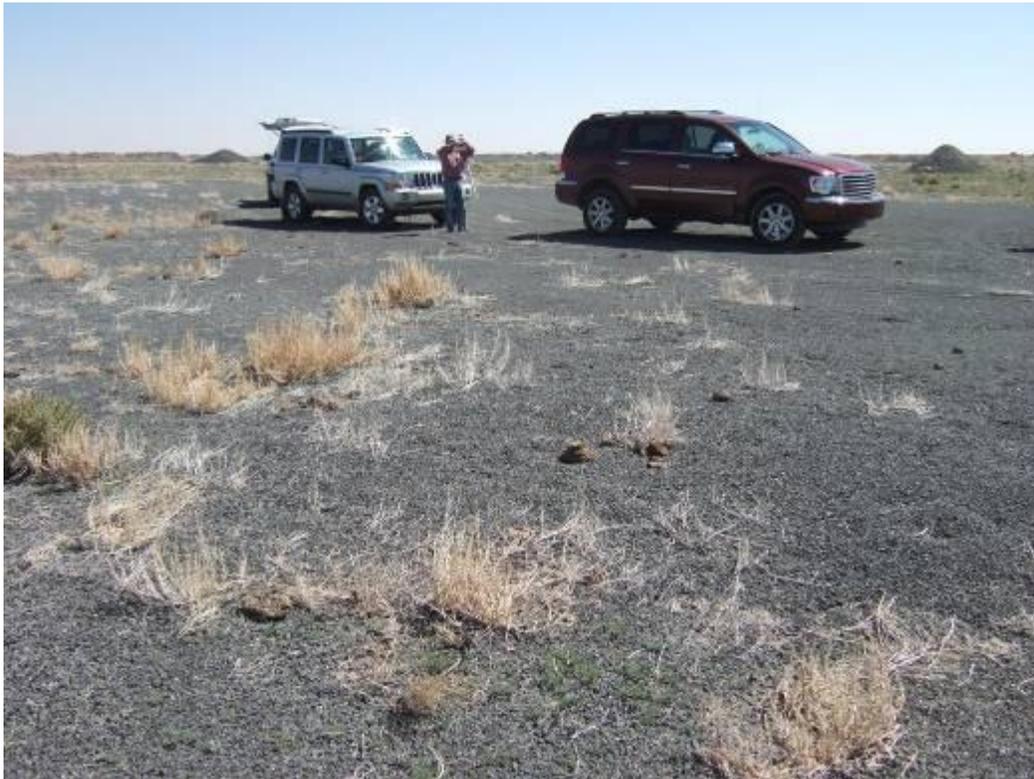
Figure 77. Test site base camp location.

The base camp location was on top of the lava flow on a hard-packed surface (193 kPa /28 psi load-bearing capability) artificially created next to a gravel quarry (Figure 77). Vegetation was minimal in the base camp area and the nearby ash and gravel quarry but became denser in some locations (Figure 78 and Figure 79).

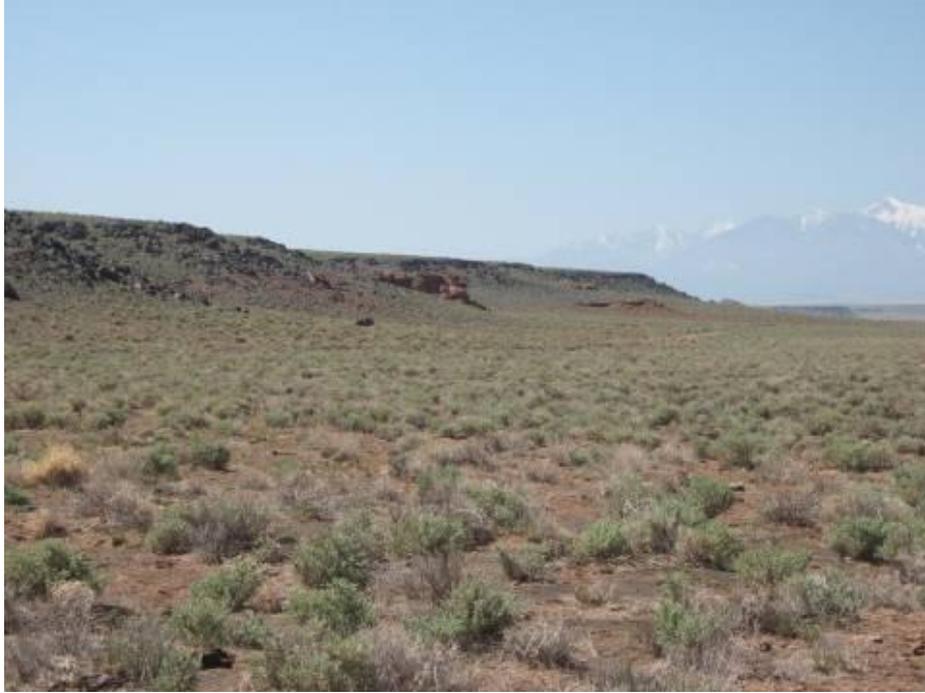
Figure 78. Looking south along the edge of BPLF; note varying slopes, varied geology, and representative vegetation.

The slopes, soil mechanics, surface properties, and existing terrain features of the test site were required to be negotiable by the SEV. The slopes from the top to the base of the BPLF vary from very slight (approx 6°) to vertical. Terrain conditions vary from powdery sand with minimum to significant vegetation (<30 cm [12 in.]) to harder packed ground with numerous small and medium-sized rocks and minimal vegetation.

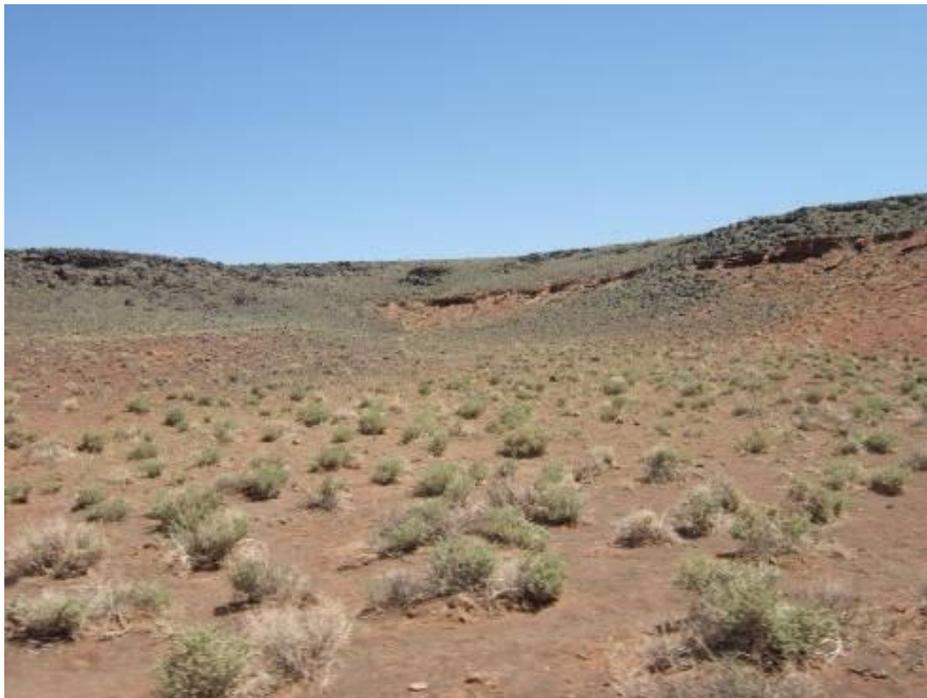
Figure 79. Example of slope variation, geological features, and moderate vegetation at edge of BPLF.
