NASA/TP-2007-213733

Johnson Space Center Material Laboratory Reproduction and Failure Analysis of Cracked Orbiter Reaction Control System Niobium Thruster Injectors

*Willard L. Castner
Jeremy B. Jacobs
Lyndon B. Johnson Space Center
Houston, Texas*

March 2007

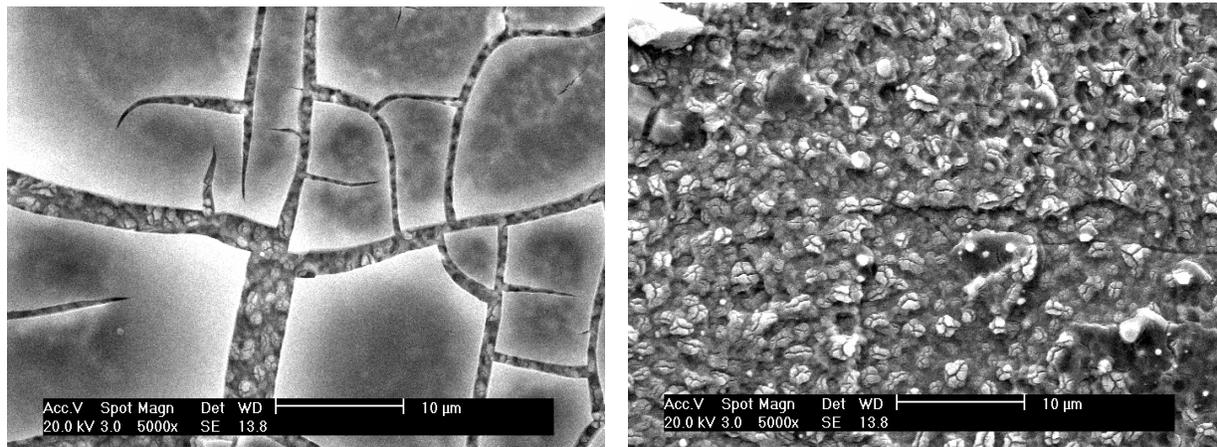
A typical surface appearance and the reaction product after exposure to the HF etch and 600°F for 48 hours is shown in Figure 9.

Figure 9 – Typical appearance of the oxide film formed as a result of exposure of a flat niobium surface with one drop of the niobium etch covered with titanium and heated to 600°F for 48 hours. The left SEM image reveals a semi-translucent brittle oxide crust (titanium oxide), with eruptions in the niobium oxide film underneath. These eruptions have been referred to as “popcorn,” as shown on the right image. This oxide film was subsequently cleaned off for surface evaluation. Magnification – 5000x.

Note the very obvious eruptions in the oxide film. These eruptions were referred to as “popcorn” (for obvious reasons) during the 1979 and 1982 investigations of the thruster cracking. Back then and until recently, the popcorn was thought to be unique to this cracking problem. It was, however, pointed out at the December TIM (Ref. 5) that popcorn appears as a result of eruptions in the oxide film when niobium is exposed to an oxidizing environment at elevated temperature. The occurrence of and the density of the popcorn features on the fracture surface were the focus of considerable effort and analyses by others during this investigation of S/N 120 and will be documented in their reports. EDS analysis of the elemental makeup of this surface oxide product shows a high oxygen and fluorine content indicative of a complex of niobium oxides, fluorides, and oxy-fluorides as could be expected. The analysis is shown in Figure 10. No attempt was made to determine the actual composition of the reaction products. Work by others (Refs. 6, 7, and 10) has indicated a major component of the product is the niobium oxide Nb_2O_5 .

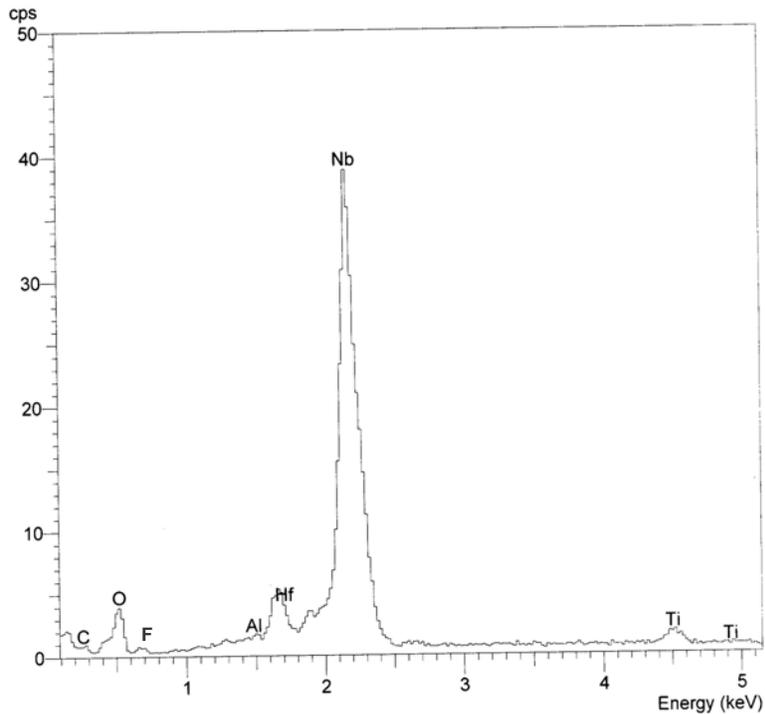
Figure 10 – EDS analysis of surface deposits on niobium surface after one drop of HF etch + titanium cover + 600°F + 48 hours. These oxide film eruptions were referred to as “popcorn” in the original Marquardt failure analysis. Significant oxygen content was observed, but fluorine was barely detected.
