Mitigation of EMU Glove Cut Hazard by MMOD Impact Craters on Exposed International Space Station Handrails

*Shannon Ryan
USRA Lunar and Planetary Institute
Johnson Space Center, Houston*

*Eric L. Christiansen
Johnson Space Center, Houston*

National Aeronautics and
Space Administration

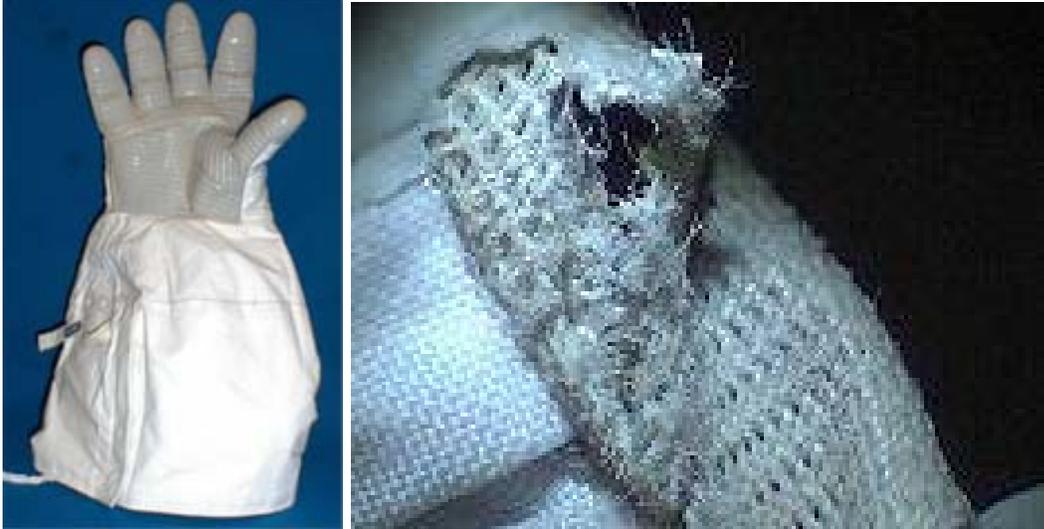
Figure 1: Damage to crew member Curbeam's Phase VI glove following EVA 3 of STS-116.

During post-flight processing of STS-116, damage to crew member Robert Curbeam's Phase VI glove thermal micrometeoroid garment was discovered (Figure 1). This damage consisted of: loss of RTV-157 (i.e., a high-strength silicone adhesive sealant) palm pads on the thumb area on the right glove and a 1.91-cm cut in the Vectran fiber that is adjacent to the seam and thumb pad (single-event cut), constituting the worst glove damage ever recorded in "the history of going EVA [extravehicular activity] for the U.S. program" [1]. The underlying bladder and restraint were found not be damaged.

Evaluation of glove damage showed that the outer Vectran fibers were sliced as a result of contact with a sharp edge or pinch point rather than general wear or abrasion (commonly observed on the RTV pads). Damage to gloves was also noted on STS-118 [2] and STS-120 [3].

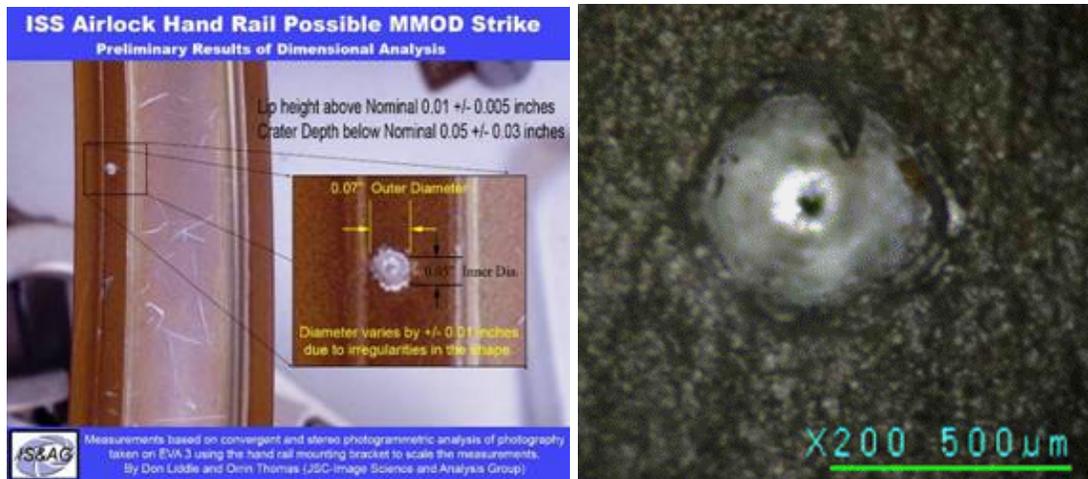
Figure 2: Damage to returned handrail surfaces by possible MMOD impacts. Left: ISS airlock handrail (~1.8-mm-outer-diameter crater); Right: S-band antenna structural assembly (SASA) handrail (~0.5-mm-diameter crater).

One potential source of extravehicular mobility unit (EMU) glove damage is the sharp crater lips on the external International Space Station (ISS) handrails. Hundreds of handrails are installed on the external surface of the ISS and are therefore subject to impact from micrometeoroid and orbital debris (MMOD) particles. Returned flight hardware has demonstrated the susceptibility of these structures to regular MMOD impacts, examples of which are shown in Figure 2 and Figure 3.

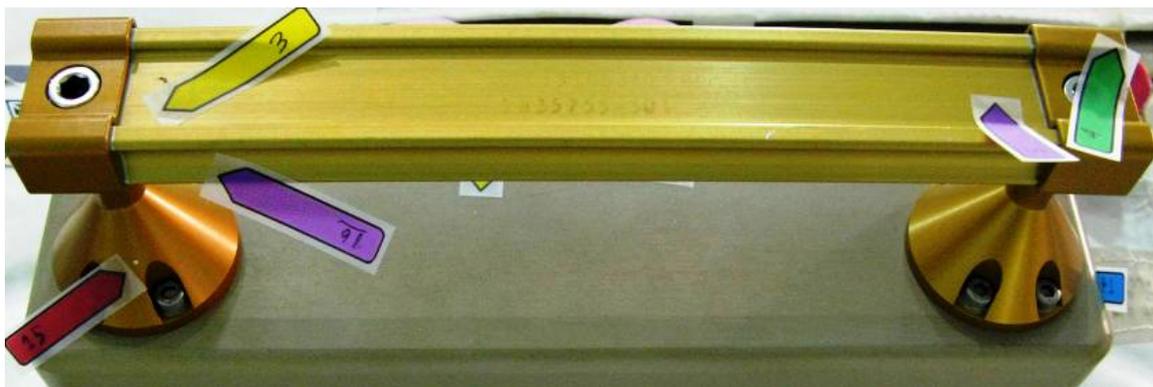
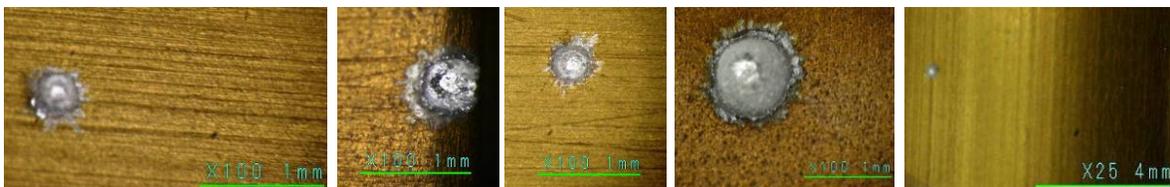
Figure 3: MMOD impacts on the returned nitrogen tank assembly (NTA) handrail. Top: Location of impacts; Below: Close-up of impact craters (from left to right: impacts 3, 4, 5, 15, and 16).

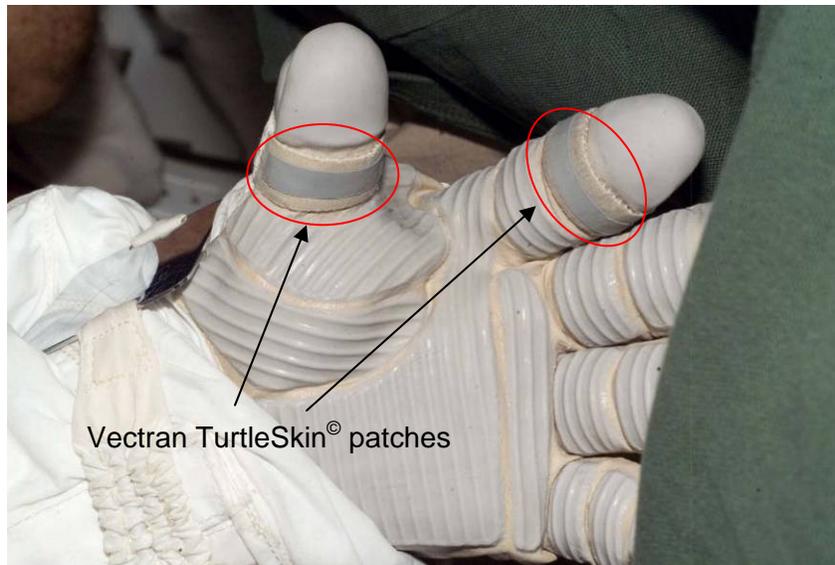
Figure 4: Vectran TurtleSkin® reinforcement patches added to index finger and thumb of the Phase VI EMU glove for STS-124.

Redesign efforts are currently under way to increase the resilience of EMU gloves. For example, during STS-124, a modified EMU glove was used that incorporated Vectran TurtleSkin[®] patches on areas of high wear (i.e., lower part of the thumb and upper part of the index finger). TurtleSkin[®] is a protective fabric material that, given its extremely tight weave, is commonly used in protective vests for knife protection as it provides greater protection against cuts and penetration than common woven fabrics. The modified glove is shown in Figure 4. Preliminary analysis of glove damage suggests that the modification was successful in reducing glove damage.

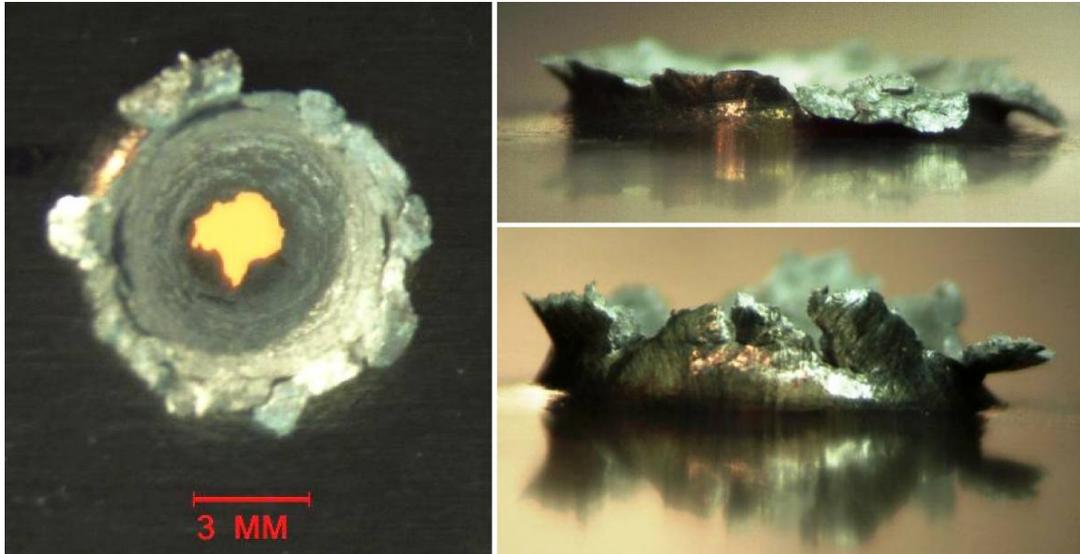
Figure 5: Crater formation in a 0.48-cm-thick Al6061-T6 plate impacted at normal incidence (0 degree) by a 0.15-cm-diameter Al2017-T4 sphere at 6.86 km/s. Left: front view; Right: side view of entry (upper) and exit (lower) crater lips.

Previous studies [4][5] have investigated the formation of sharp-edged crater lips that are induced by the impact of MMOD particles on ISS handrails as a possible source of glove damage. Hypervelocity impact tests were performed on metal plates that were representative of the materials and thicknesses used for ISS handrails [4]. Crater lip profiles were evaluated for impacts using 1-mm-diameter spherical projectiles at approximately 7 km/s with varying angles of obliquity (0 to 75 degrees). For non-penetrating impacts, the authors recorded crater lip heights of 0.1 to 1.4 mm. For penetrating impacts, front and rear-side crater lip heights of up to 1.4 and 3.1 mm, respectively, were measured. Sharp edges were observed on the crater lips in both non-penetrating and penetrating impacts, an example of which is shown in Figure 5.

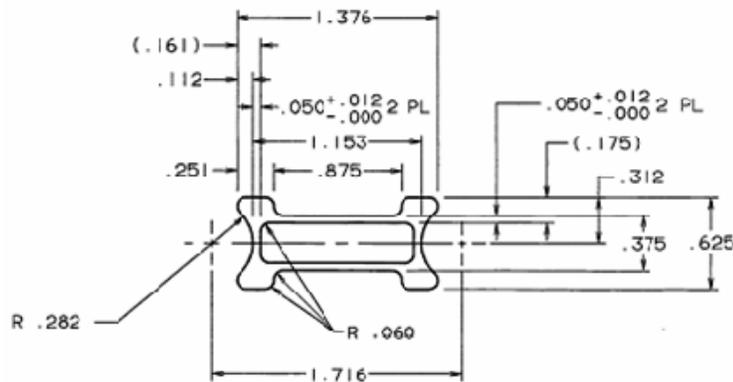
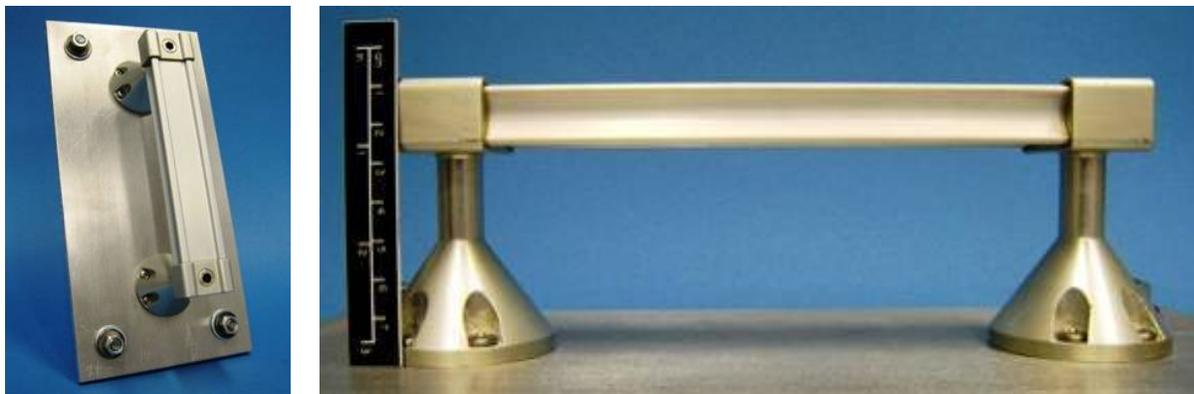
Figure 6: ISS tube handrail (part number (P/N) SDD33107728-073) subject to hypervelocity impact (HVI) testing in Reference [5].

Investigations into crater lip formation on ISS handrails were continued in Reference [5], in which crater formation on actual flight hardware was considered instead of on the handrail-representative plates as in Reference [4]. An example of a handrail target that was used in the study is shown in Figure 6.

The handrails were subject to normal and oblique (45-degree) impact by aluminum spheres that were 1.0 to 2.0 mm in diameter at approximately 6.8 km/s. Different impact locations on the handrail structure were considered to replicate a wide range of possible in-flight scenarios. For non-penetrating impacts, the authors recorded crater lip heights of 0.9 to 2.0 mm. For penetrating impacts, front and rear-side crater lip heights of up to 2.0 and 4.6 mm, respectively, were measured. Sharp edges were observed on the crater lips in both non-penetrating and penetrating impacts, an example of which is shown in Figure 7.

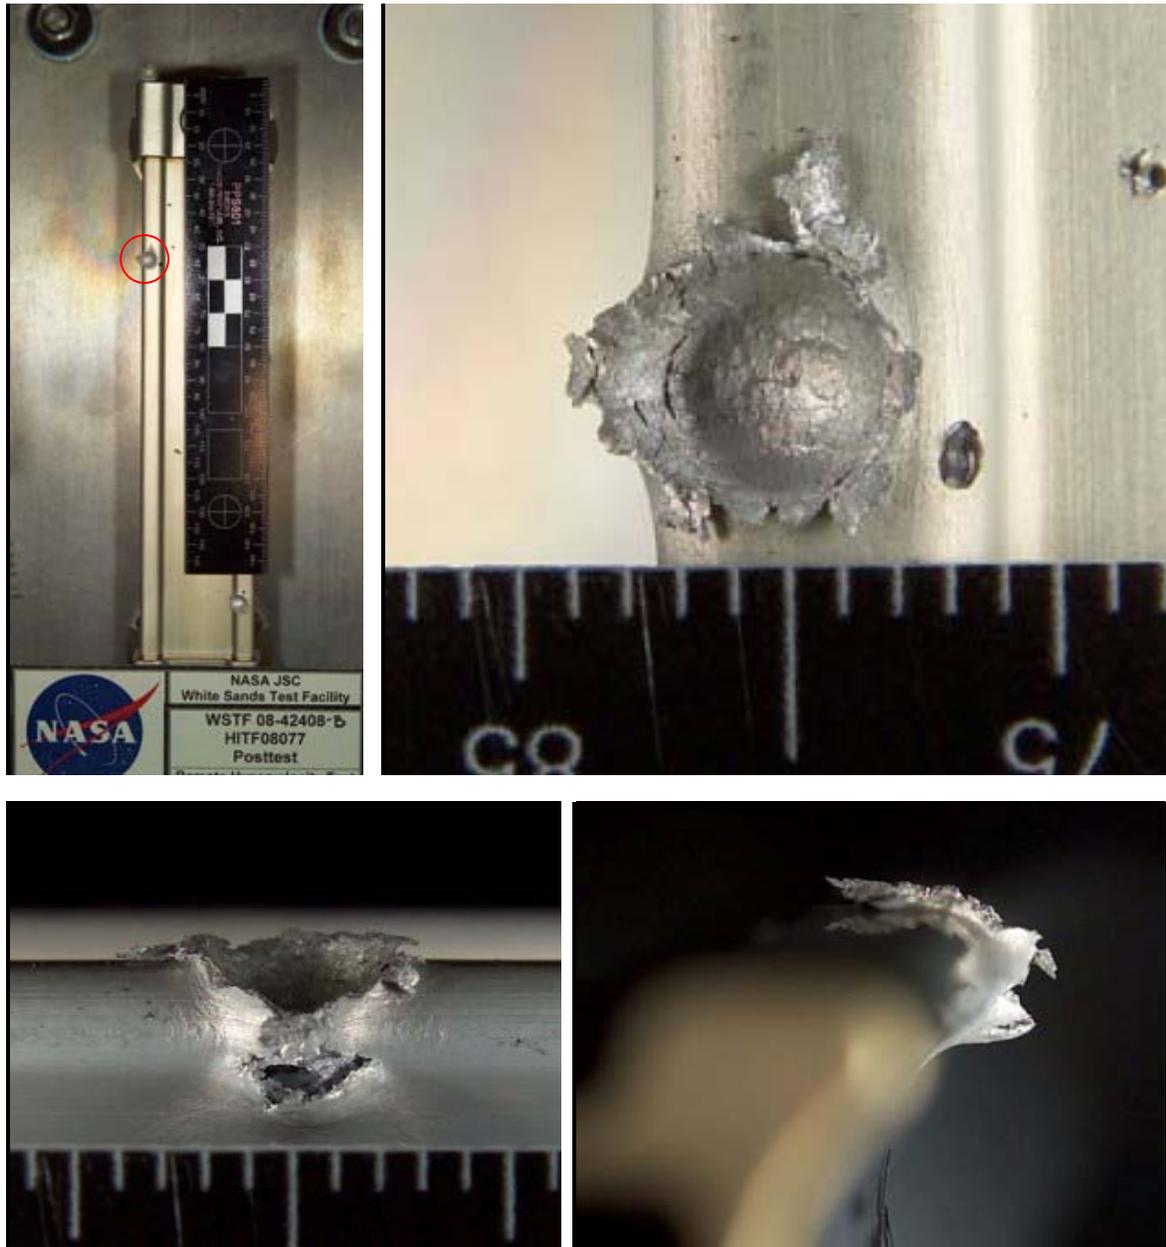
Figure 7: Crater formation on an ISS handrail resulting from oblique (45-degree) impact of a 1.0-mm-diameter Al2017-T4 sphere at 6.94 km/s. Maximum crater lip height measured as 1.7 mm on side of handrail.

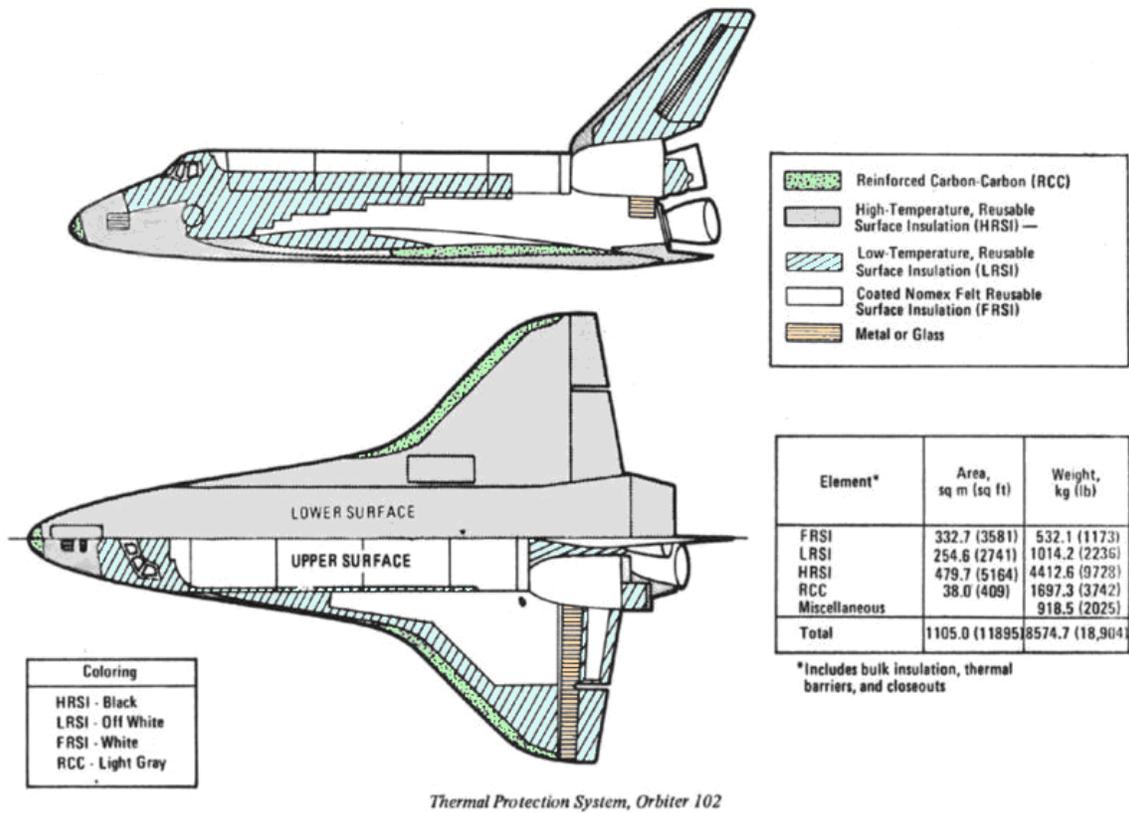
Figure 8: TPS constituent materials (Space Shuttle *Columbia*).

FRSI is a silicone-rubber-coated Nomex[®] felt that is used as part of the space shuttle Thermal Protection System (TPS) on areas that do not sustain heat exposure greater than 400°C during ascent. These include: fuselage top and sides, payload bay doors, tops of the winds, and the Orbiter Maneuvering System (OMS) pods near the tail (Figure 8).

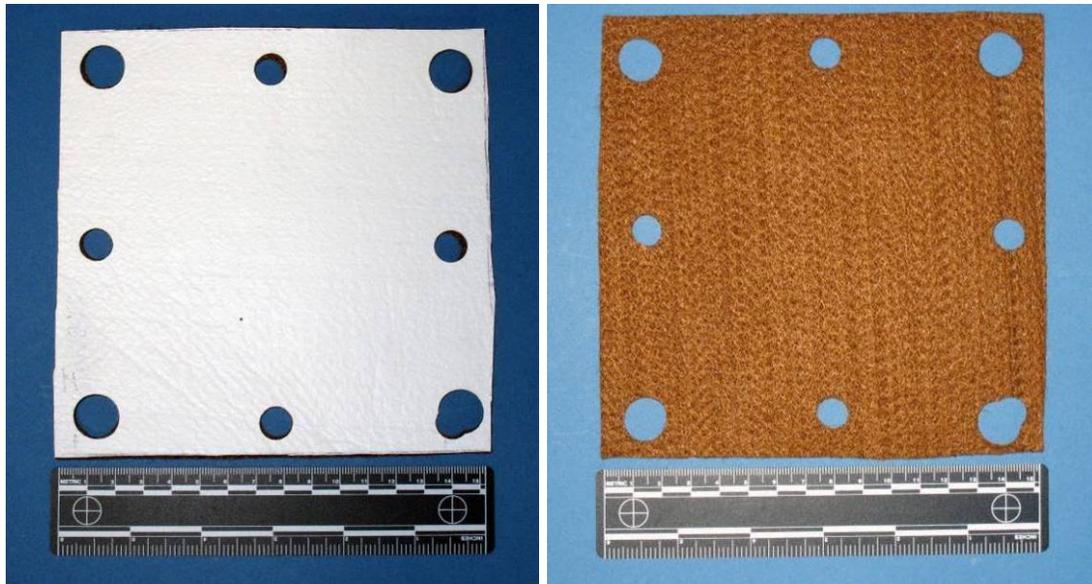
Figure 9: FRSI. Left: front view; Right: rear view.

The silicon-rubber coating of the FRSI has a thickness of 127 to 203 μm . The Nomex[®] felt contains fibers that are nominally 76.2 mm in length and 2.0 denier. The configuration that was used in this test program has an uncompressed thickness of 3.89 mm and a fully compressed thickness of 2.15 mm. The areal density of the FRSI overwrap is 0.066 g/cm^2 (measured). The FRSI is shown in Figure 9.

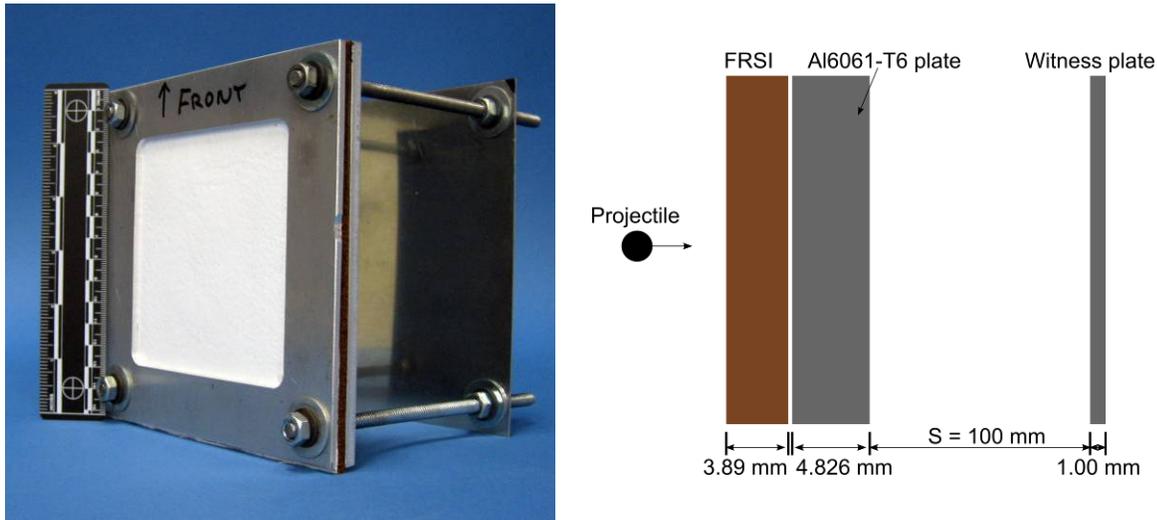
Figure 10: Photograph and schematic of the FRSI overwrap target configuration.

A schematic and photograph of the FRSI overwrap target setup is given in Figure 10.

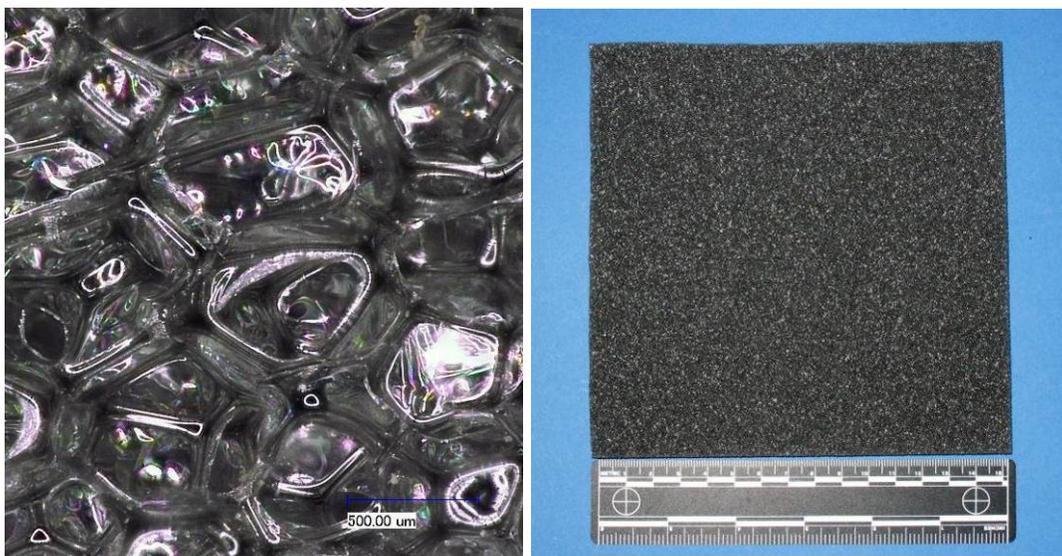
Figure 11: Open-cell non-reticulated polyurethane foam. Left: microstructure; Right: front view.

The OCF+BC configuration is comprised of an open-cell, non-reticulated polyether polyurethane flexible foam that has an outer layer of Beta-cloth. The foam is sold under the trade name Hyfonic[®] by Stephenson & Lawyer, Inc. and has a nominal uncompressed thickness of 12.7 mm (0.5 in.), a volumetric density of 0.0293 g/cm³, a pore density of 65 ppi, and a tensile strength of 96.53 kPa. Photographs of the foam are shown in Figure 11. A single layer of 20-micron-thick aluminized Beta-cloth is placed on top of the foam, with the aluminized side facing downrange (i.e., against the foam). Beta-cloth is a nonflammable glass fiber cloth with very small-diameter fibers that is currently used in the EMU as well as various multilayer insulation (MLI) configurations. The Beta-cloth has an areal density of 0.0284 g/cm². When it is fully compressed, the measured thickness of the overwrap is 1.95 mm. The total areal density is 0.063 g/cm² (measured).

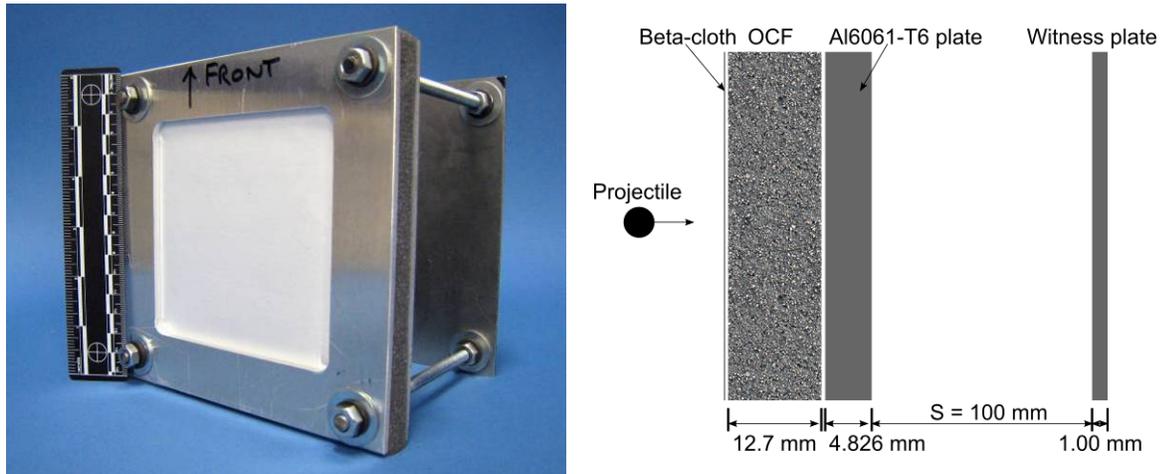
Figure 12: Photograph and schematic of the non-reticulated polyurethane OCF+BC overwrap target configuration.

A schematic and photograph of the PU foam/Beta-cloth overwrap target setup is given in Figure 12.

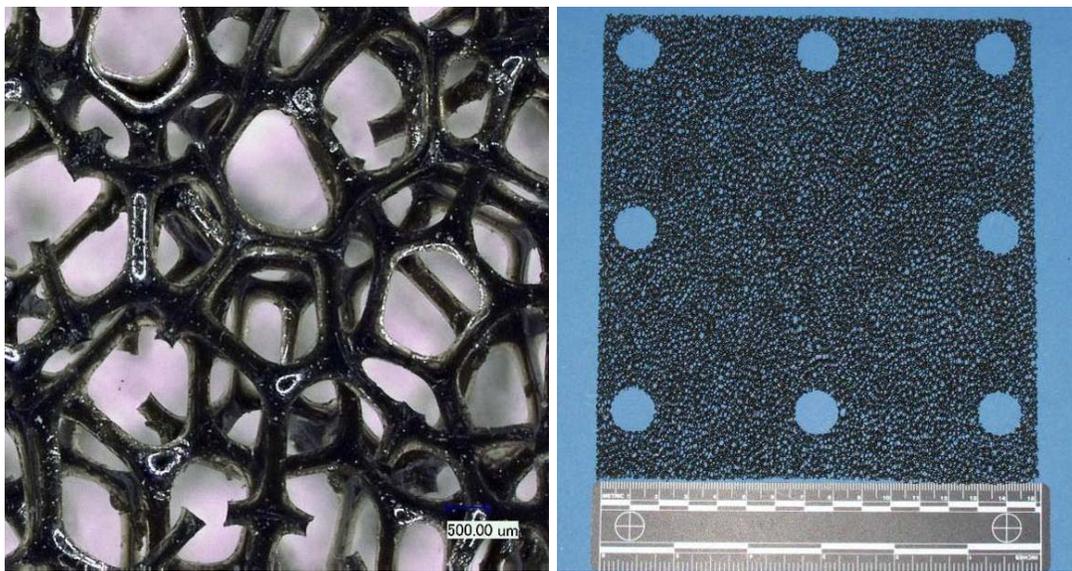
Figure 13: Open cell reticulated polyether polyurethane foam. Left: foam microstructure; Right: front view.

The DROCF+BC overwrap configuration comprises two layers of open-cell reticulated polyether polyurethane foam that alternates with two layers of aluminized Beta-cloth. The foam has an uncompressed thickness of 6.35 mm per layer, a volumetric density of 0.034 g/cm^3 , and a pore density of 20 ppi (measured). Reticulation is a process that removes the membrane between foam cells, leaving a skeletal structure behind that has a significantly lower density than a traditional open-cell foam (up to 97% void volume). The ligaments of the foam skeletal structure have a diameter of approximately 25 microns. Layers of 20-micron-thick aluminized Beta-cloth are placed between the foam layers, and on the upper surface of the configuration, with the aluminized side facing downrange in both instances. The Beta-cloth has an areal density of 0.0284 g/cm^2 . When fully compressed, the measured thickness of the overwrap is 1.98 mm. The total areal density of the configuration is 0.094 g/cm^2 .

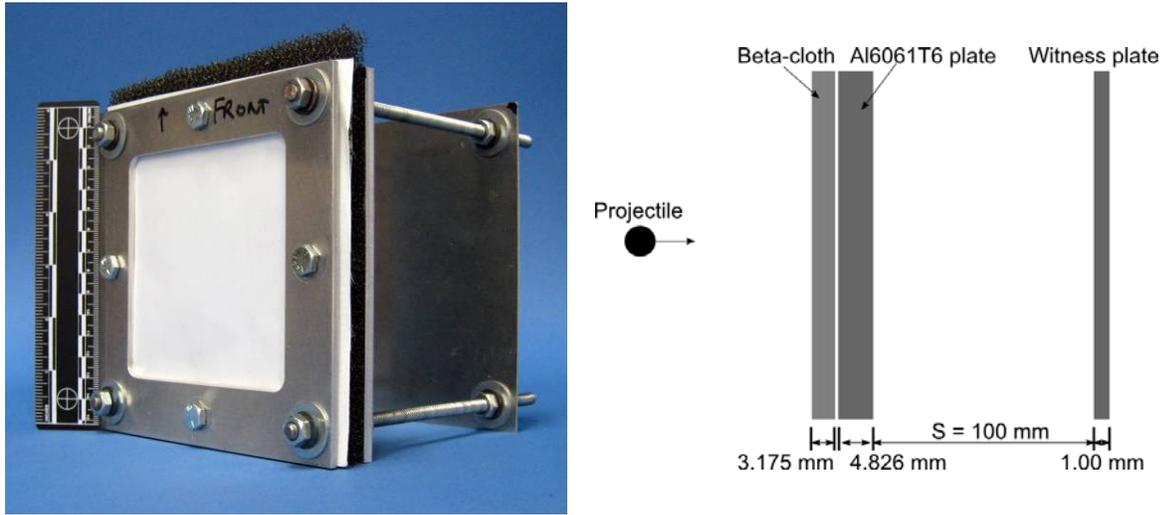
Figure 14: Photograph and schematic of the DROCF+BC overwrap target configuration.

A schematic and photograph of the double-layer polyurethane foam/Beta-cloth overwrap target setup is given in Figure 14.

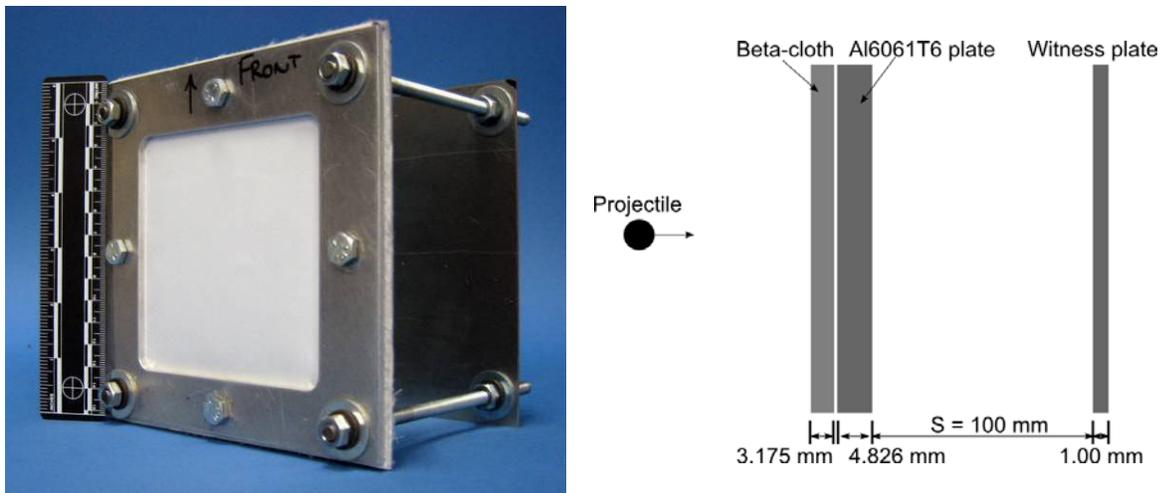
Figure 15: Photograph and schematic of the Beta-cloth overwrap target configuration.

The Beta-cloth overwrap is made of 16 layers of 20-micron-thick aluminized Beta-cloth that is separated by Dacron™ netting spacers, which are commonly used in MLI. The total uncompressed thickness of the configuration is 3.175 mm . When fully compressed the thickness is reduced to 2.70 mm. The overwrap is held in place via a target frame, while the fabric is stretched to minimize billowing. For all of the layers, the aluminized side of the Beta-cloth is facing downrange. The total areal density of the Beta-cloth overwrap is 0.424 g/cm².

A schematic and photograph of the Beta-cloth overwrap target set-up is given in Figure 15.

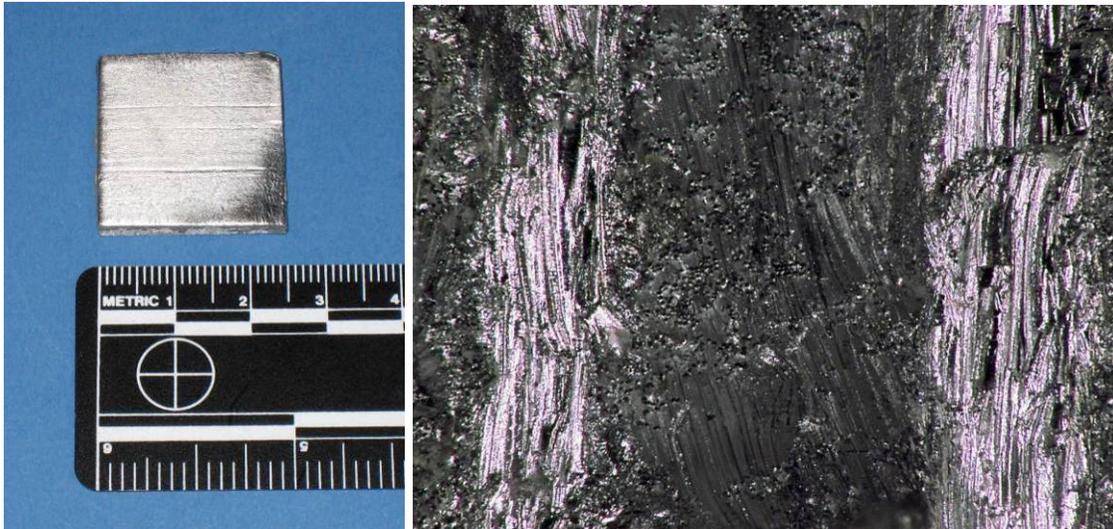
Figure 16: Nextel[®]/Al metal matrix composite. Left: test sample; Right: magnified view showing individual layer orientations within the composite laminate.

The metal matrix composite (MMC) that was selected for impact testing was manufactured by Touchstone Research Laboratory. The composite consisted of four 0.66-mm nominally thick uni-directional (u.d.) plies of Nextel[®] 610 ceramic fiber with a pure aluminum metal matrix (40% fiber content by volume). The stacking sequence of the u.d. plies was given as 0/90/90/0 degree. Photographs of the material and target assembly are shown in Figure 16 and Figure 17. The target sample, which measures 2.54×2.54 cm, was mounted in a recessed frame with a 1.9×1.9-cm opening during impact testing.

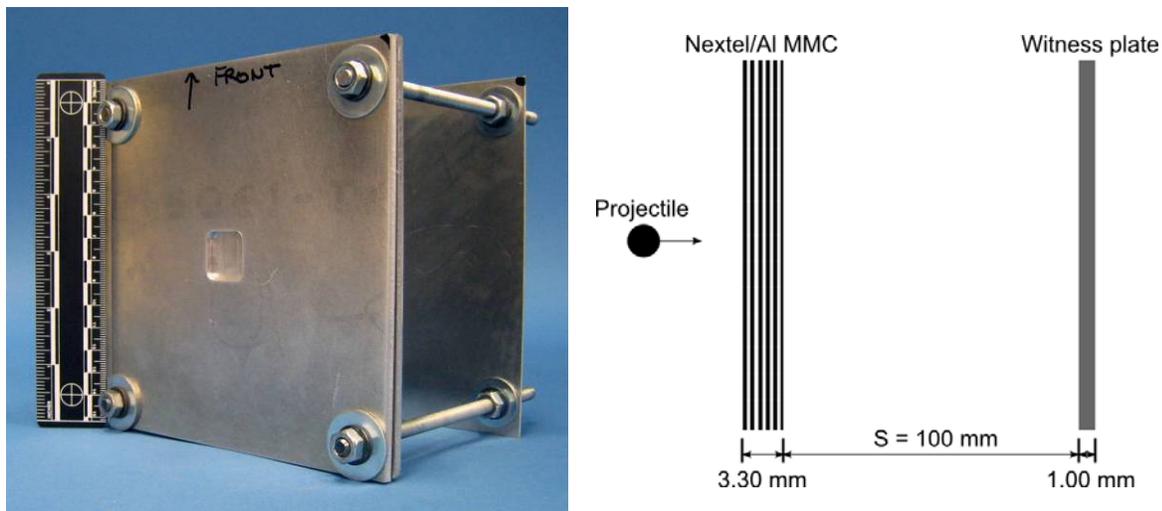
Figure 17: Photograph and schematic of the Nextel[®]/Al MMC target configuration.

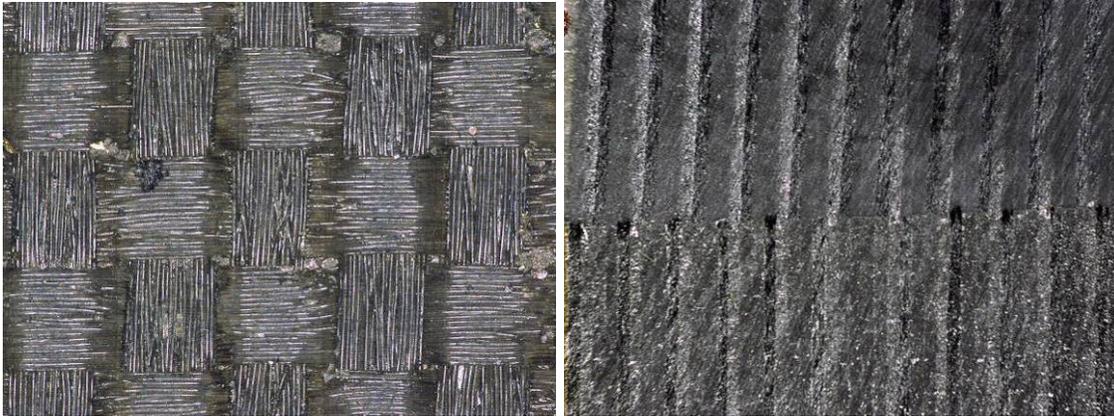
Figure 18: Visual inspection of the CFRP target material. Left: outer fabric layer plain weave (x200 magnification); Right: varying orientation of the u.d. layers (x30 magnification).

The CFRP that was selected for testing was manufactured for use as an external skin on board the NASA X-38 crew return vehicle. The panel, which is 7.03 mm thick, consists of 48 u.d. plies of IM-7-type fiber with 954-2A cyanate ester resin (60% fiber content by volume), a plain-weave IM7/954-2A fabric cover on one side, and a film of Araldite[®] AF191 adhesive that is imbedded with a fine copper mesh on the other side. The stacking sequence of the u.d. plies is $[0/+45/90/-45/0/+45/90/-45/0/+45/90^\circ/-45/0/+45/90/-45/0/+45/90/-45/0/+45/90/-45 \text{ degrees}]_s$. The plain-weave pattern of the upper layer is shown in Figure 18 along with a microscopic image that clearly shows ply orientation differentiation.

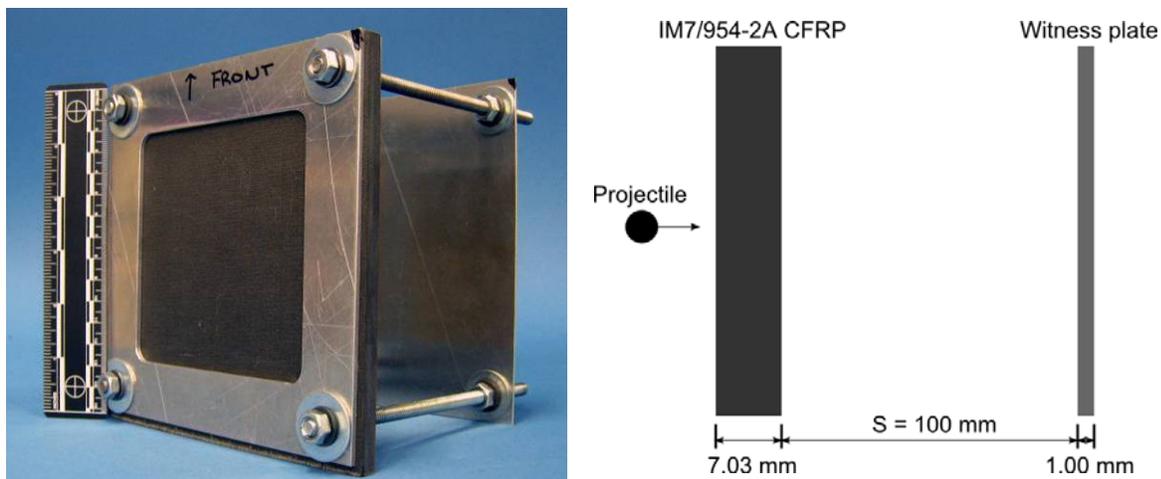
Figure 19: Photograph and schematic of the IM7/954-2A CFRP target configuration.

The CFRP target was impacted on the side of the woven fabric layer to mitigate the influence of the copper-reinforced adhesive layer. The test sample, which had lateral dimensions of 152.4×152.4 mm, was mounted in a target frame. A 1-mm-thick Al6061-T6 witness plate was spaced 100 mm from the target rear side using threaded rods. A schematic and photograph of the target configuration are shown in Figure 19.

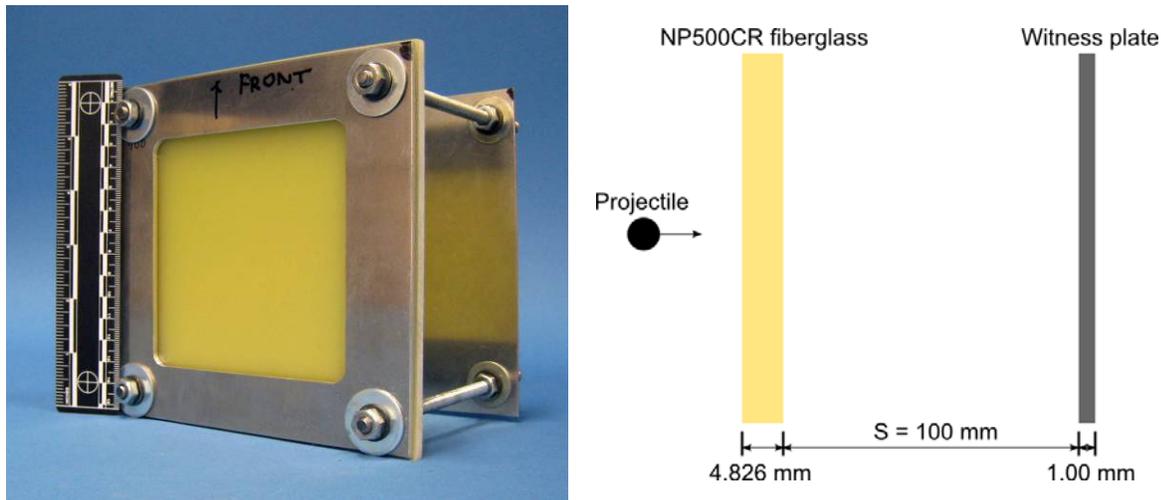
Figure 20: Photograph and schematic of the NP500CR fiberglass target configuration.

A 4.83-mm thick woven-glass fabric/halogen-free epoxy resin system, which was produced by Norplex-Micarta with the trade name NP500CR, was selected as another alternative material for ISS handrails. NP500CR, which is manufactured to the National Institute of Standards and Technology G-10CR process specifications for deep-space and cryogenic applications, is currently in use on board the NASA solar terrestrial relations observatory satellite (STEREO). A photograph and schematic of the fiberglass target configuration are shown in Figure 20.

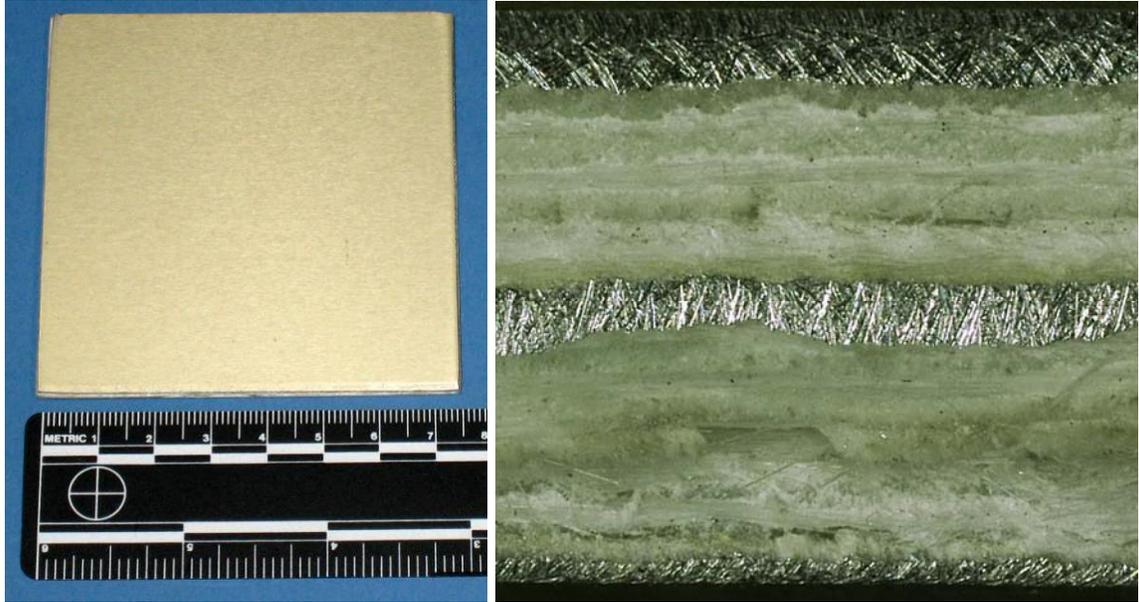
Figure 21: Glare[®] fiber metal laminate. Left: top view; Right: magnified view (x50) showing individual aluminum and glass composite layers.

Glare[®] is a glass fiber reinforced fiber metal laminate that consists of alternating layers of Al2024-T3 and u.d. S-2/FM94 glass fiber/epoxy composite. Glare[®] is currently used in the upper fuselage of the Airbus A380 and in explosive-containing devices (e.g., hardened aircraft cargo carrier). The fiber composite reinforcement increases the tensile and fatigue strength of the baseline aluminum, and has shown promising performance in explosive testing as a result of high strain-rate strengthening of the glass fibers [7]. A 3.74-mm thick Glare[®] sample was selected for testing with a stacking sequence of [Al/0/90/90/0/0/90 degrees/Al/90/0/0/90/90/0 degrees/Al/0/90/90/0/0/90 degrees/Al], referred to as Glare[®] 7, 4/3 (i.e., seven total layers, a four-to-three ratio of aluminum-to-glass/epoxy layers). Photographs of the material and target assembly are shown in Figure 21 and Figure 22.

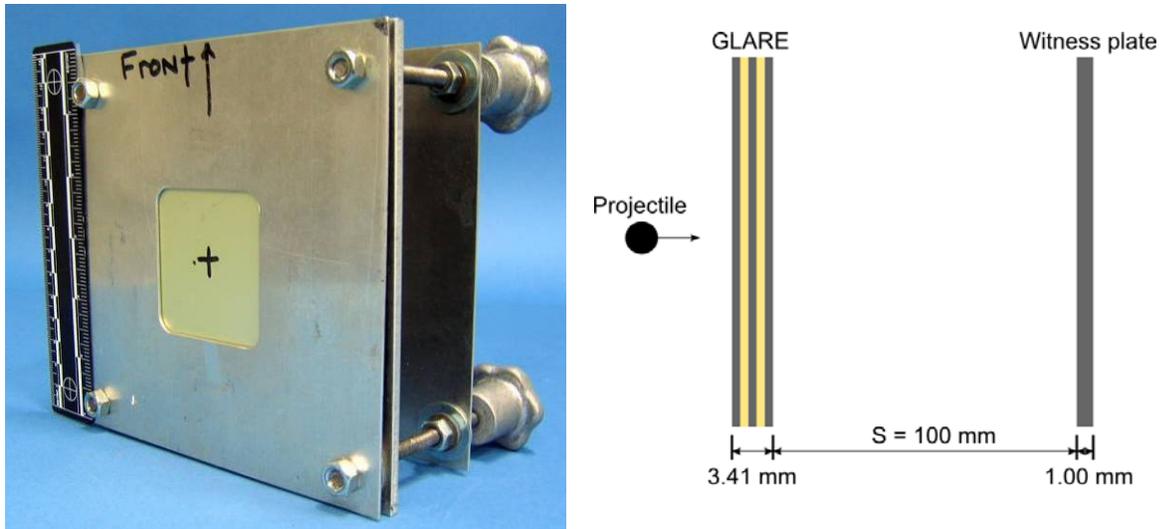
Figure 22: Photograph and schematic of the Glare[®] fiber metal laminate target configuration.

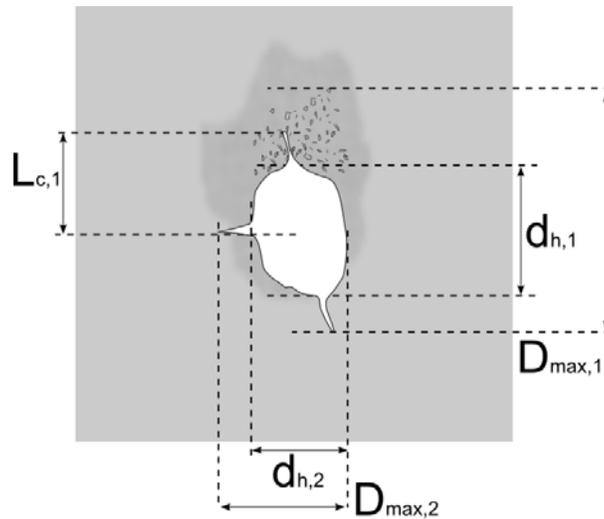
Figure 23: Definition of handrail overwrap damage measurements.

Eight impact tests were performed on the handrail overwrap targets, two shots on each configuration. An overview of test impact conditions and key damage measurements is provided in Table 4. Descriptions of overwrap and handrail damage measurements are shown in Figure 23 and Figure 24. Four hypervelocity impact tests were performed on alternate materials for ISS handrails, one test on each of the four material candidates. An overview of test impact conditions and key damage measurements is provided in Table 5.

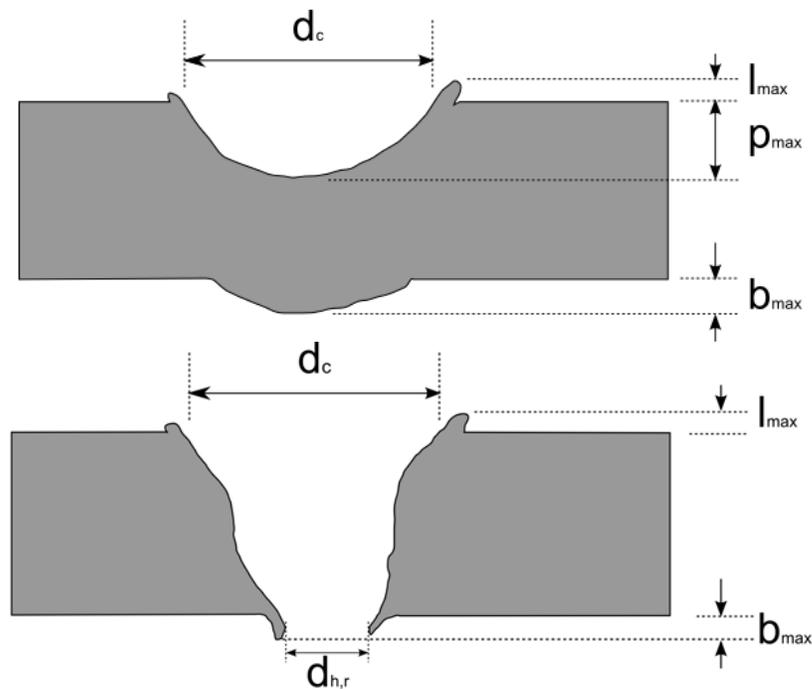
Figure 24: Definition of handrail damages. Top: cratered handrail. Bottom: perforated handrail.

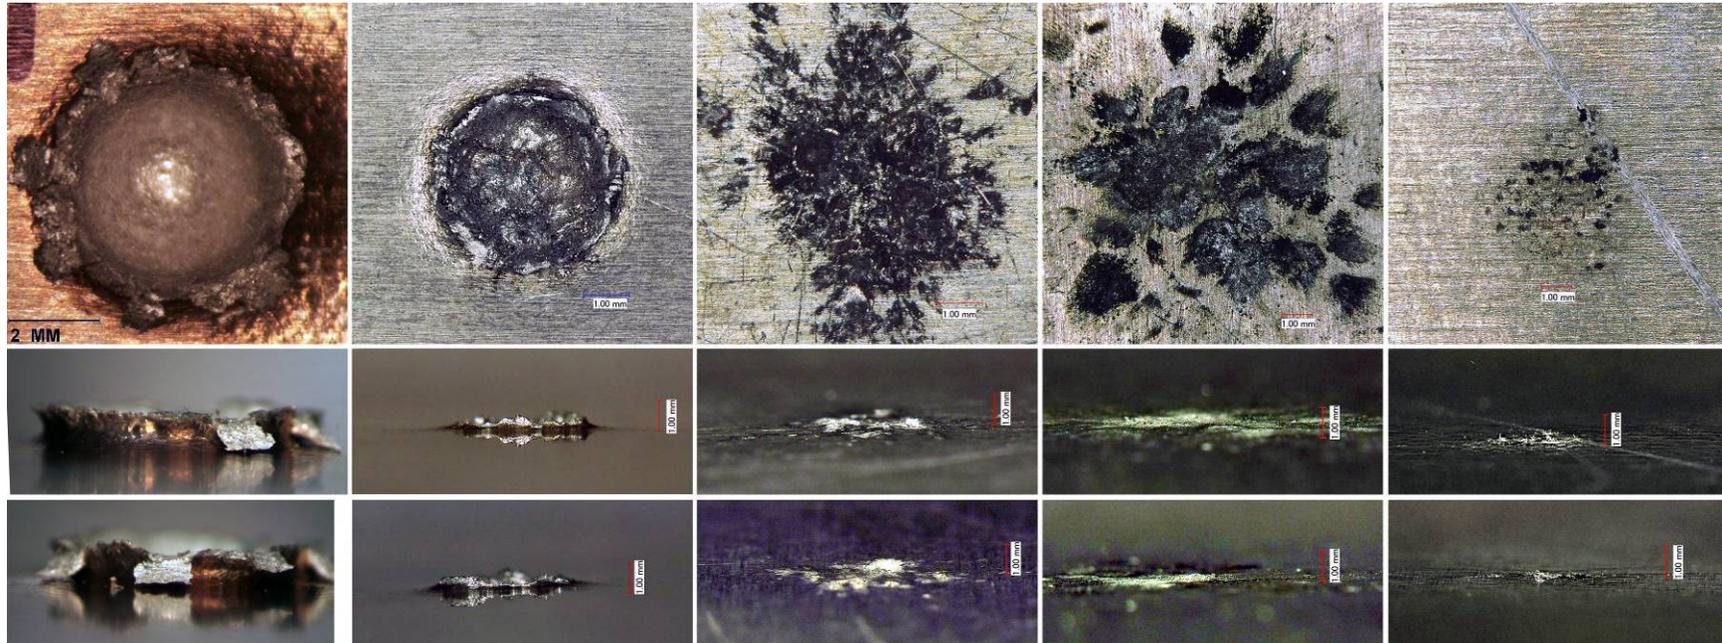
Figure 25: Comparison of impact crater profile in an unshielded Al 6061-T6 plate (representative of an ISS handrail) and overwrap shielded plates impacted by a 1.0-mm-diameter Al 2017-T4 sphere at 6.77 ± 0.22 km/s with normal incidence (0 degree).

A comparison between the impact-generated crater in the unshielded handrail (Ref. [4]) with those that were protected by the overwraps is given in Figure 25 (for normal tests) and Figure 26 (for oblique tests). In Figure 25, it can be seen that the impact crater in the unshielded handrail is clearly defined with a well-formed lip protruding above the plate surface. Of the overwrap configurations, only the FRSI target shows a cleanly formed crater with a discernable lip; however, the diameter of the crater and height of the protruding lip are clearly smaller than those of the baseline target. The target plate that was wrapped by the OCF+BC configuration shows a small crater and a number of deposits and dents in the target surface; however, there is very little protrusion above the target plane. The target plates that were covered with the DROCF+BC and Beta-cloth configurations show no discernable crater formation, only some discoloration and shallow denting of the target surface. For the oblique tests, a clearly formed crater and protruding crater lip are observed on the unshielded target. Cratering of the target plate is apparent on the FRSI target as well as that of the OCF+BC and DROCF+BC. Only the Beta-cloth configuration appears to have prevented the formation of any impact crater. On the FRSI target, the crater is cleanly formed and has a clearly observable lip protruding from the target surface. For the OCF+BC configuration, multiple overlapping craters can be observed, suggesting fragmentation of the projectile during impact with the overwrap. Although the craters are cleanly formed, there is minimal protrusion of material above the target surface. A similar damage profile is seen on the DROCF+BC target, which shows a single, cleanly formed crater (albeit with a diameter that is significantly smaller than that of the unshielded target) with minimal protrusion of the crater lip above the target surface. The Beta-cloth configuration shows minimal damage to the target plate. Of the four configurations that were tested, the Beta-cloth overwrap proved the most effective at limiting damage to the underlying metallic handrail. Given the comparatively large areal density of the Beta-cloth overwrap (0.424 g/cm²), this is to be expected. The only configuration to show a significant amount of damage to the outer surface was the FRSI overwrap in the oblique impact tests. It is important to note, however, that this damage was predominantly a removal of the silicon rubber coating and did not significantly reduce the thickness of the underlying Nomex[®] felt. Considering that the compressed thickness of the four overwrap configurations is larger than that of the measured crater lip height in all eight impact experiments, all four overwrap configurations must be considered successful in preventing contact between EVA crew member gloves and MMOD cut-hazards (for the specific impact conditions and handrail configuration that were tested).
