Mitigation of EMU Glove Cut Hazard by MMOD Impact Craters on Exposed International Space Station Handrails

*Shannon Ryan
USRA Lunar and Planetary Institute
Johnson Space Center, Houston*

*Eric L. Christiansen
Johnson Space Center, Houston*

National Aeronautics and
Space Administration

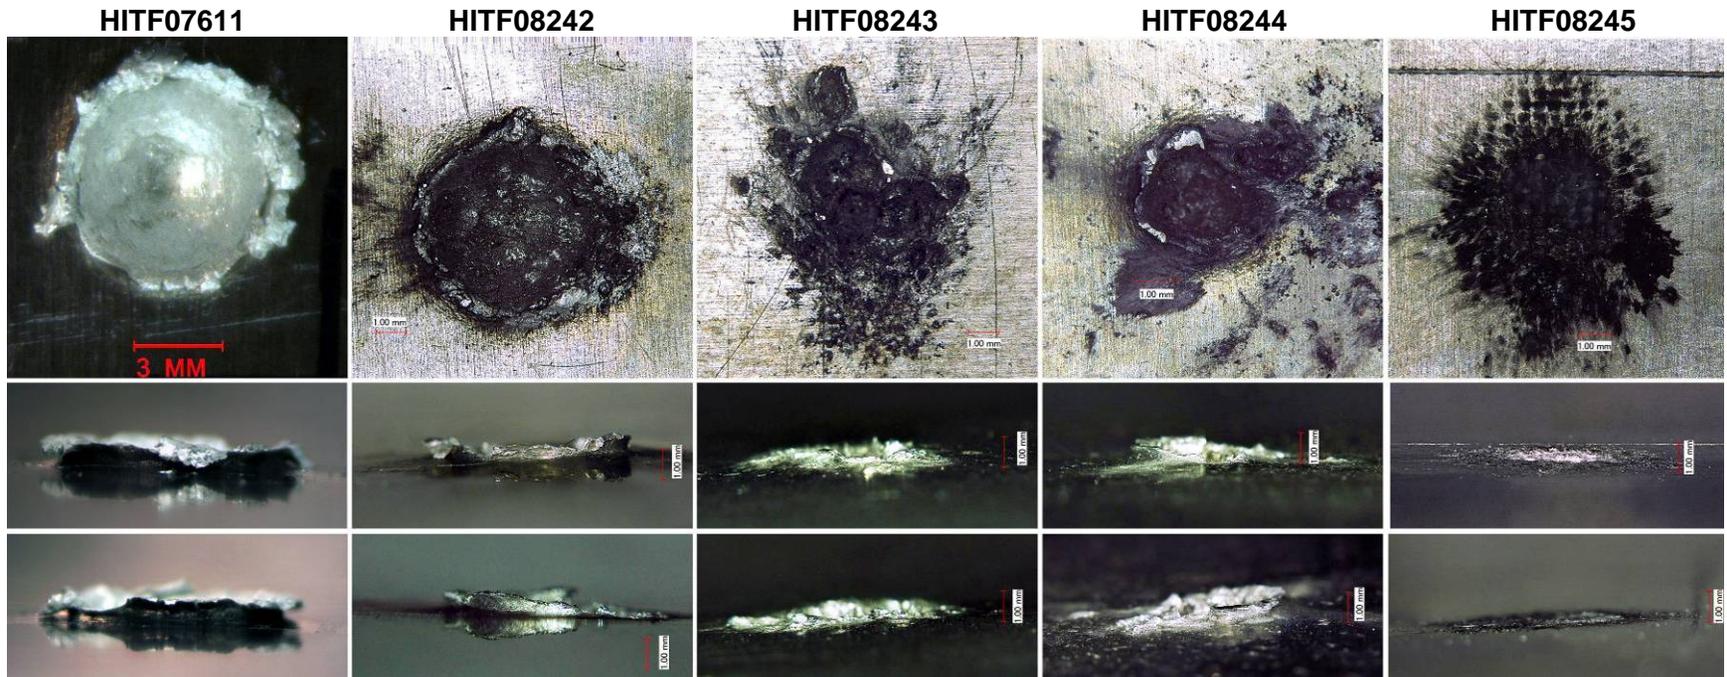
Figure 26: Comparison of impact crater profile in an unshielded Al 6061-T6 plate (representative of an ISS handrail) and overwrap shielded plates impacted by a 1.5-mm-diameter Al 2017-T4 sphere at 6.94 ± 0.09 km/s with oblique incidence (45 degrees).

A comparison between the impact-generated crater in the unshielded handrail (Ref. [4]) with those that were protected by the overwraps is given in Figure 25 (for normal tests) and Figure 26 (for oblique tests). In Figure 25, it can be seen that the impact crater in the unshielded handrail is clearly defined with a well-formed lip protruding above the plate surface. Of the overwrap configurations, only the FRSI target shows a cleanly formed crater with a discernable lip; however, the diameter of the crater and height of the protruding lip are clearly smaller than those of the baseline target. The target plate that was wrapped by the OCF+BC configuration shows a small crater and a number of deposits and dents in the target surface; however, there is very little protrusion above the target plane. The target plates that were covered with the DROCF+BC and Beta-cloth configurations show no discernable crater formation, only some discoloration and shallow denting of the target surface. For the oblique tests, a clearly formed crater and protruding crater lip are observed on the unshielded target. Cratering of the target plate is apparent on the FRSI target as well as that of the OCF+BC and DROCF+BC. Only the Beta-cloth configuration appears to have prevented the formation of any impact crater. On the FRSI target, the crater is cleanly formed and has a clearly observable lip protruding from the target surface. For the OCF+BC configuration, multiple overlapping craters can be observed, suggesting fragmentation of the projectile during impact with the overwrap. Although the craters are cleanly formed, there is minimal protrusion of material above the target surface. A similar damage profile is seen on the DROCF+BC target, which shows a single, cleanly formed crater (albeit with a diameter that is significantly smaller than that of the unshielded target) with minimal protrusion of the crater lip above the target surface. The Beta-cloth configuration shows minimal damage to the target plate. Of the four configurations that were tested, the Beta-cloth overwrap proved the most effective at limiting damage to the underlying metallic handrail. Given the comparatively large areal density of the Beta-cloth overwrap (0.424 g/cm²), this is to be expected. The only configuration to show a significant amount of damage to the outer surface was the FRSI overwrap in the oblique impact tests. It is important to note, however, that this damage was predominantly a removal of the silicon rubber coating and did not significantly reduce the thickness of the underlying Nomex[®] felt. Considering that the compressed thickness of the four overwrap configurations is larger than that of the measured crater lip height in all eight impact experiments, all four overwrap configurations must be considered successful in preventing contact between EVA crew member gloves and MMOD cut-hazards (for the specific impact conditions and handrail configuration that were tested).

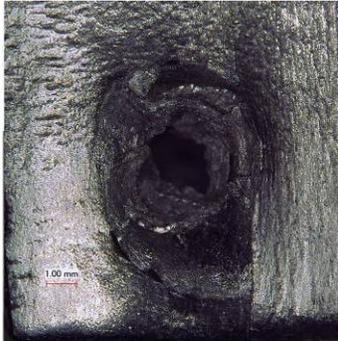
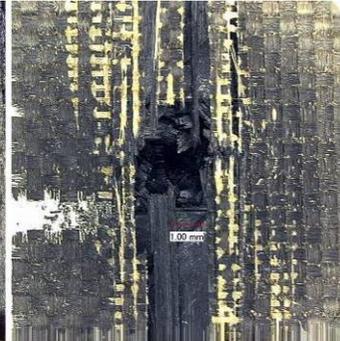
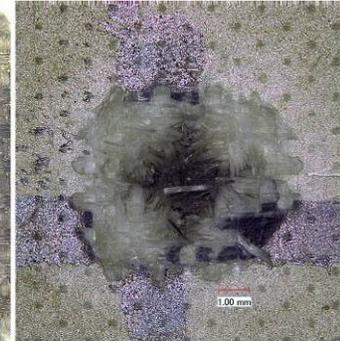
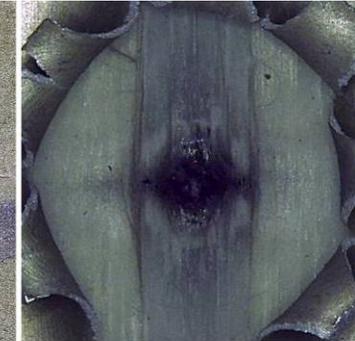
Figure 27: Comparison of impact crater profile in a simulated ISS Al handrail and alternate handrail materials (from left to right: Al 6061-T6, MMC, CFRP, fiberglass, FML) impacted by a 1.0-mm-diameter Al 2017-T4 sphere at 6.91 ± 0.08 km/s with normal incidence (0 degree).

In Table 5, two of the four alternate materials that were tested were shown to reduce the lip height of MMOD craters compared to that of a baseline Al6061-T6 target when impacted by a 1.0-mm-diameter Al2017-T4 sphere at normal incidence with a velocity of 6.91 ± 0.08 km/s. There was no measurable crater lip on the CFRP laminate; however, there was a degree of surface spallation about the impact site, including groups of single-ply-thick material that protruded above the target surface. Surface spallation is limited by the outer plain-weave fabric layer (compared with a u.d. outer layer); however, the surface spallation is still deemed to be potentially hazardous to EMU gloves (potentially more so than are the sharp crater lips on metallic handrails). As such, this particular CFRP laminate is considered to be unsuitable as a potential material for ISS handrails. By increasing the number of fabric layers on the outer

surfaces of the laminate, the degree of surface spallation can be reduced, which should be considered in any further investigations. The other material to decrease the height of the cut-hazard was the NP500CR fiberglass. For this material, fractured and delaminated fibers protruded above the target surface. Unlike the protrusions that are associated with the CFRP laminate, however, these protrusions were not rigid, nor did they extend beyond the local impact site (Figure 27). In this case, the epoxy material has been completely removed from the protruding fibers; and it is considered that the puncture hazard of the fibers is minimal. The Glare[®] fiber metal laminate provided the largest crater lip height, which was 3.3 times that of the original Al6061-T6 material. As shown in Figure 27, the outer aluminum layer of the FML peeled back from the glass/epoxy composite layer during impact, resulting in a large crater diameter with very sharp petalled edges. By modifying the laminate lay-up such that a number of glass/epoxy layers were on the outer surface, it is expected that the height of any damage features would be reduced. The Nextel[®] 610/ pure Al metal matrix composite provided similar performance (in terms of protruding crater lip height) to that of the baseline Al6061-T6 handrail. The Nextel[®] fiber reinforcements act to increase the stiffness of the pure Al and reduce its ductility. A more brittle material would be expected to form smaller protruding crater lips, given the reduced plastic flow sustained in the material.

It can be seen in Figure 27 that the outer layer of the MMC laminate fractured about the impact site, resulting in almost no protrusion above the target surface. Indeed, the 1.0-mm lip height was measured from the second layer of laminate. The MMC target is penetrated by the projectile, resulting in a rear-side damage feature with a maximum height of 2.45 mm. Given that the thickness of the MMC was less than that of the baseline handrail target, this does not indicate a decreased performance. However, for penetrating impacts using a 1.5- and 2.0-mm projectile on the baseline Al6061-T6 target in Reference [4], a maximum exit hole lip height of 1.9 mm was measured (normal impact). Therefore, it is considered that the performance of the Nextel[®] 610/pure Al MMC is worse than the performance of the baseline Al alloy.

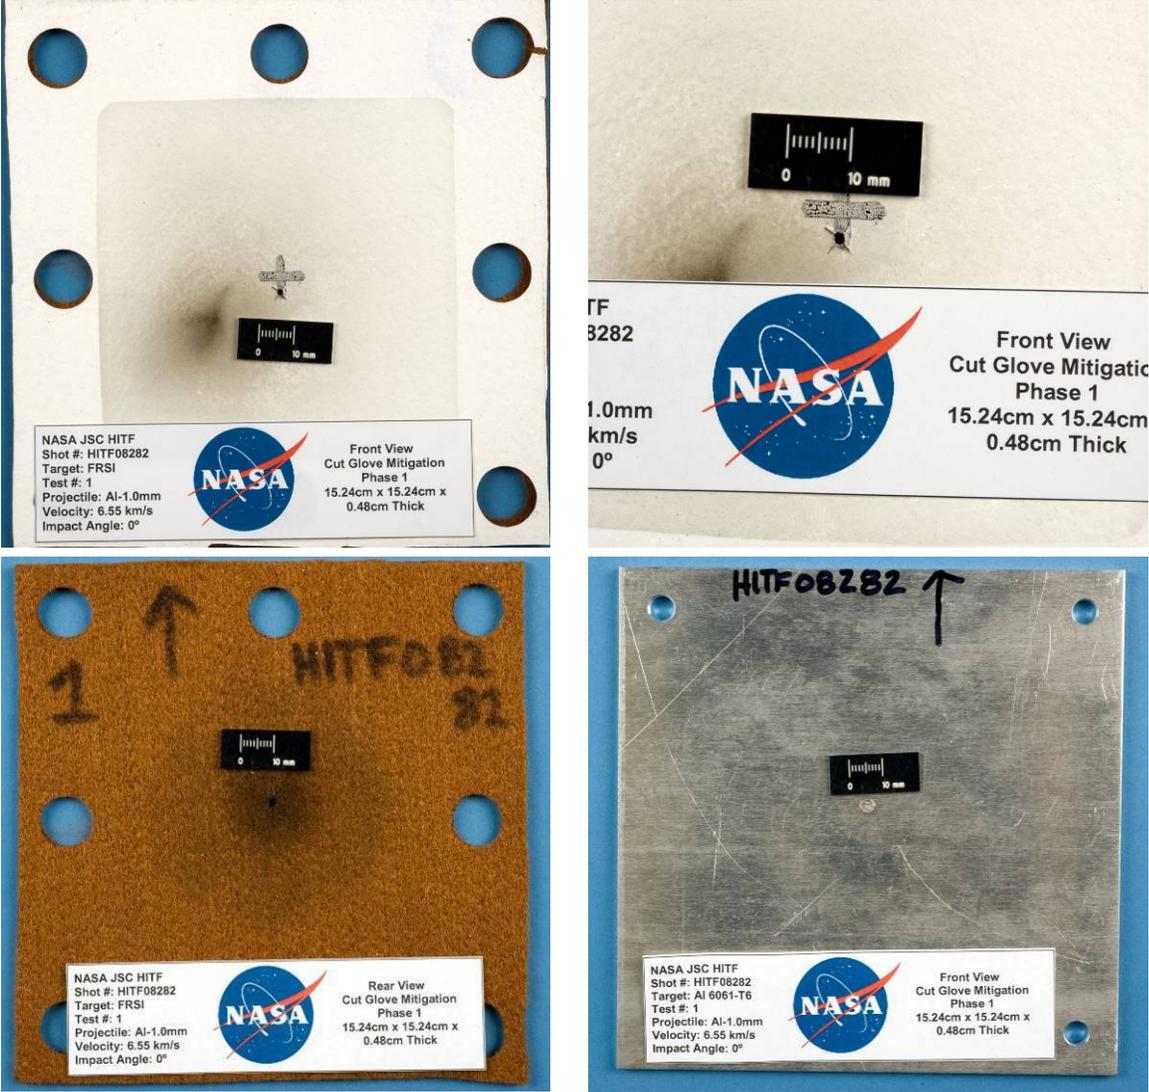
Figure A-1: HITF08282 post-test damage photographs. Top left to bottom right: overwrap front side, overwrap front side (zoom), overwrap rear side, target plate front side.

Test 1 of Phase 1 (HITF08282) investigated a 1.0-mm-diameter Al 2017-T4 sphere impacting at a velocity of 6.55 km/s with normal incidence (0 degree) on a 4.82-mm-thick Al6061-T6 plate covered by an FRSI overwrap. Impact of the projectile generated a roughly circular entry hole in the overwrap, with four radial cracks (length \approx 3mm) propagating from each corner of the hole (Figure A-1, Table A-1). On the rear side, the exit hole was centered in a zone of dark discoloration (diameter \approx 19mm). The crater on the target plate was clearly formed with a roughly hemispherical shape and a protruding crater lip (Figure A-2). There was no noticeable damage on the rear side of the target.

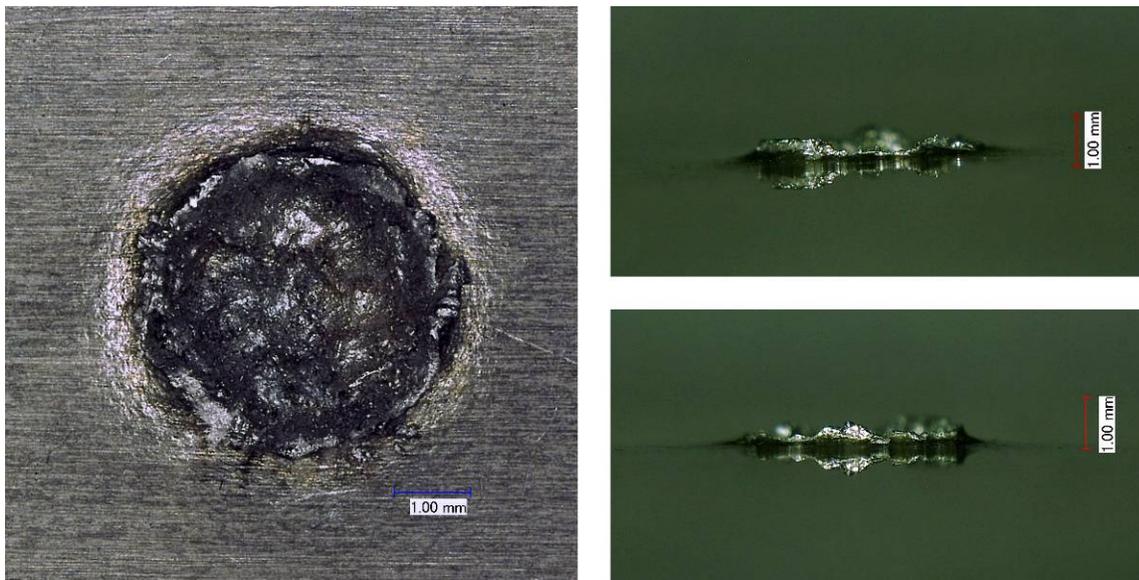
Figure A-2: HITF08282 impact crater.

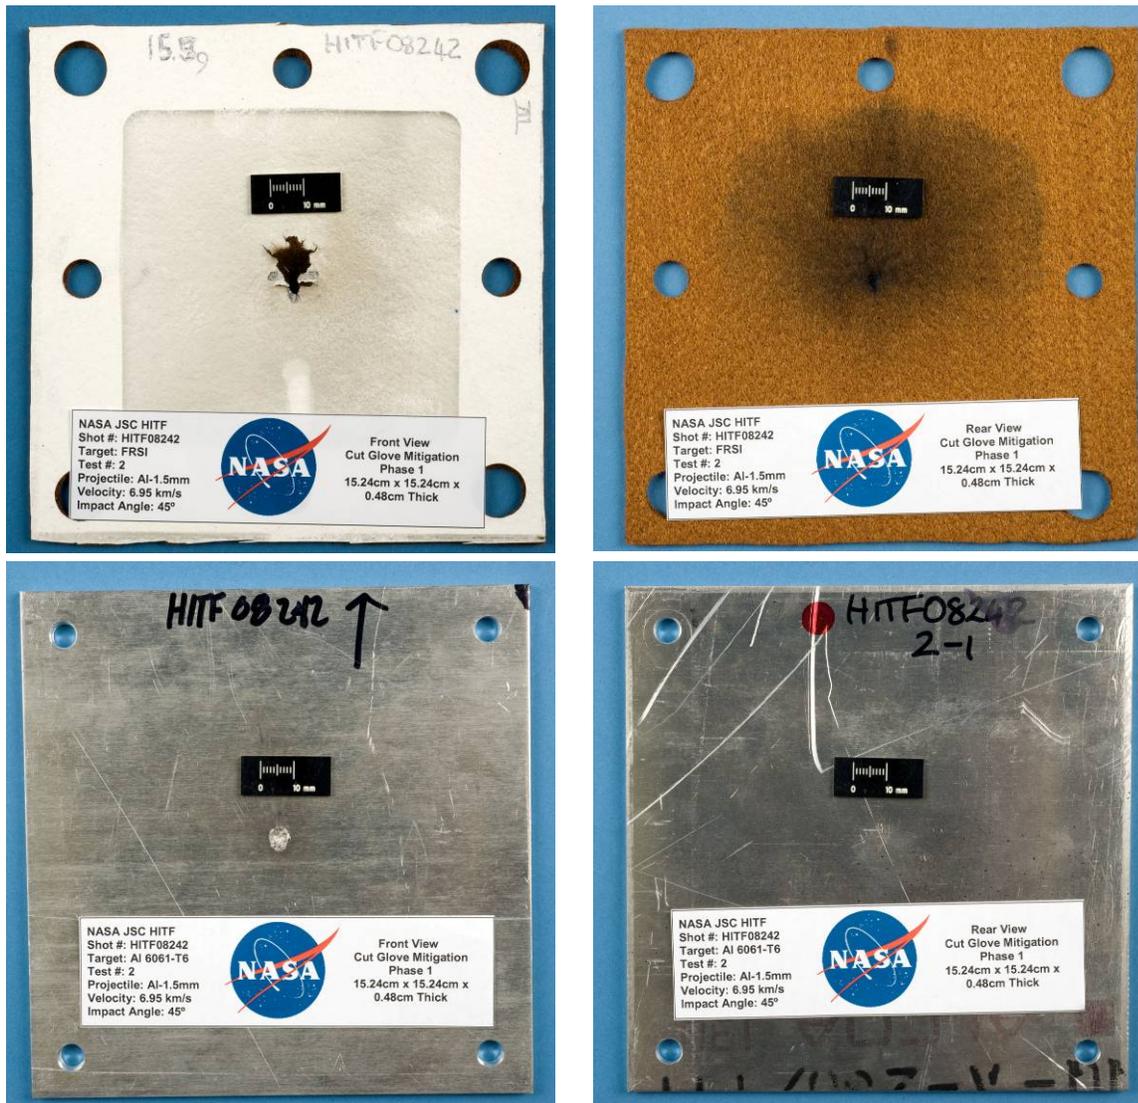
Figure A-3: HITF08242 post-test damage photographs. Top left to bottom right: overwrap front side, overwrap rear side, target plate front side, target plate rear side.

Test 2 of Phase 1 (HITF08242) investigated a 1.5-mm-diameter Al 2017-T4 sphere impacting obliquely (45 degrees) with a velocity of 6.95 km/s on a 4.826-m-thick Al6061-T6 plate that was covered by an FRSI overwrap. Impact of the projectile generated an elliptical entry hole in the overwrap, which was surrounded by a number of cracks (~8) and frayed felt. The rear side of the overwrap showed a semi-circular region of discoloration (radius \approx 52mm) about the elliptical exit hole, with the darkest region located above the clear hole (Figure A-3). The crater on the target plate, which was clearly formed, was slightly elliptical in shape with a sharply protruding crater lip (max height = 0.7 mm). The rear side of the target showed a minimal amount of bulging (Table A-2, Figure A-4).

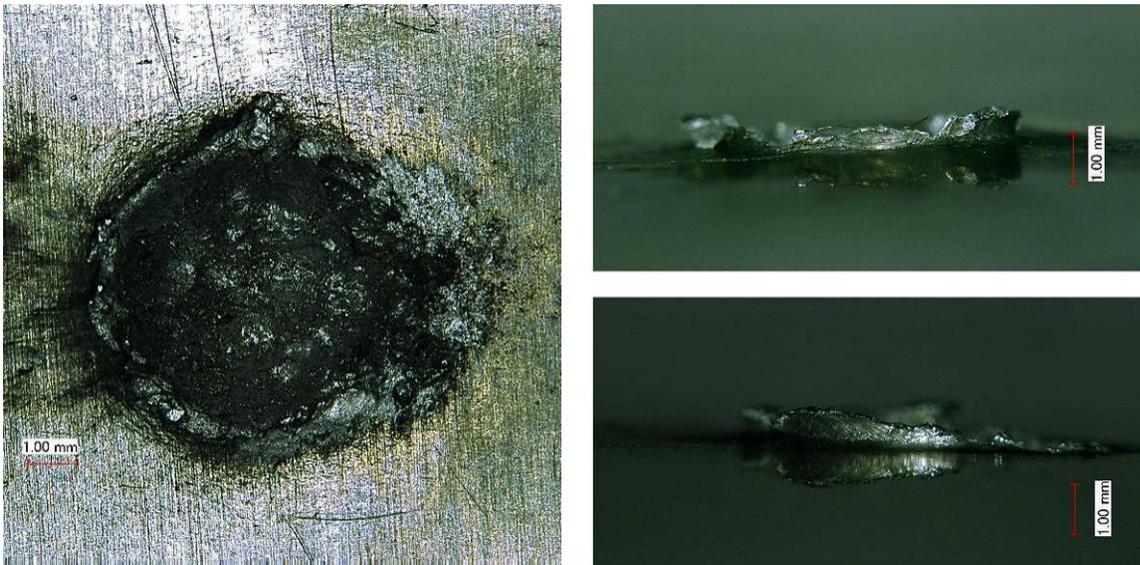
Figure A-4: HITF08242 impact crater.

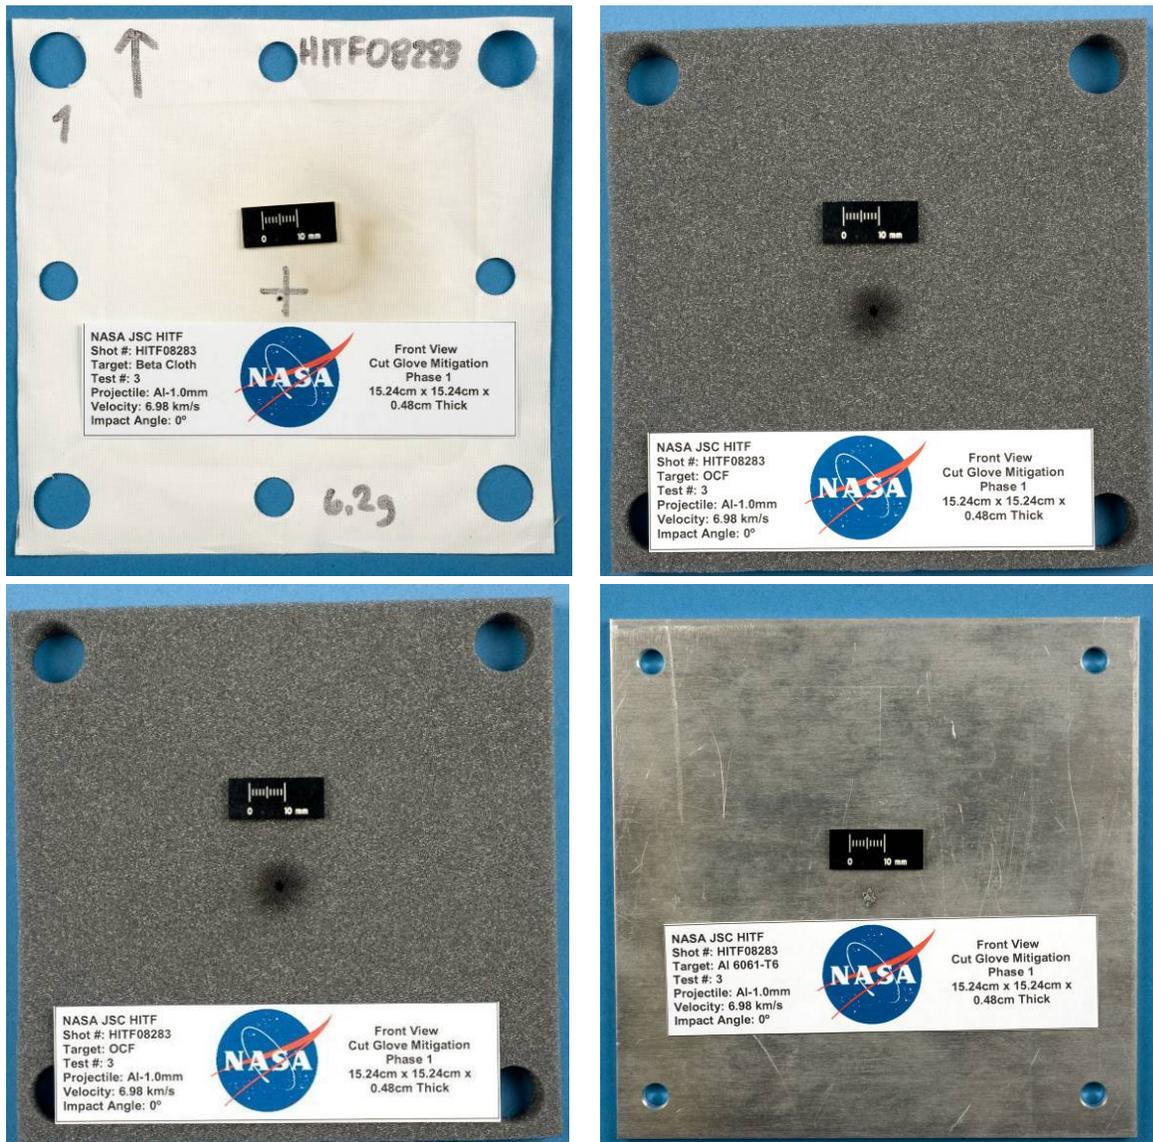
Figure A-5: HITF08283 post-test damage photographs. Top left to bottom right: Beta-cloth cover front side, open cell foam front side, open cell foam rear side, target plate rear side.

Test 3 of Phase 1 (HITF08283) investigated a 1.0-mm-diameter Al 2017-T4 sphere impacting at a velocity of 6.98 km/s with normal incidence (0 degree) on a 4.82-mm-thick Al6061-T6 plate that was covered by a non-reticulated OCF with an aluminized Beta-cloth cover (Figure A-5). Impact of the projectile generated a circular entry hole in the Beta-cloth. The OCF shows a roughly circular through-hole with surrounding black discoloration. The exit hole in the OCF is larger than the entry hole, suggesting an expanding fragment cloud. The target plate shows a single large crater, with numerous smaller craters and melted aluminum deposits about the central damage zone. The large crater is circular shape with a small lip height. There is no noticeable damage on the rear side of the target plate (Table A-3, Figure A-6).

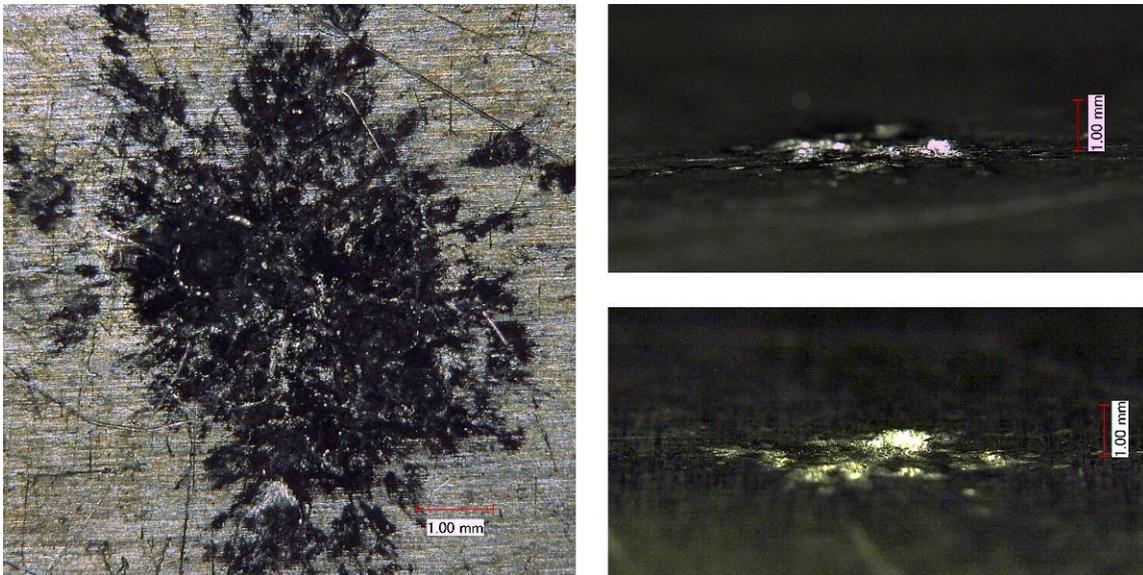
Figure A-6: HITF08283 impact crater.

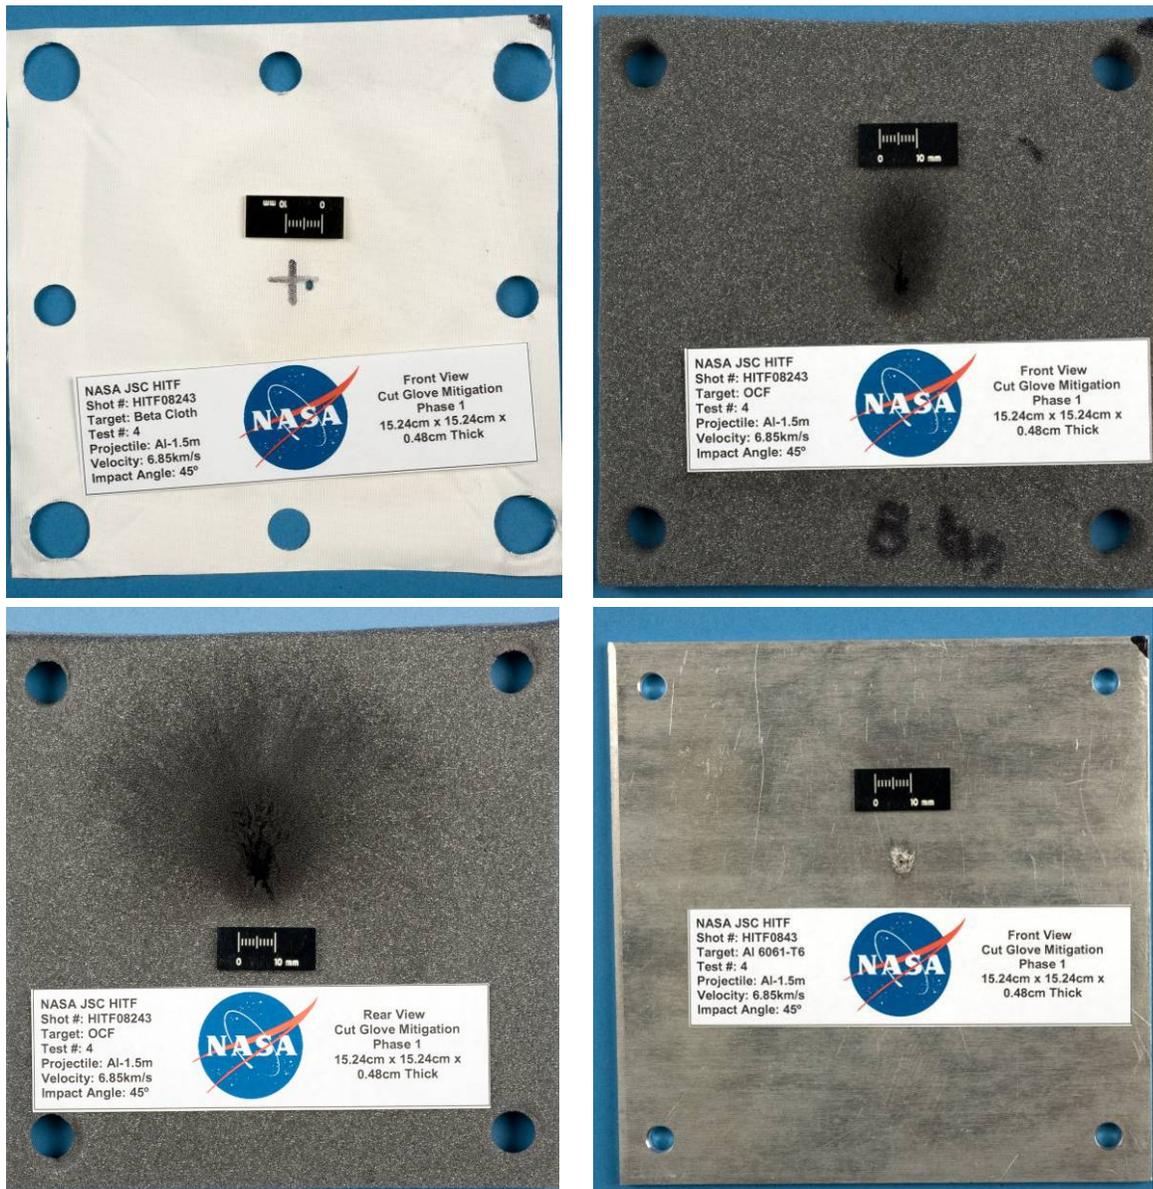
Figure A-7: HITF08243 post-test damage photographs. Top left to bottom right: Beta-cloth cover front side, open cell foam front side, open cell foam rear side, target plate front side.

Test 4 of Phase 1 (HITF08243) investigated a 1.5-mm-diameter Al 2017-T4 sphere impacting obliquely (45 degrees) with a velocity of 6.95 km/s on a 4.826-mm-thick Al6061-T6 plate that was covered by a non-reticulated OCF with an aluminized Beta-cloth cover (Figure A-7). Impact of the projectile generated an elliptical entry hole in the Beta-cloth. The entry hole in the OCF is elliptical in shape with a diameter that is larger than that of the clear hole in the Beta-cloth. The exit hole diameter in the OCF is larger than the entry hole, suggesting an expanding fragment cloud. The foam about the clear hole is discolored (black). The target plate shows multiple overlapping craters, creating a single, roughly elliptical-shaped crater. Melted deposits of aluminum are at the bottom of the craters as well, and black striations are on the plate above the cratered area. There is no apparent damage to the rear side of the target plate (Table A-4, Figure A-8).

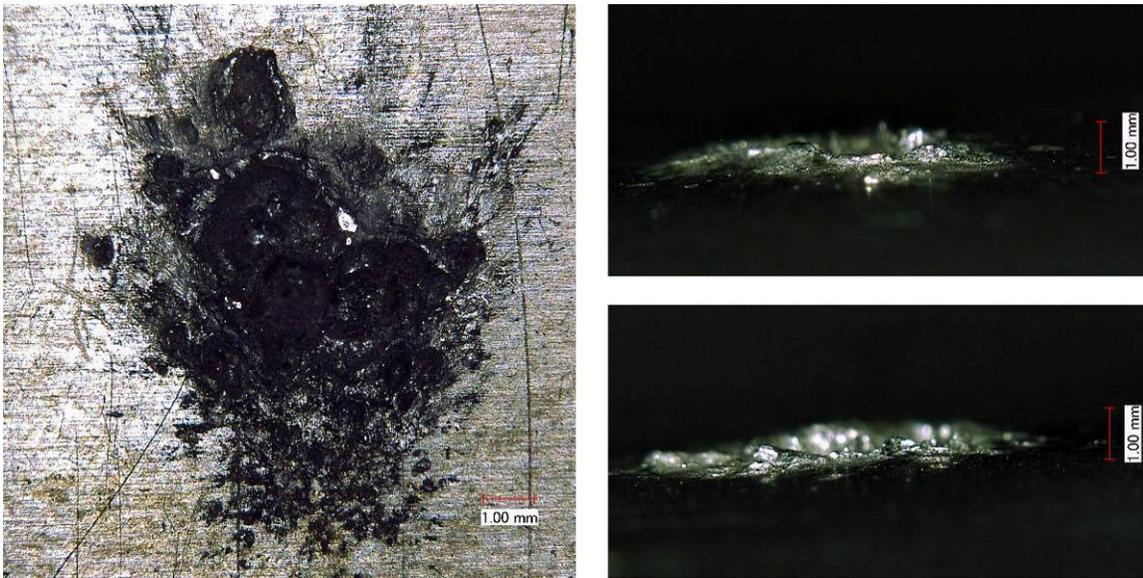
Figure A-8: HITF08243 impact crater.

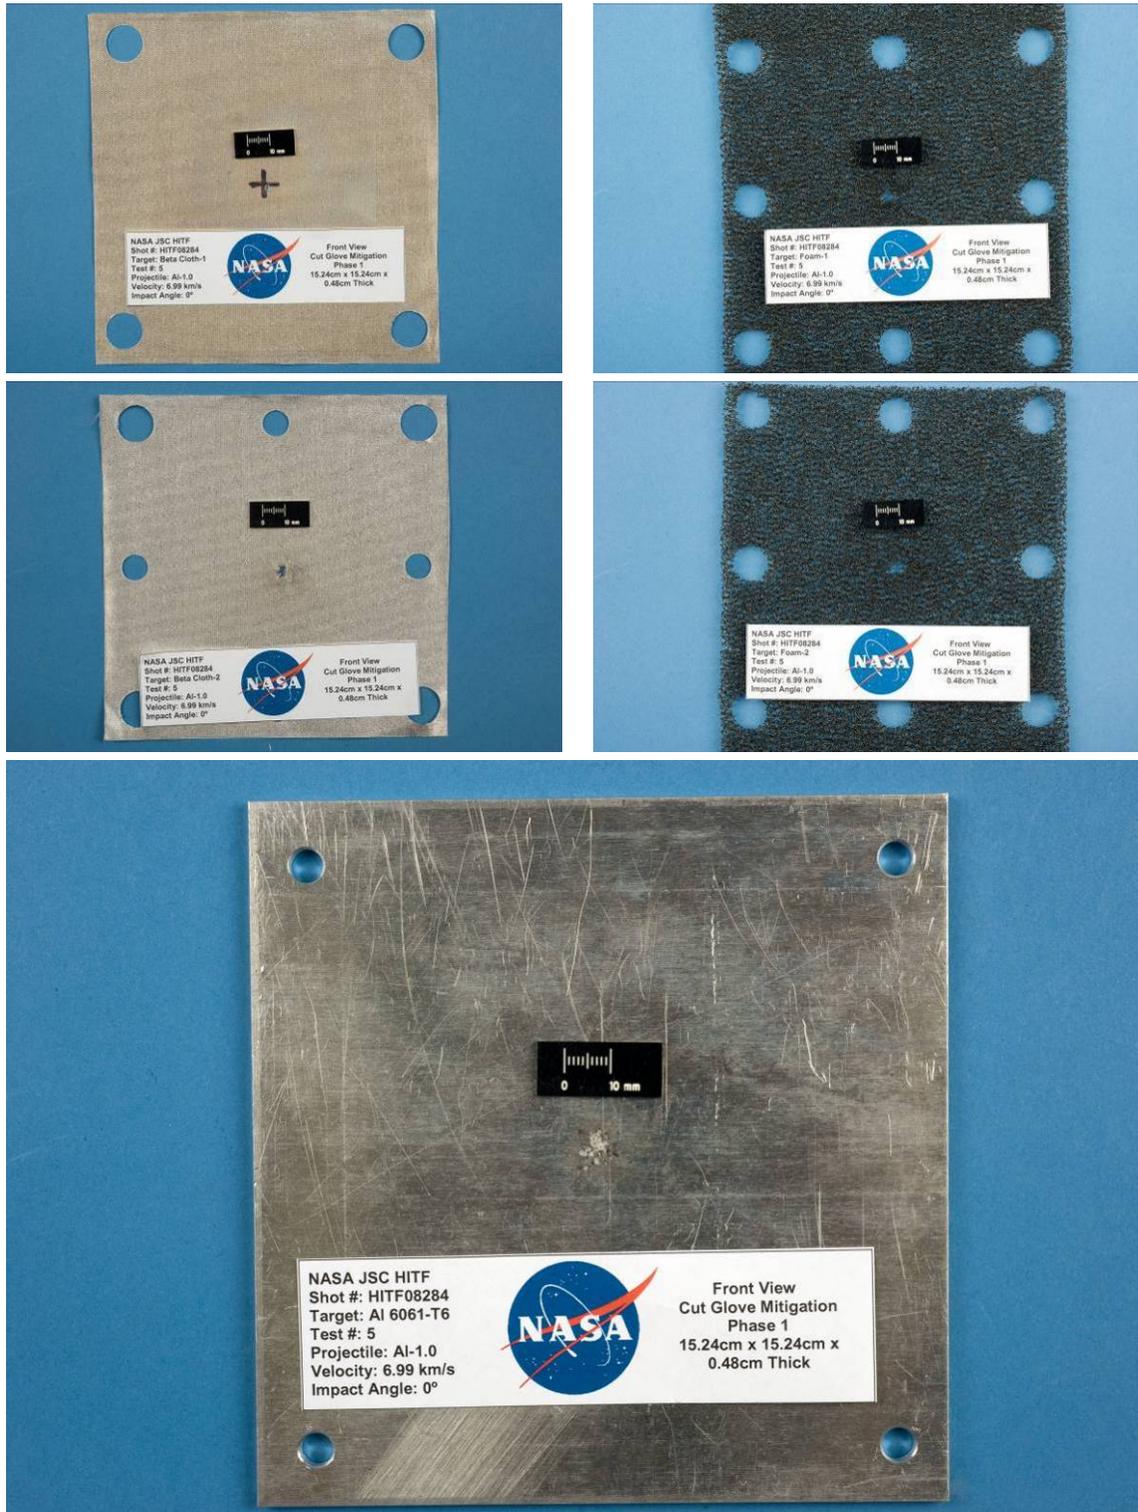
Figure A-9: HITF08284 post-test damage photographs. Top to bottom: outer Beta-cloth cover front side (left), outer open cell foam layer front side (right), inner Beta-cloth cover (left), inner open cell foam layer (right), target plate front side.

Test 5 of Phase 1 (HITF08284) investigated a 1.0-mm-diameter Al 2017-T4 sphere impacting at a velocity of 6.98 km/s with normal incidence (0 degree) on a 4.826-mm-thick Al6061-T6 plate that was covered by a double-layer open-cell polyurethane foam overwrap with a Beta-cloth cover and an intermediate layer (DROCF+BC) (Figure A-9). Impact of the projectile on the overwrap generated a roughly circular entry hole that was slightly frayed about the edges. The evolution of hole size through both layers of the ROCF and intermediate Beta-cloth layer shows an expanding fragment cloud (i.e., progressively larger hole diameters). The minimal damage on the target plate consists of some black discoloration and a single shallow crater showing the projectile barely perforating the surface of the target plate. There is no apparent damage to the rear side of the target plate (Table A-5, Figure A-10).

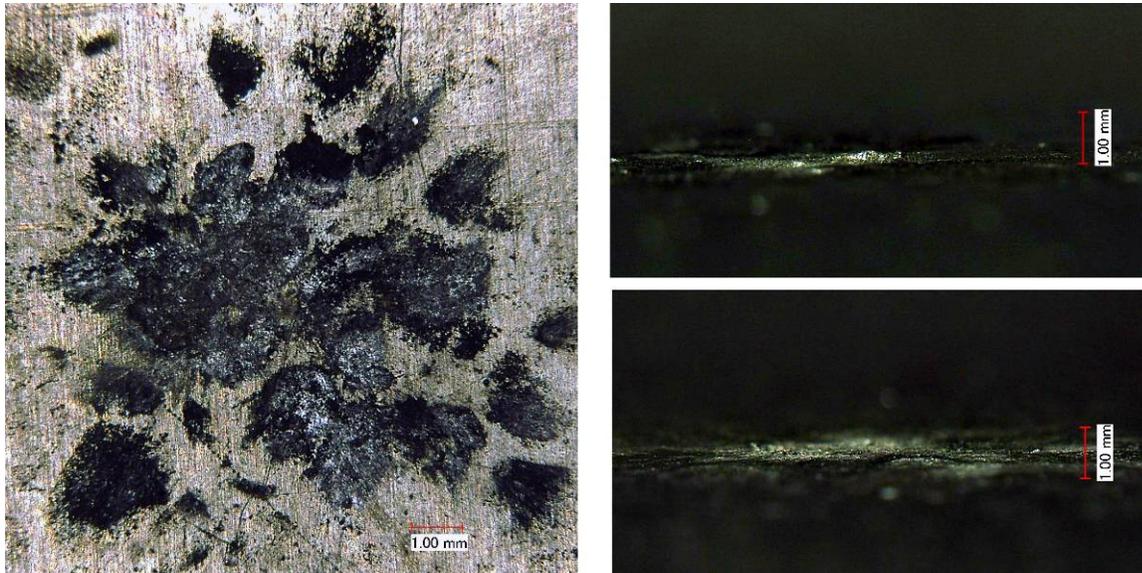
Figure A-10: HITF08284 impact crater.

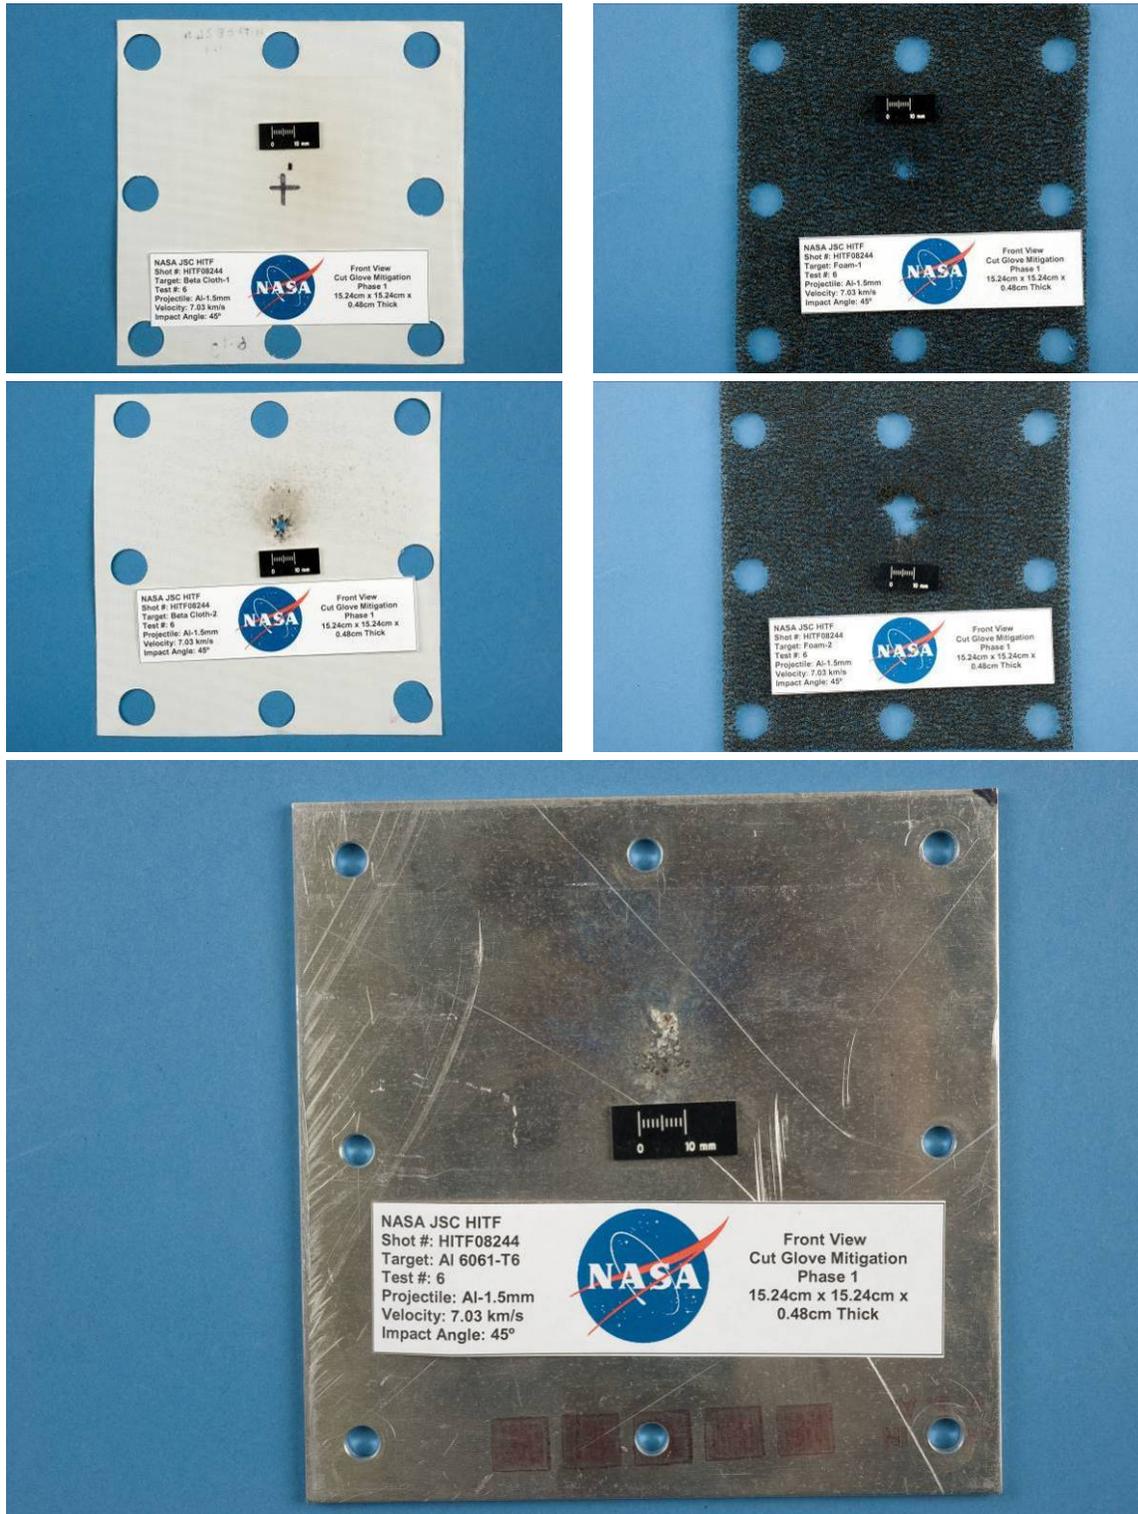
Figure A-11: HITF08244 post-test damage photographs. Top to bottom: outer Beta-cloth cover front side (left), outer open cell foam layer front side (right), inner Beta-cloth cover (left), inner open cell foam layer (right), target plate front side.

Test 6 of Phase 1 (HITF08244) investigated a 1.5-mm-diameter Al 2017-T4 sphere impacting obliquely (45 degrees) with a velocity of 7.03 km/s on a 4.826-mm-thick Al6061-T6 plate that was covered by a double-layer open-cell polyurethane foam overwrap with a Beta-cloth cover and an intermediate layer (DROCF+BC) (Figure A-11). Impact of the projectile generated an elliptical entry hole in the Beta-cloth. The clear hole diameter increases with progression through the overwrap layers, suggesting an expanding fragment cloud. The single, elliptical-shaped crater on the front side of the target plate has a black discoloration and melted aluminum deposits below the crater (Table A-6, Figure A-12).

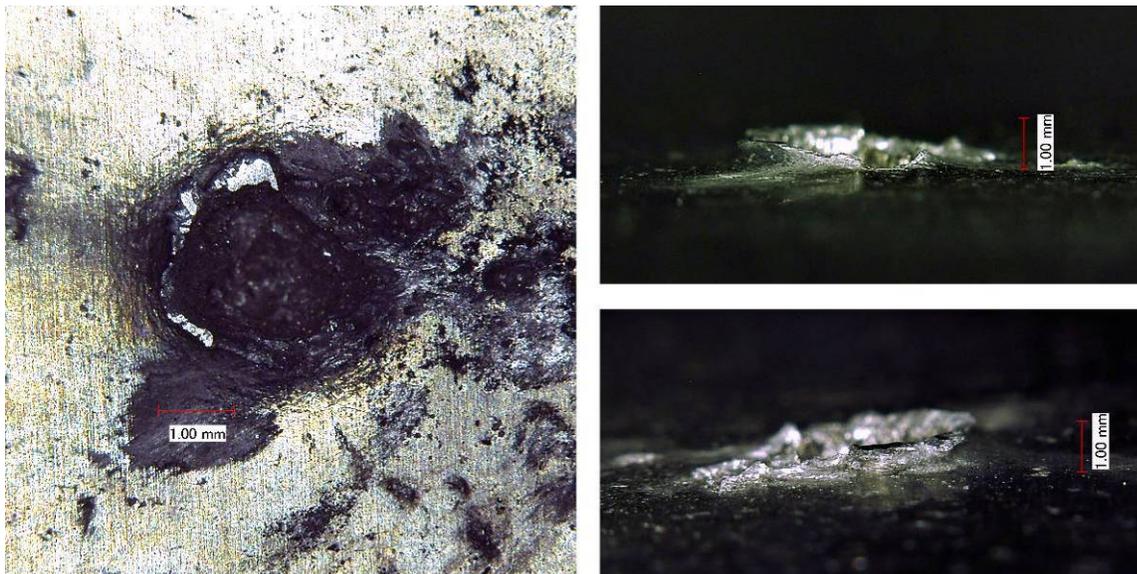
Figure A-12: HITF08244 impact crater.

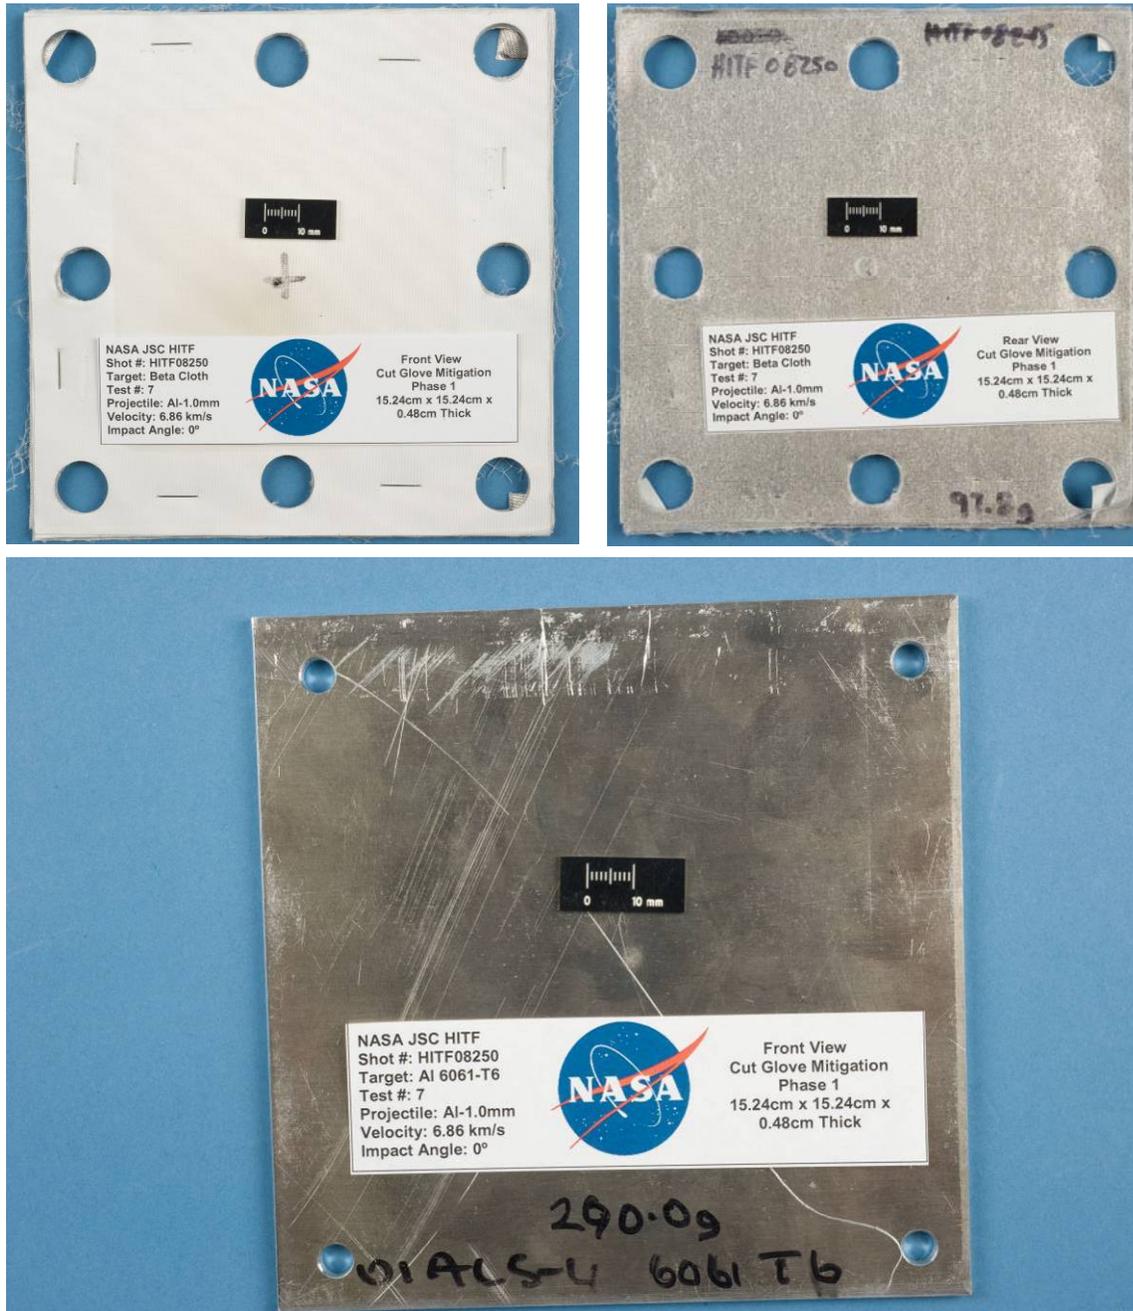
Figure A-13: HITF08250 post-test damage photographs. Clockwise from top left: outer Beta-cloth cover front side, innermost Beta-cloth cover rear side, target plate front side.

Test 7 of Phase 1 (HITF08250) investigated a 1.0-mm-diameter Al 2017-T4 sphere impacting at a velocity of 6.86 km/s with normal incidence on a 4.826-mm-thick Al6061-T6 plate that was covered by an overwrap consisting of 16 layers of 20-micron-thick aluminized Beta-cloth, which was separated by Dacron™ netting spacers, which is commonly used in MLI. Impact of the projectile generated a roughly circular entry hole in the overwrap (Figure A-13). The rear side of the Beta-cloth overwrap shows a small bulge (diameter \approx 5 mm) with a single vertical tear through its center. There is a small amount

of discoloration (black) of the target plate, which is likely deposits of charred Beta-cloth fibers. No damage is noticeable on the target surface (i.e., craters, protrusions, etc.) or the target rear side (Table A-7, Figure A-14).

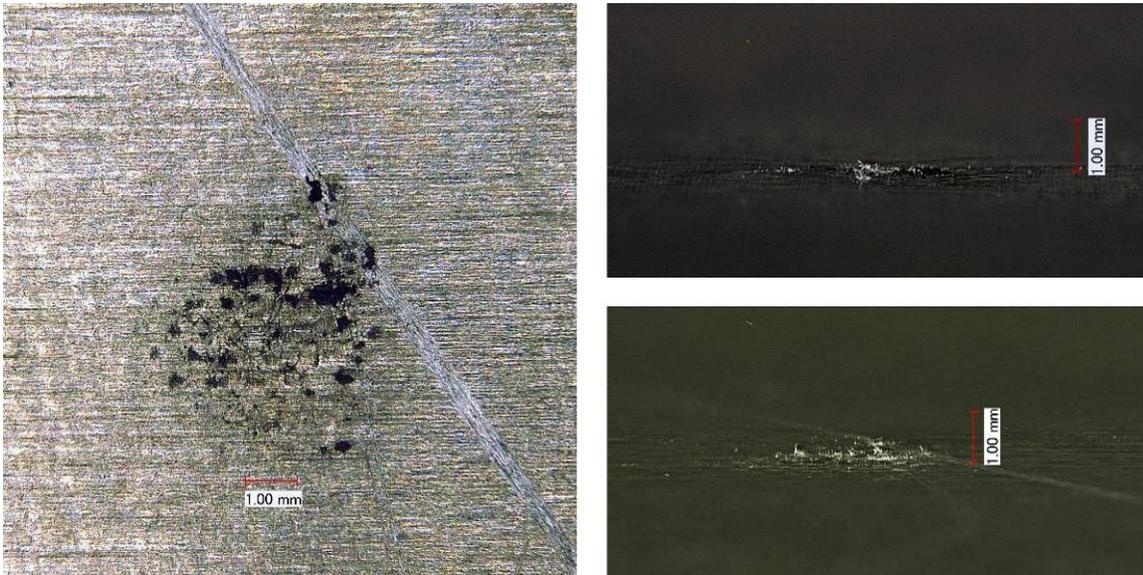
Figure A-14: HITF08250 impact crater.

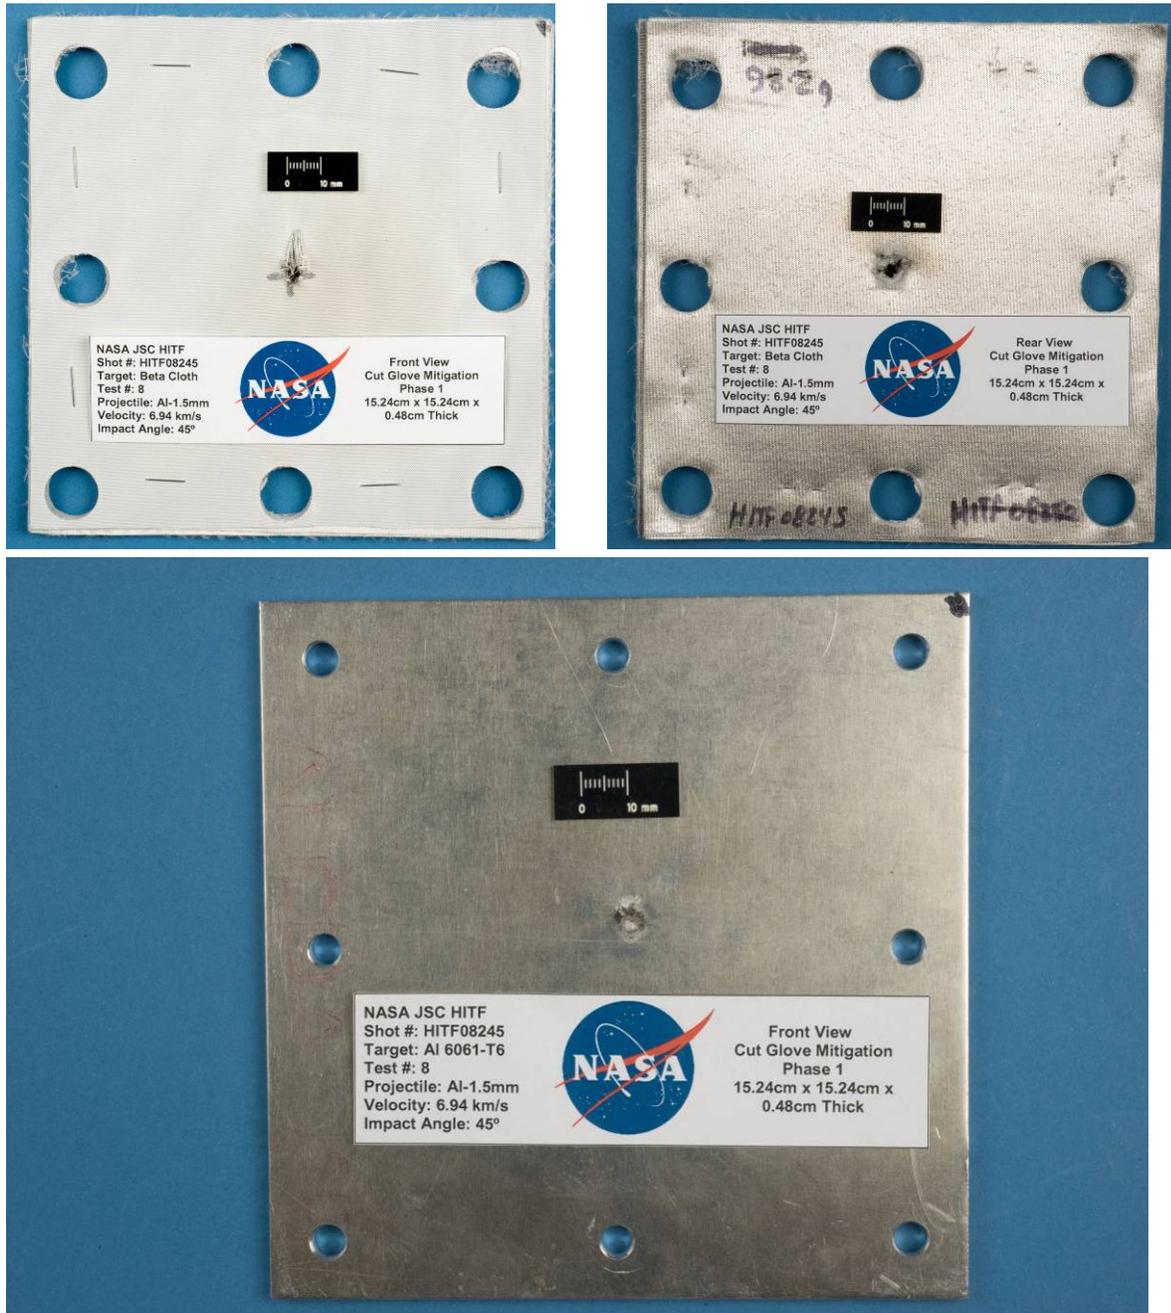
Figure A-15: HITF08245 post-test damage photographs. Clockwise from top left: outer Beta-cloth cover front side, innermost Beta-cloth cover rear side, target plate front side.

Test 8 of Phase 1 (HITF08245) investigated a 1.5-mm-diameter Al 2017-T4 sphere impacting obliquely (45 degrees) with a velocity of 6.94 km/s on a 4.826-mm-thick Al6061-T6 plate that is covered by an overwrap consisting of 16 layers of 20-micron-thick aluminized Beta-cloth, separated by Dacron™ netting spacers, which are commonly used in MLI (Figure A-15). Impact of the projectile generated a roughly circular entry hole in the overwrap, with a single tear (length \approx 12mm) above the hole. The exit hole in the overwrap is considerably larger than the entry hole, suggesting a fragmented

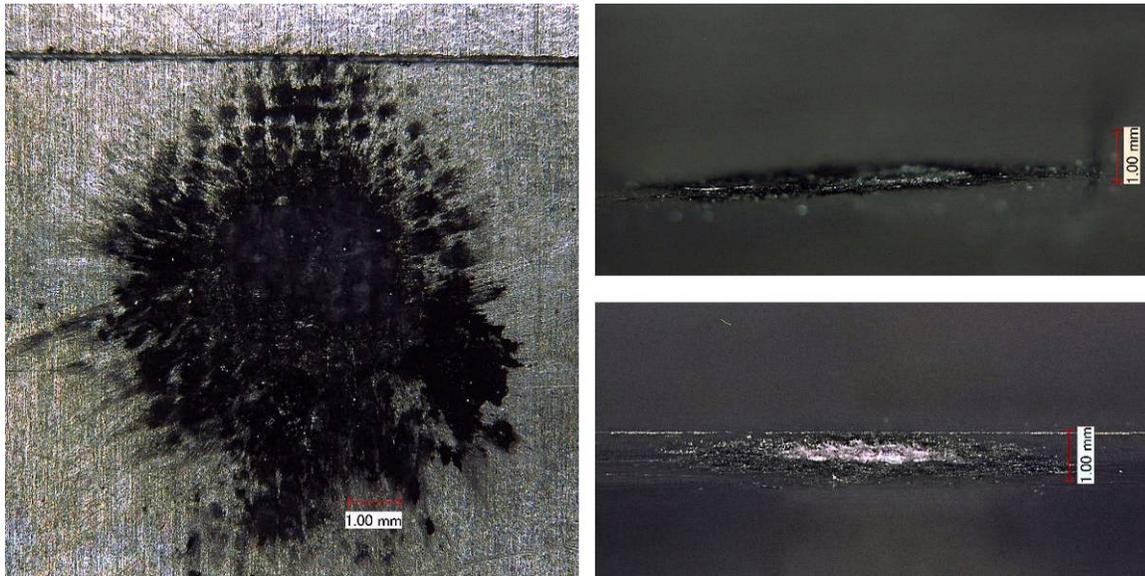
Figure A-16: HITF08245 impact crater.
