Mitigation of EMU Glove Cut Hazard by MMOD Impact Craters on Exposed International Space Station Handrails

*Shannon Ryan
USRA Lunar and Planetary Institute
Johnson Space Center, Houston*

*Eric L. Christiansen
Johnson Space Center, Houston*

National Aeronautics and
Space Administration

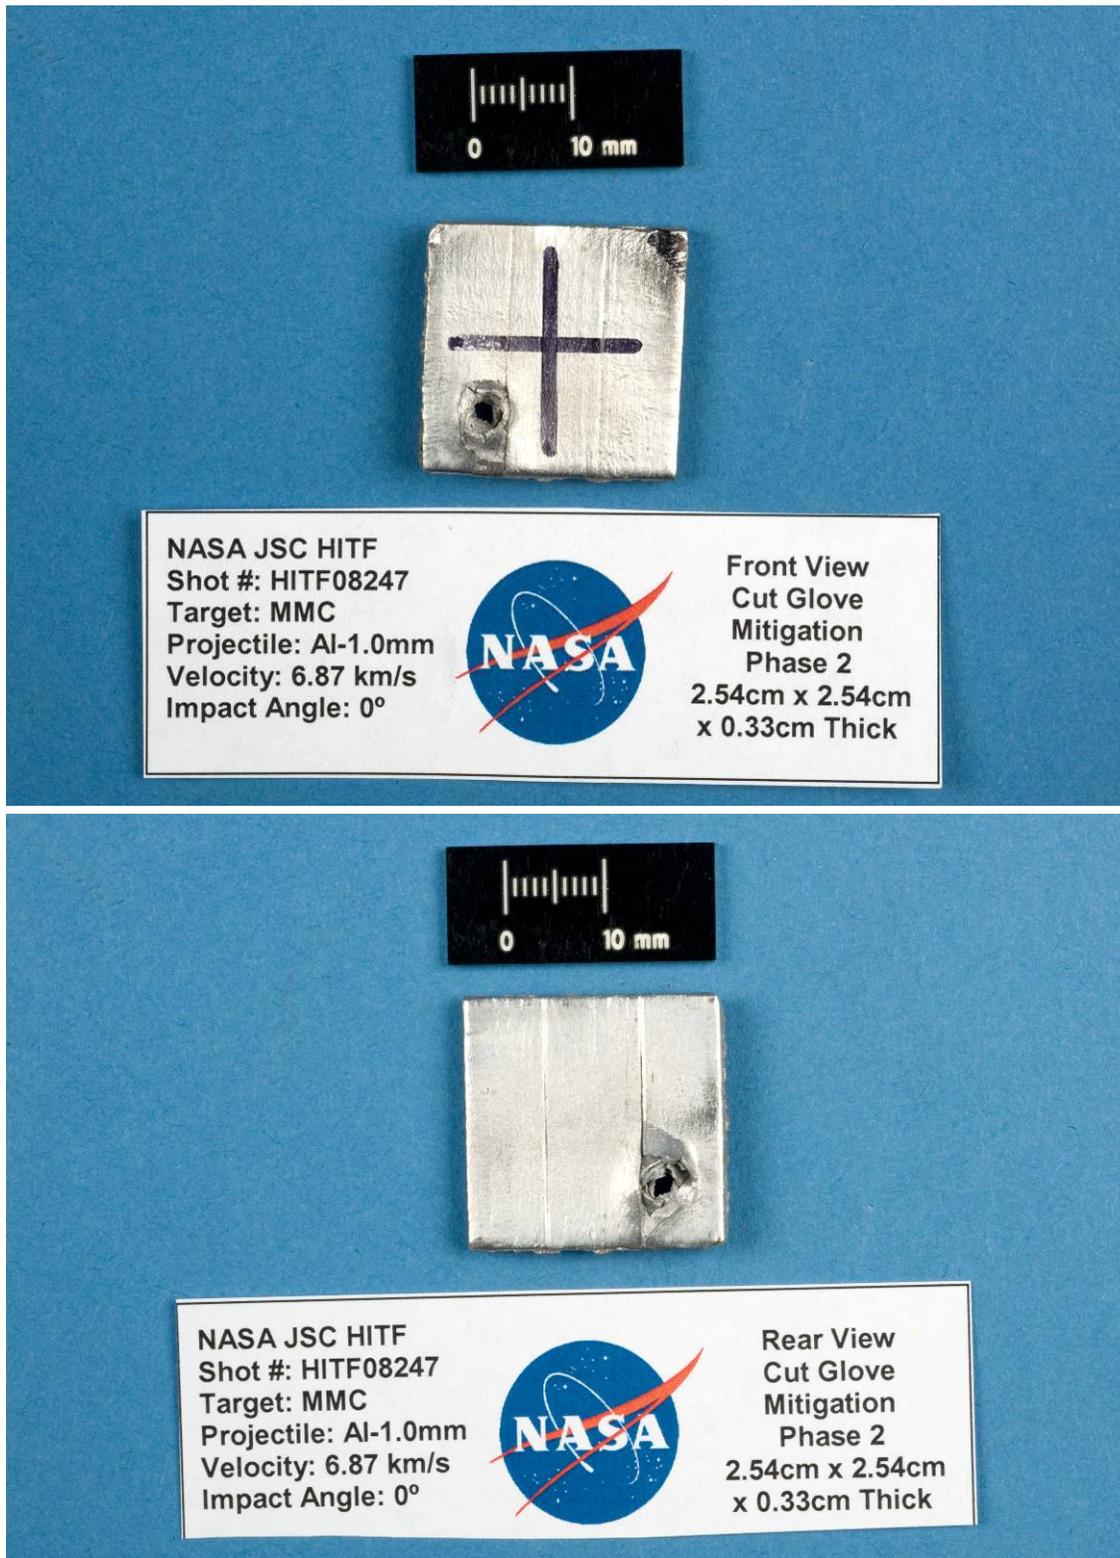
Figure A-17: HITF08247 post-test damage photographs. Top to bottom: front side damage (entry hole), rear side damage (exit hole).

Test 1 of Phase 2 (HITF08247) investigated a 1.0-mm-diameter Al 2017-T4 sphere impacting at a velocity of 6.87 km/s with normal incidence (0 degree) on a 3.3-mm-thick Nextel[®] 610 fiber reinforced aluminum composite (Figure A-17). The projectile clearly perforated the target, generating a circular entry hole. The upper lamina of the MMC shows brittle failure of the crater lip, resulting in the maximum lip height being measured on the second composite lamina. The rear of target shows an elliptical clear hole with surface spallation of the outer ply. There is some cracking on the top edge of exit hole as well as some slight petalling about the lower edge of the hole (Table A-9, Figure A-18).

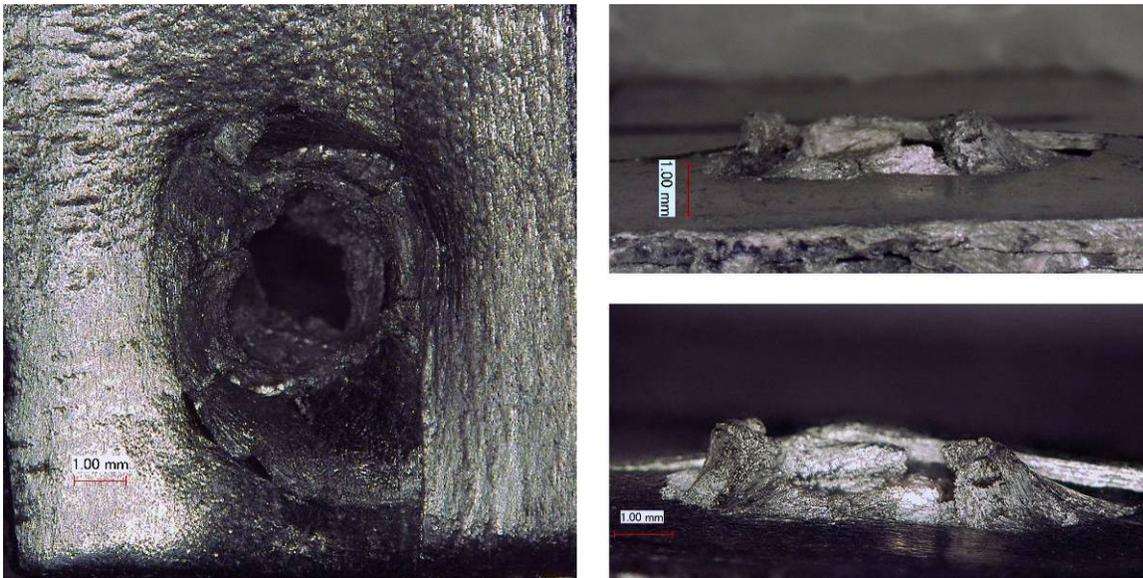
Figure A-18: HITF08247 impact crater.

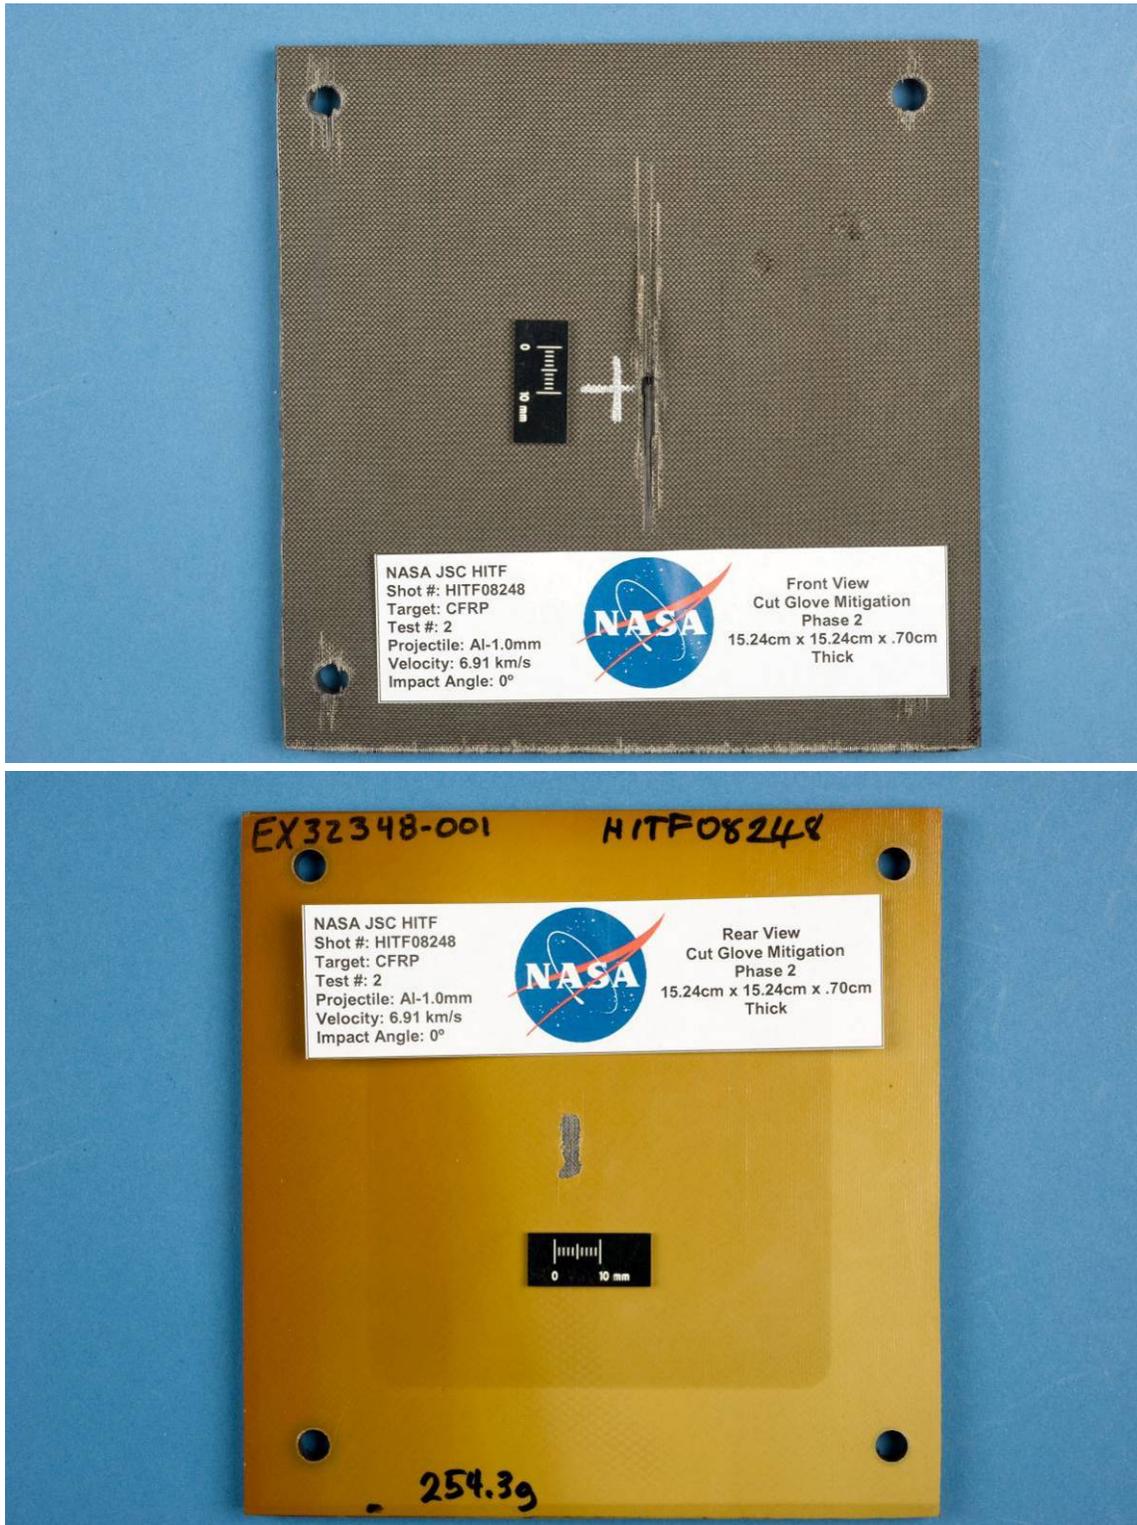
Figure A-19: HITF08248 post-test damage photographs. Top to bottom: front side damage (entry hole), rear side damage (surface spallation).

Test 2 of Phase 2 (HITF08248) investigated a 1.0-mm-diameter Al 2017-T4 sphere impacting at a velocity of 6.91 km/s with normal incidence on a 7.03-mm-thick CFRP panel (Figure A-19). Impact from the projectile generated a circular entry hole that had significant surface spallation and cracking along the target vertical axis. Although the entry hole does not have any visible lip, the spalled fibers protrude significantly from the face of the laminate. An area ($\approx 4 \times 14$ mm) of adhesive (AF191) was spalled from the rear side of the target; however, this is not considered as damage to the test article as the CFRP rear side was undamaged (Table A-10, Figure A-20).

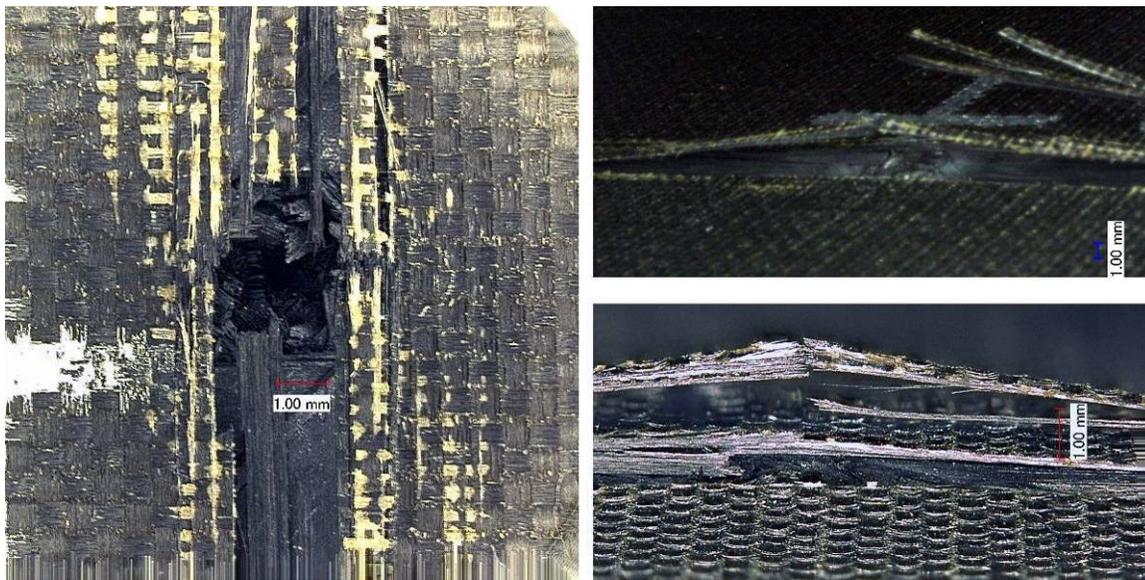
Figure A-20: HITF08248 impact crater.

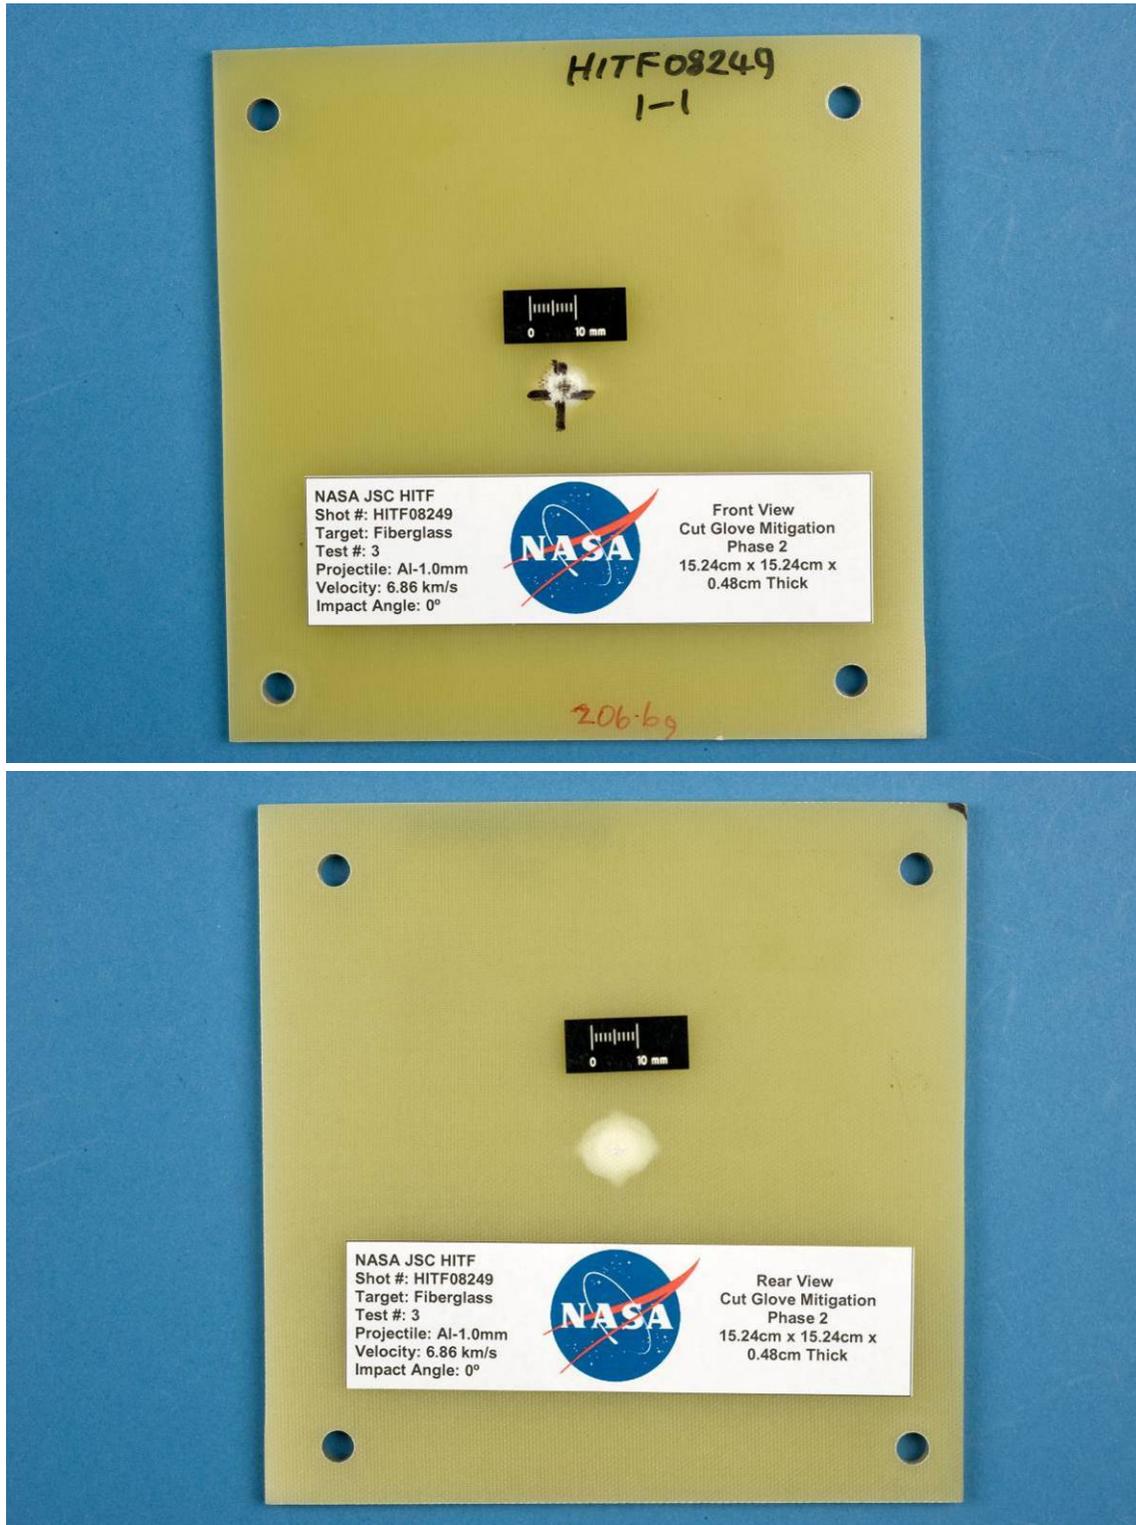
Figure A-21: HITF08249 post-test damage photographs. Top to bottom: front side damage (entry hole), rear side damage (white area is internal damage and delamination).

Test 3 of Phase 2 (HITF08249) investigated a 1.0-mm-diameter Al 2017-T4 sphere impacting at a velocity of 6.86 km/s with normal incidence (0 degree) on a 4.826-mm-thick NP500CR fiberglass composite panel (Figure A-21). There is a roughly circular entry hole, about which frayed and broken glass fibers are observable. There is also clear internal delamination, which is identified as a white area about the clear hole, that measures approximately 11mm in diameter. The rear of target shows a small area of surface damage (considerably smaller than the extent of internal delamination) that is slightly bulged from the plane of the target rear side. There is noticeable bias of the delamination along the fiberglass primary in-plane directions (Table A-11, Figure A-22).

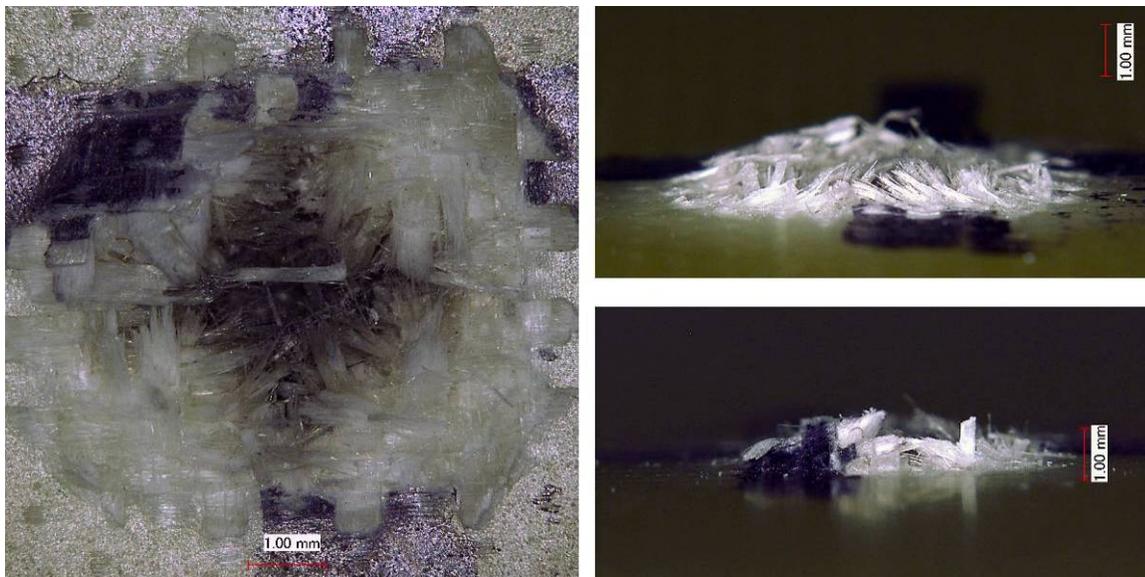
Figure A-22: HITF08249 impact crater.

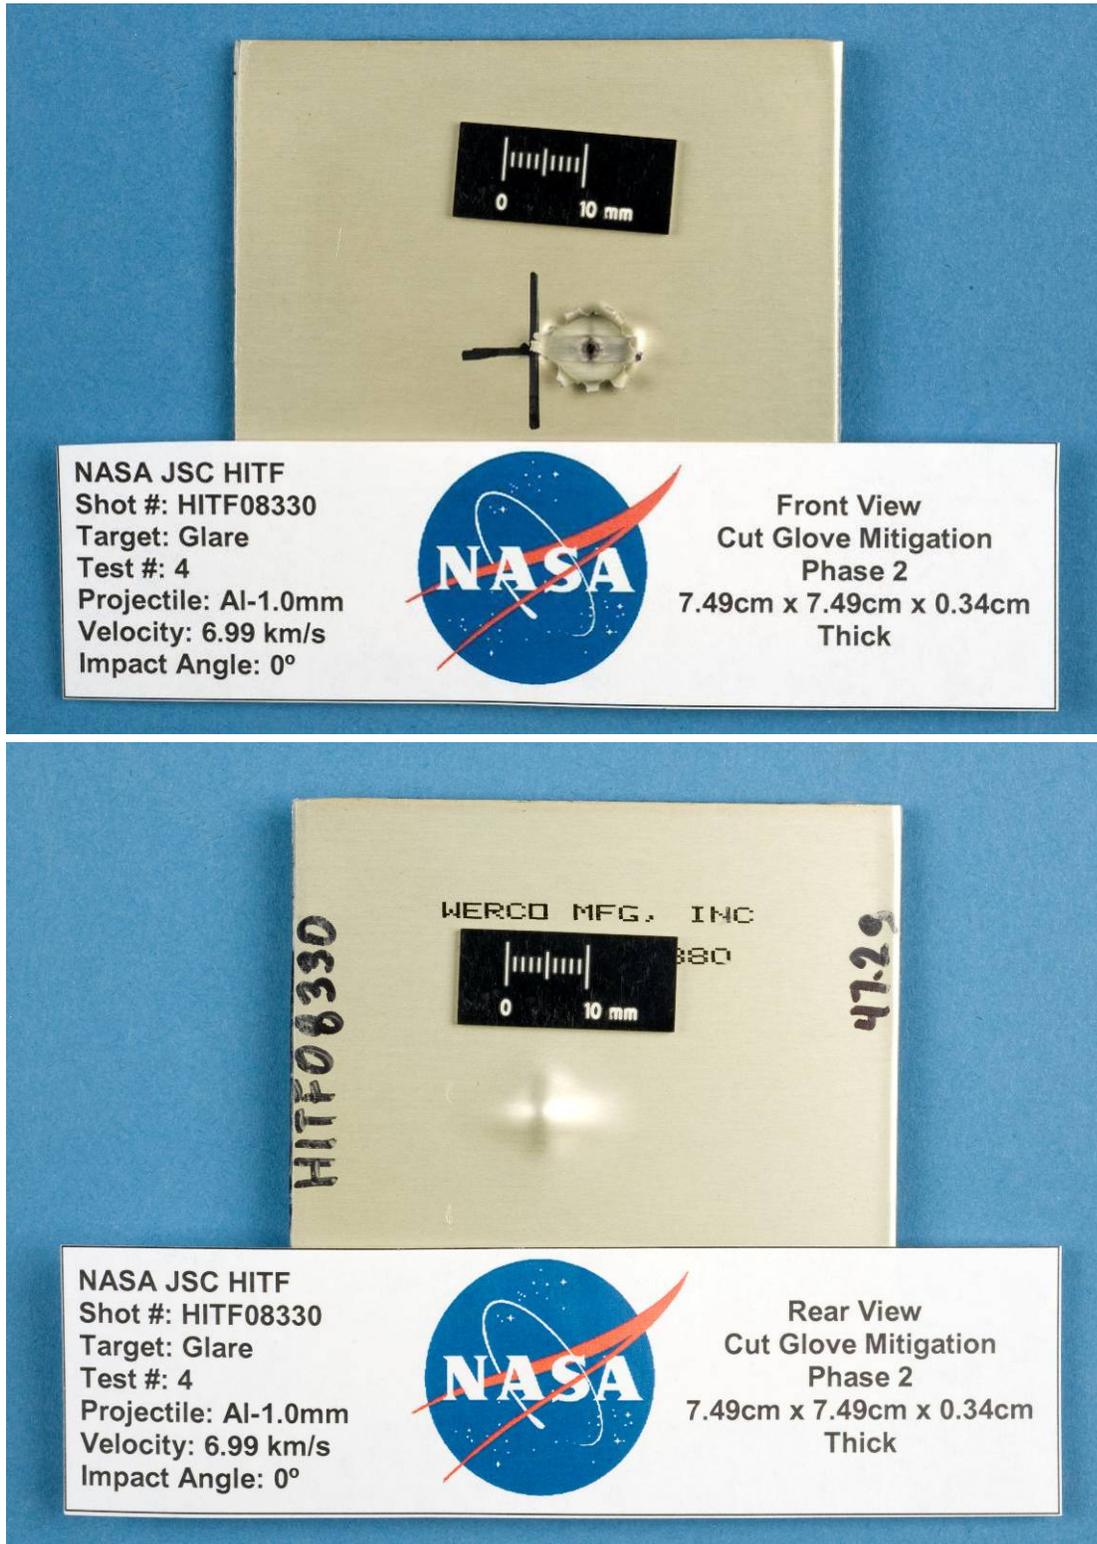
Figure A-23: HITF08330 post-test damage photographs. Top to bottom: front side damage (entry hole), rear side damage (rear surface bulge).

Test 4 of Phase 2 (HITF08330) investigated a 1.0-mm-diameter Al 2017-T4 sphere impacting at a velocity of 6.99 km/s with normal incidence (0 degree) on a 3.4-mm-thick glass-reinforced fiber metal laminate (Glare[®]) (Figure A-23). Impact from the projectile generated an entry hole into the target that was circular in shape with petalling of the crater lip (seven petals, height = 3.5 mm). The petals are formed from the upper aluminum layer in the FML. Although the rear of target shows a steep bulge, there is no spallation of any material (Table A-12, Figure A-24).

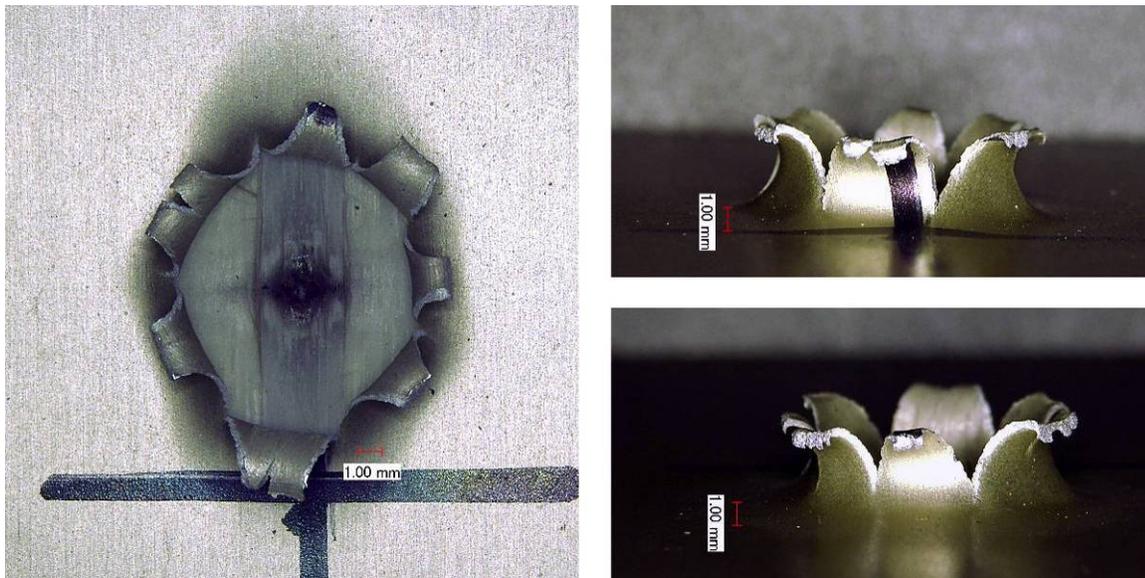
Figure A-24: HITF08330 impact crater.
