NASA/TP-98-201793

# **Photogrammetric Assessment of the Hubble Space Telescope Solar Arrays During the Second Servicing Mission**

## **Final Report**

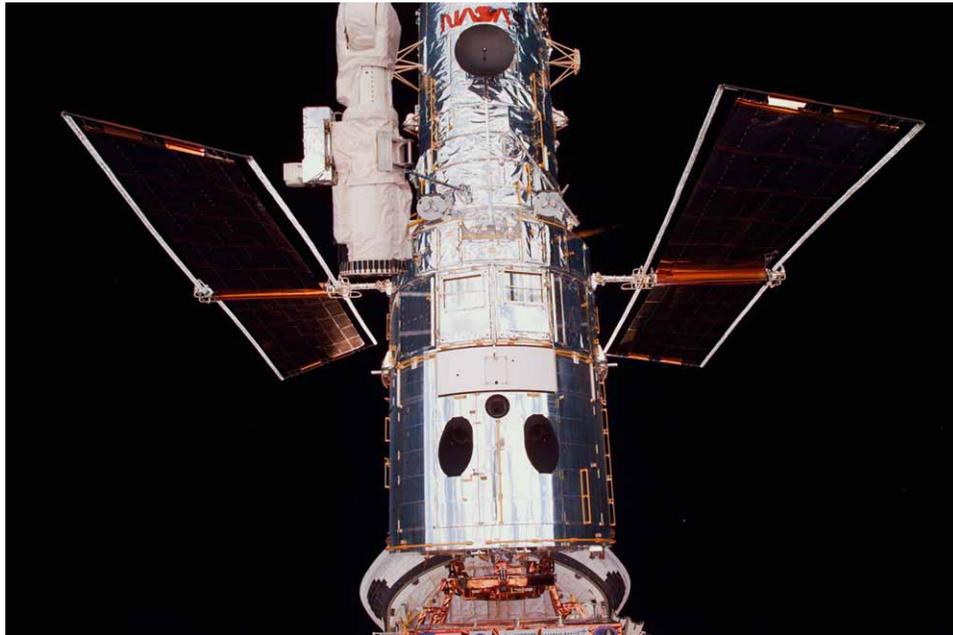
*Figure 1.1 The Hubble Space Telescope.*

The Hubble Space Telescope (HST, Fig. 1.1) was launched on the Space Shuttle in April 1990. The HST is the first space-borne observatory designed to be serviced on orbit and is intended to be serviced by the Shuttle every 2-3 years. During the first servicing mission (SM-1) in December 1993, the two solar arrays that power the telescope were replaced. The new arrays, which were designed and built by British Aerospace, were a semi-rigid design, deployable from a central cassette, with structural rigidity provided by two interlocking metal bands called bistems. The arrays were designed to be able to be unfurled and furled multiple times to facilitate servicing and reboost of the HST. Figure 1.2 shows details of the HST solar array.

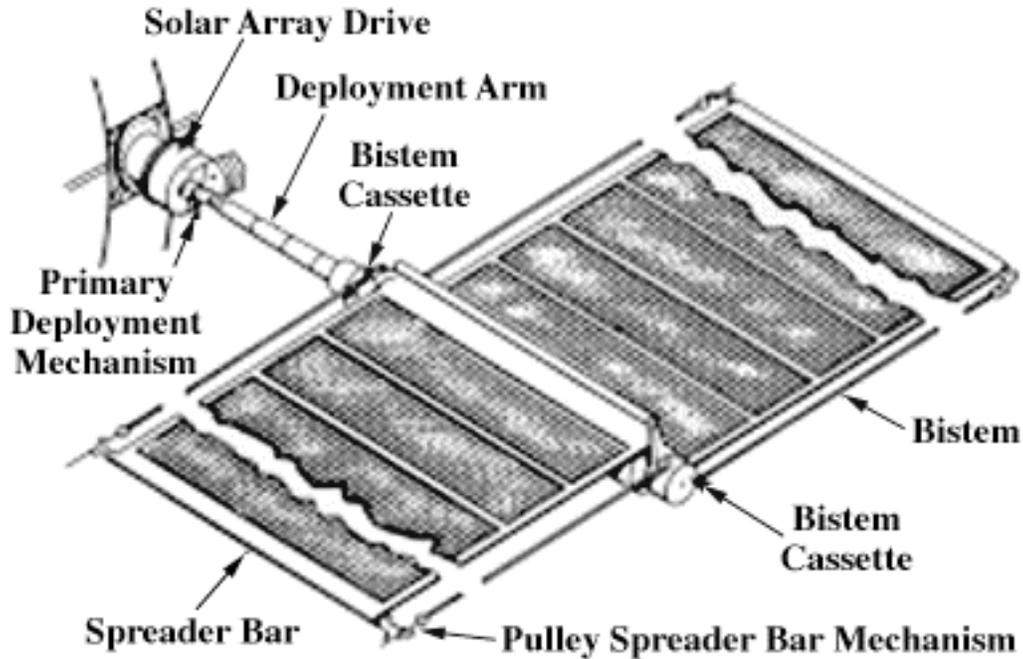
*Figure 1.2 HST solar array details.*

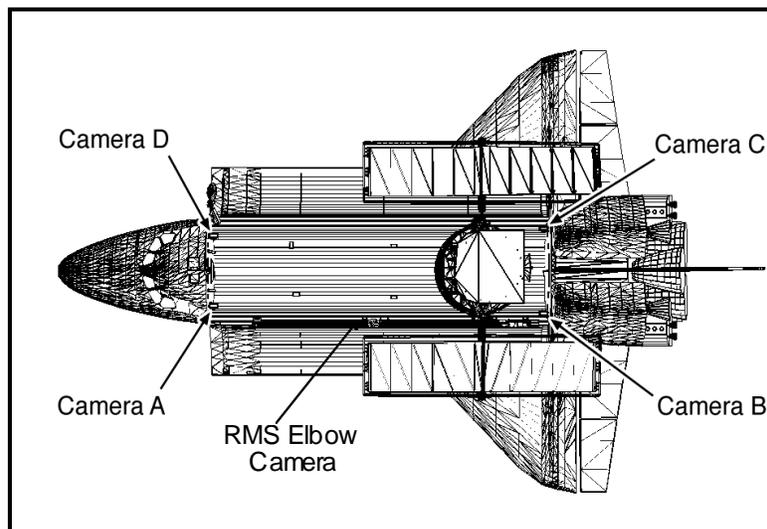
*Figure 3.1 Shuttle camera locations in the payload bay.*

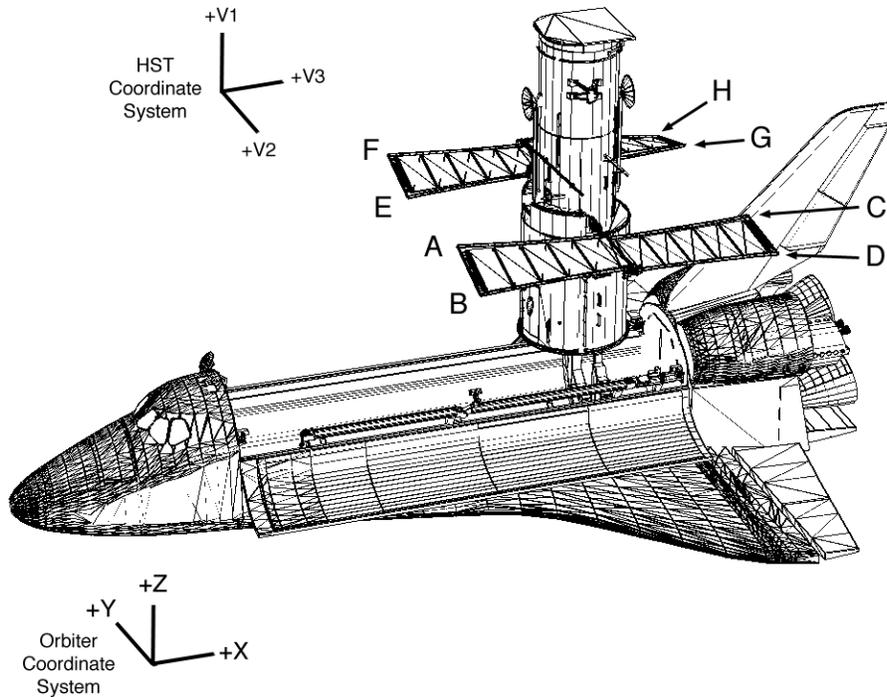
*Figure 3.2 Illustration of HST in Shuttle payload bay, demonstrating solar array tips and Shuttle and HST coordinate systems.*

The objective of the static twist analysis was, for specified times, to determine the positions of tips of the solar arrays in the Hubble coordinate system. (Figure 3.2 is an illustration of the HST in the Shuttle PLB, the tips of the solar arrays, and the HST and Shuttle coordinate systems.) The Shuttle PLB cameras provided imagery for determining the 3D position of each array tip, using a two-camera phototheodolite technique. This section describes the phototheodolite method, the implementation of the phototheodolite technique to the array tip location task, the method for estimation of the accuracy of the phototheodolite solutions, and the validation test of the methodology.

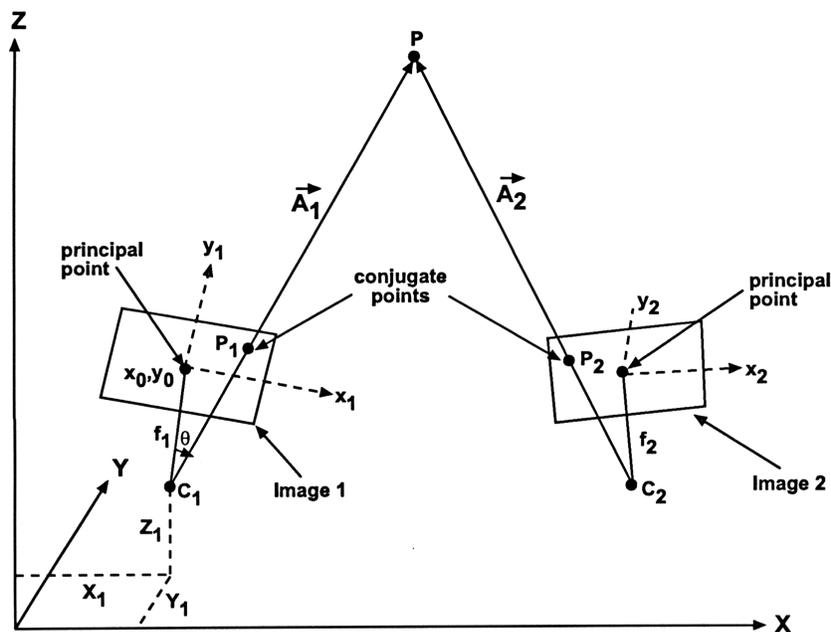
**Figure 3.3** *Elements of two-camera photogrammetric triangulation based on intersection of convergent rays in space.*

Once the interior and exterior orientations of the two cameras are determined, the intersections of the two vector rays to the object point can be determined from the image measurements. These are, of course, not trivial measurements or calculations, especially for non-metric cameras such as the Shuttle video cameras. All of the parameters, including determinations of the effective focal length (EFL) of the zoom lens and lens distortions, contribute to the vectors' failure to intersect. A common solution to the issue of the two vectors' failure to intersect at a point is to calculate the shortest distance miss of the two vectors and take the midpoint as the position of the object point of interest. Solutions that take advantage of having multiple images of the object of interest employ methods of photogrammetry called "bundle adjustments" to determine the point of intersection. The method of bundle adjustments was used in the post-mission analyses and is described in Section 6.1.

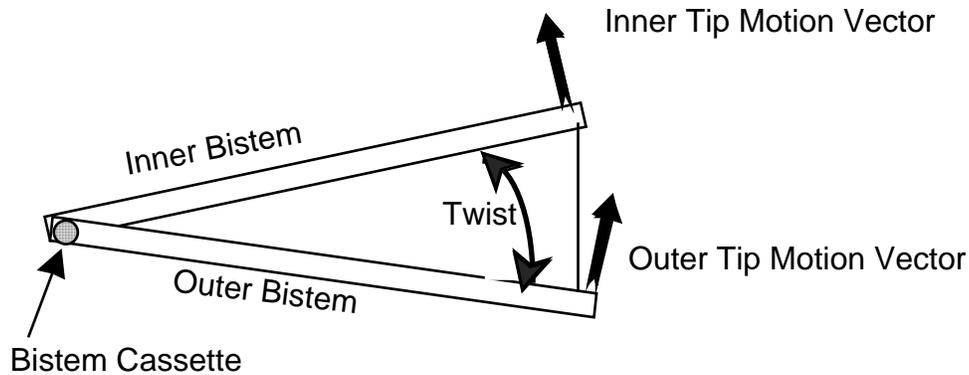
*Figure 3.4 Diagram illustrating the effect of solar array twist on the direction assumed for solar array motion.*

The twist in the solar arrays created a problem in defining a common plane to which the motion of both tips could be assumed perpendicular. The twist caused separate planes for each tip to be defined. (See Figure 3.4.) Each plane was defined by three points: the solar array tip, and the inner and outer edges of the bistem cassette for that array. The inner and outer bistem cassette edge coordinates were determined by using the fixed HST coordinates of those two points, and transforming them into the Shuttle coordinate system using the current FSS rotation value. However, because of the twist, the radii of the two tips are not aligned and hence the direction of motion of each tip is different.

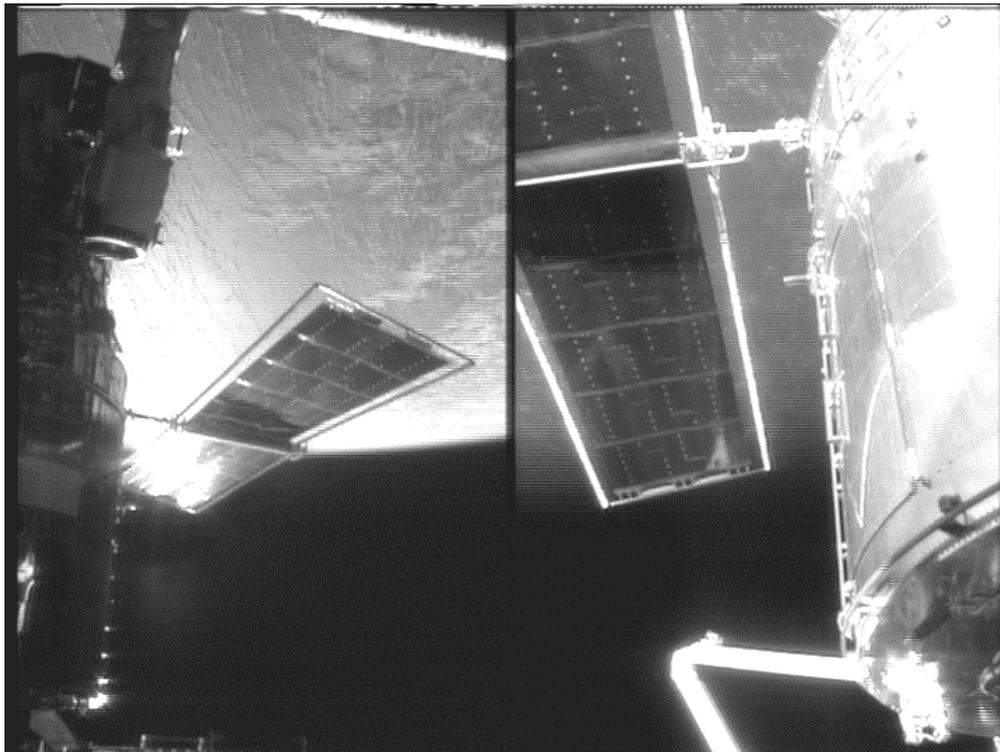
**Figure 4.1 Multiplexed video showing simultaneous view of HST solar array tips A & B from cameras B and D.**  
(left view is from camera D, right view is from camera B)

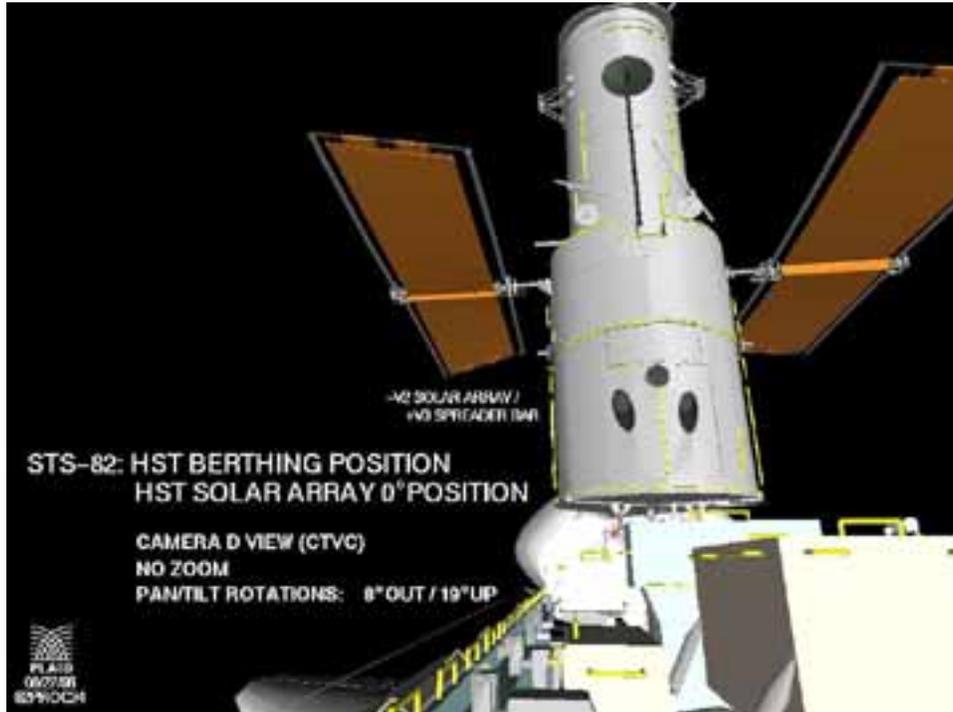
*Figure 4.2 Representative CAD view used in image acquisition planning.*

The viewing analysis identified the cameras and camera settings to use for the measurement of solar array motion. The camera views were simulated from JSC GRAF CAD drawings. Figure 4.2 shows a representative simulated view.

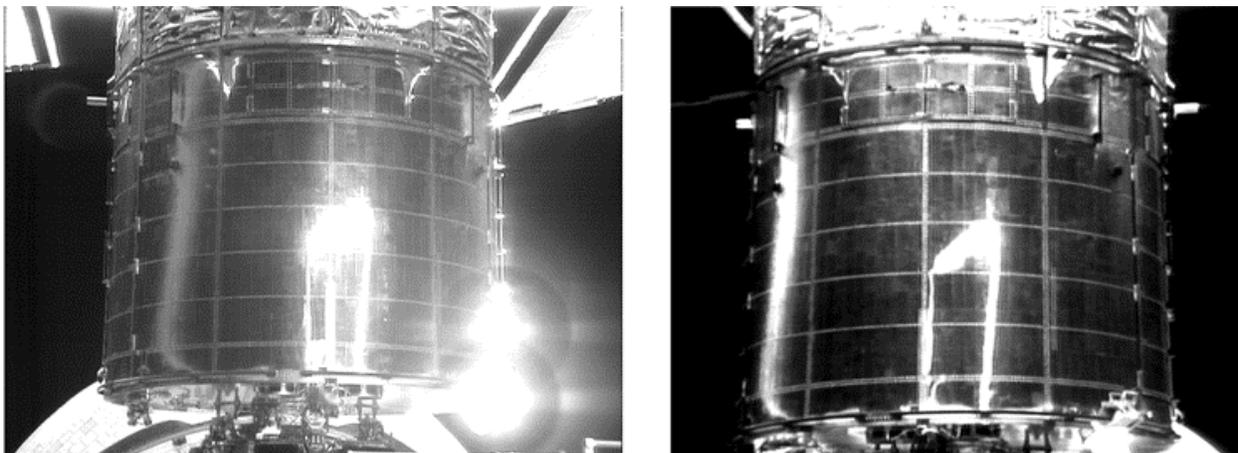
*Figure 5.1 Rotation view from cameras D (left) and A (right).*

1. Acquire HST rotation view and required static twist analysis views. (See Figure 5.1.)

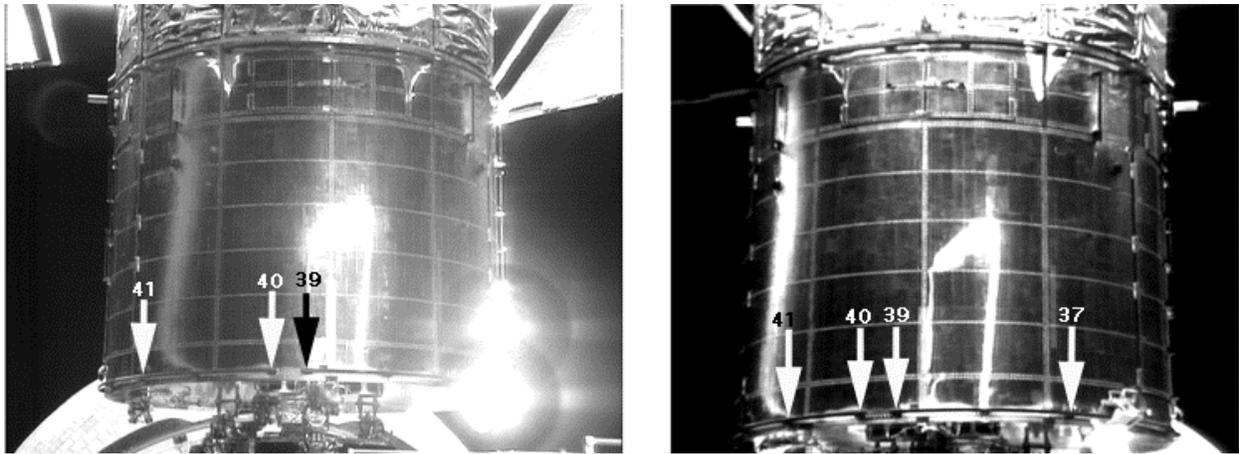
Figure 5.2 Reference points on rotation images.

- Digitize, label, and correct aspect ratio of rotation image.
- Select reference points from rotation image. (Note: Rotation calculations were performed only once per day.) (See Figure 5.2.)

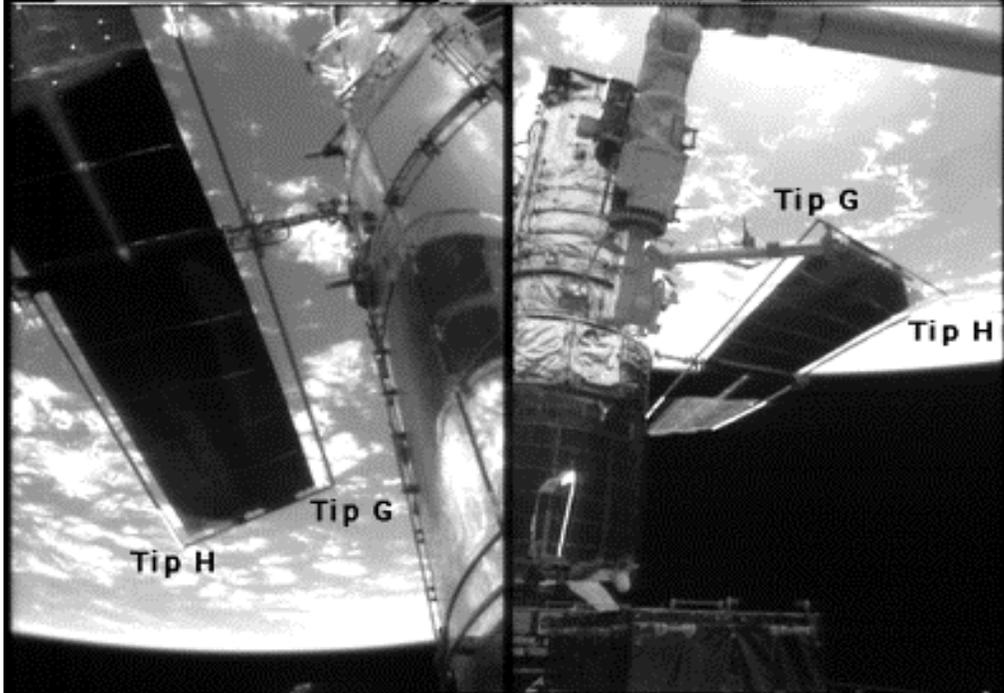
Figure 5.6 Multiplexed images of HST solar array tips.

8. Enter reference point ID numbers on data entry sheet.
9. Select solar array tip image coordinates from multiplexed views. (See Figure 5.6.)
10. Enter reference point image coordinates into user input spreadsheet.

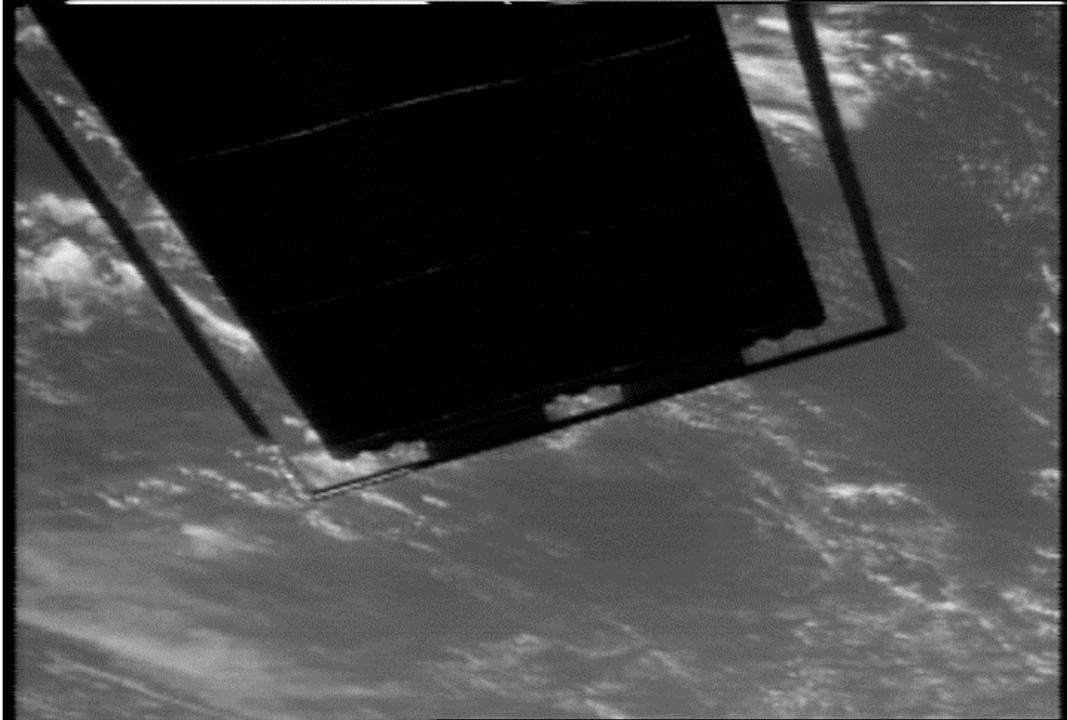
*Figure 5.10 View of +V2 solar array tips A & B from camera B during the VRCS-induced solar array motion on Flight Day 3.*

The 1-minute sequence of video that was used for analysis extended from 044:20:28:39.48 to 044:20:29:39.48 UTC. The video data was of very good quality although lighting was variable. Camera positioning was as expected. The analysis required approximately six hours to complete. See Figure 5.10 for a representative image showing the camera view.

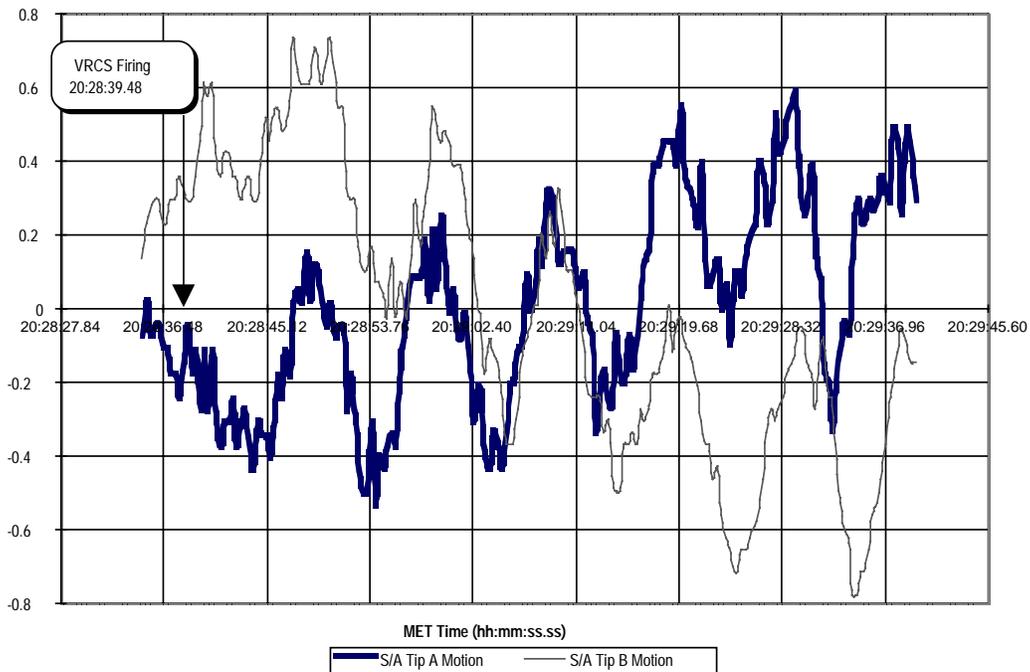
*Figure 5.11 Displacement of tips A and B during VRCS firing on Flight Day 3.*

Based on the solar array motion analysis procedures defined pre-mission, the video frames were sampled at a rate of 3 frames per second (3 Hz), for a total of 180 frames analyzed. The results showed a maximum peak-to-peak displacement of approximately 0.7 inches for tip B and 0.6 inches for tip A, with a frequency of approximately 0.1 Hz for both tips (see Figure 5.11). The displacements and the frequency were as expected, based on HST FS&S Project structural dynamics models. The motion continued for approximately 3 minutes after the analysis interval and no apparent damping was noted.

The plot of tip displacement vs. time depicted in Figure 5.11 shows an apparent discrepancy in tracking the tips, since the displacement for tip A crosses that of tip B. Post-mission, it was determined that this effect was caused by a shift in the line-tracking intersection point for both tips during the tracking process. The line intersection that defines the tip position migrated from one edge of the spreader bar to the other causing an apparent translational motion. This problem was caused by variable lighting conditions that changed the appearance of the spreader bar edges and caused the fitted line to move from one side of the spreader bar to the other. To correct for this problem and to analyze the motion over a longer period, the solar array motion was re-analyzed after the mission using improved motion analysis methods. See Section 6.2.4 for the results of the post-mission analyses.

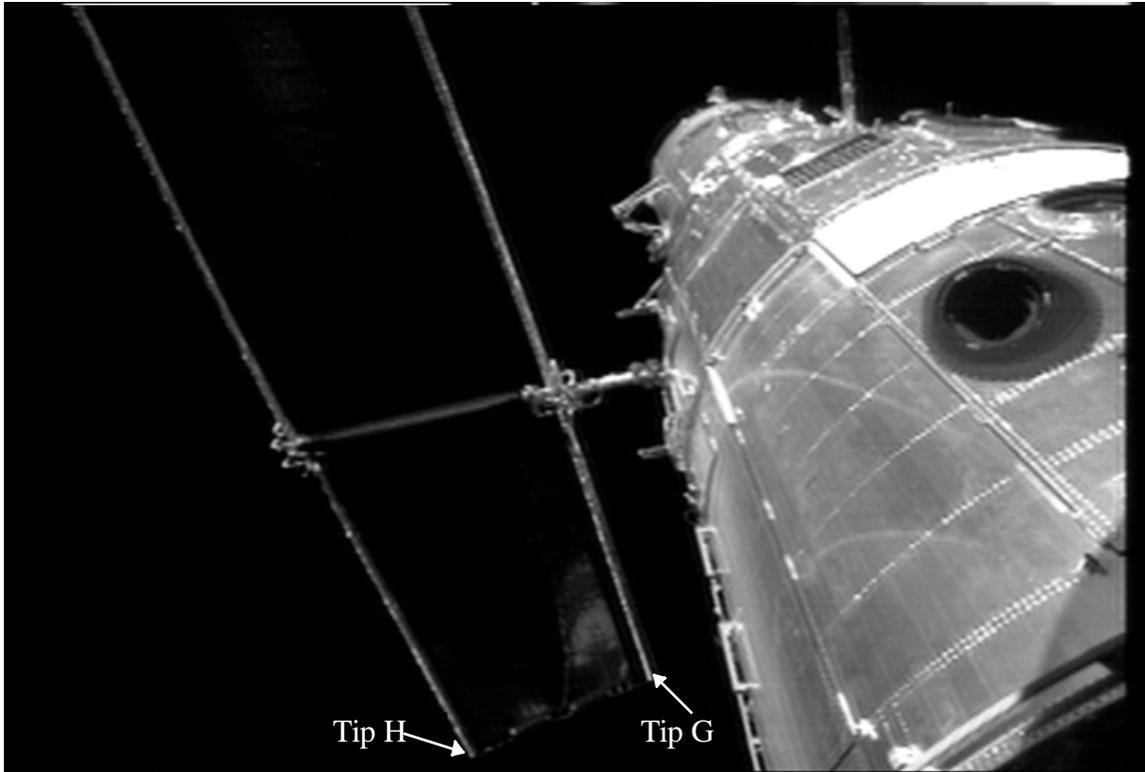
*Figure 5.12 View of -V2 solar array tips G & H from camera B during airlock depressurization-induced solar array motion.*

A video sequence of approximately 1 minute (UTC 049:03:12:32 to 049:03:13:32), taken from camera B of the -V2 forward solar array tips G & H, was analyzed. Figure 5.12 is a representative view of the solar array during the airlock depressurization event. Because of the low contrast of the spreader bar in the image, the automated edge detection and line-tracking analysis procedure was not used. Therefore, all data points were extracted manually. To minimize point selection bias, the data points were independently selected by two analysts, whose results were in very good agreement ( $\pm 1$  pixel). The motion analysis was completed in approximately 5 hours. The analysis sample rate was 3 frames per second, for a total of 161 frames analyzed.

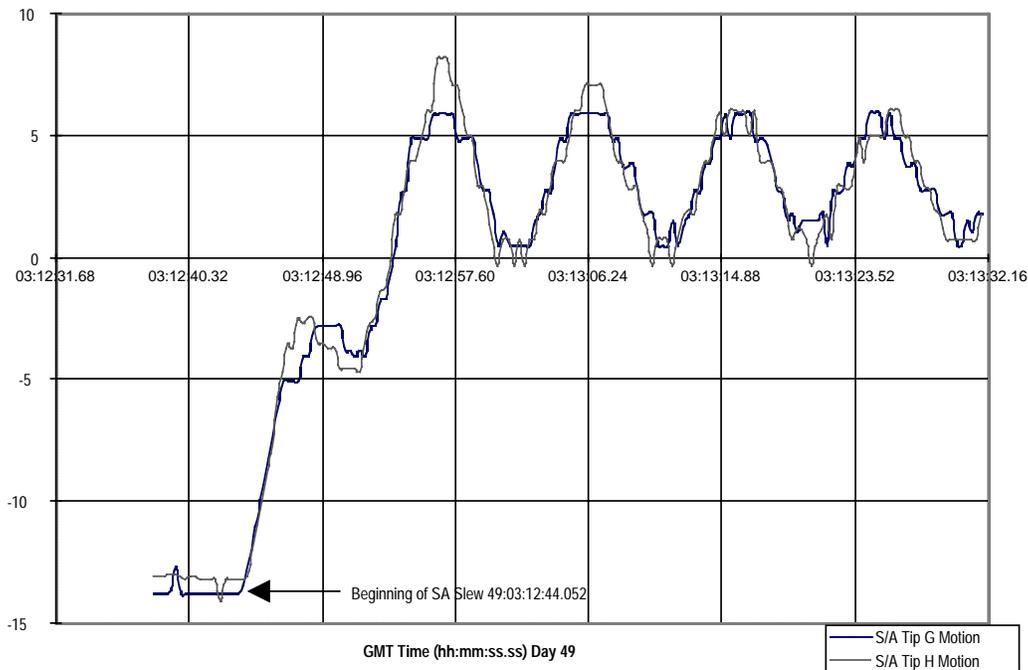
**Figure 5.13** Displacement of tips G and H during airlock depressurization on Flight Day 8.

The airlock depressurization-induced solar array motion was re-analyzed after the mission using improved motion analysis methods. See Section 6.2.6 for the results of the post-mission airlock depressurization analysis.

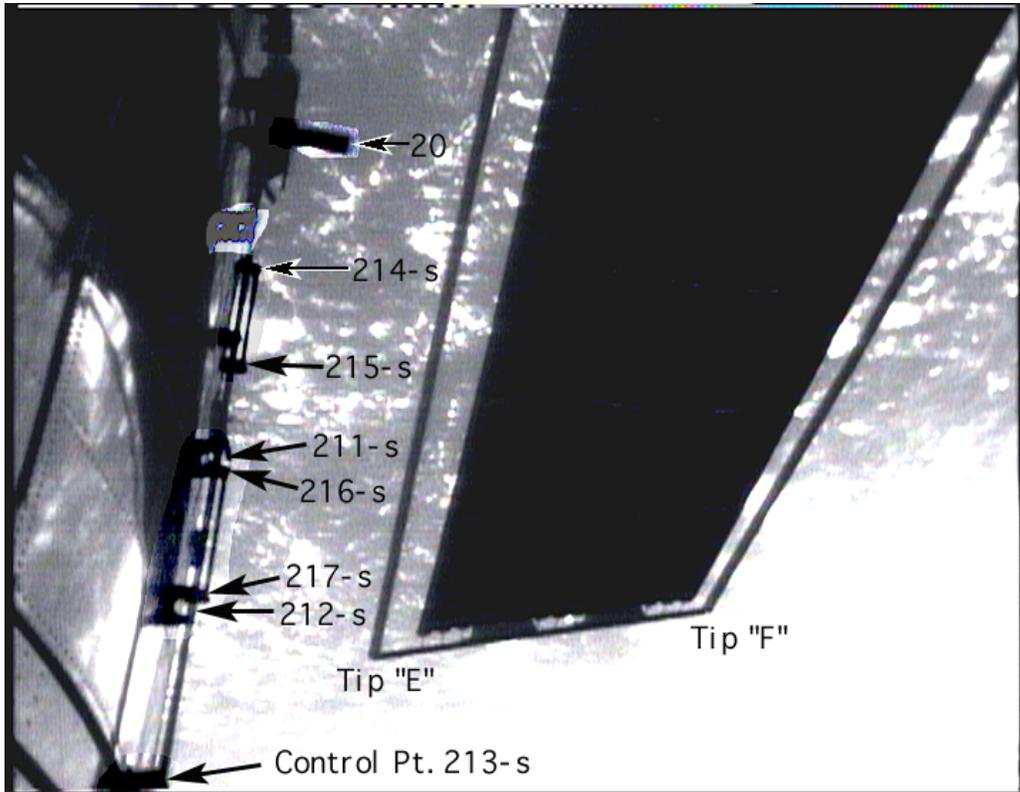
*Figure 6.1 Image of tips E and F taken from camera C, showing the linear configuration of control points.*

Note that the control point numbers with the attached post-script “-s” designate control points that were originally located at the handrail attach points, but were extended 3.003 inches radically outward from the HST “V1” axis to produce a control point on the top surface of the handrail.

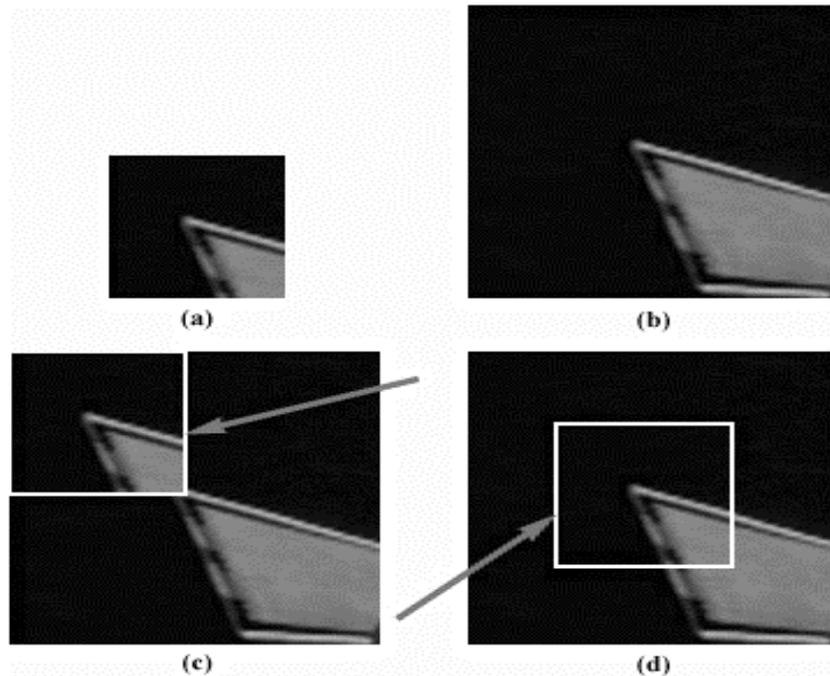
***Figure 6.2 Point tracking method applied to tracking an HST solar array tip.***

Figure 6.2 illustrates the point-tracking method as it was applied to the HST solar array motion-tracking task. The search pattern surrounding the array tip is shown in (a). The window in the next video frame to search for the pattern is shown in (b). The pattern passing over the window is shown in (c). Correlation values are computed for each pixel that the pattern passes over and (d) shows the pattern matching over the target. The correlation should be the highest at this pixel position (i.e., at the center of the white box). The coordinates of this position are saved and the same steps are repeated for the next frame.

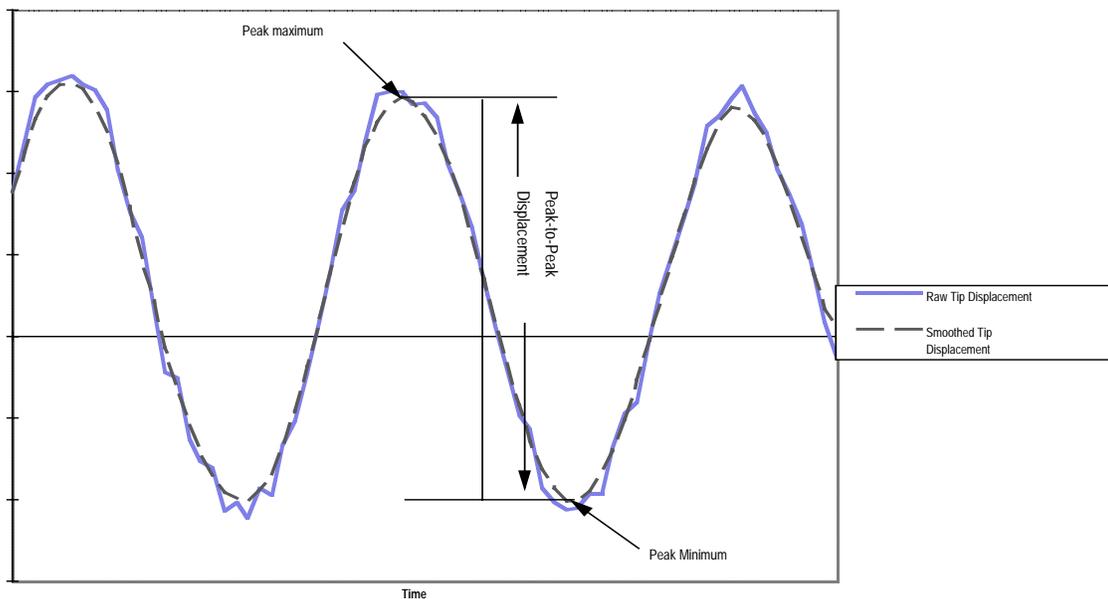
***Figure 6.3 Illustration of maximum peak-to-peak displacement of solar array tips.***

3. The peak-to-peak displacements were obtained from the smoothed displacement data. The peak-to-peak displacement was calculated by finding the values for the peak maximum and peak minimums for the selected peak-to-peak displacement. The difference in the peak maximum and peak minimum values was then used as the peak-to-peak displacement.

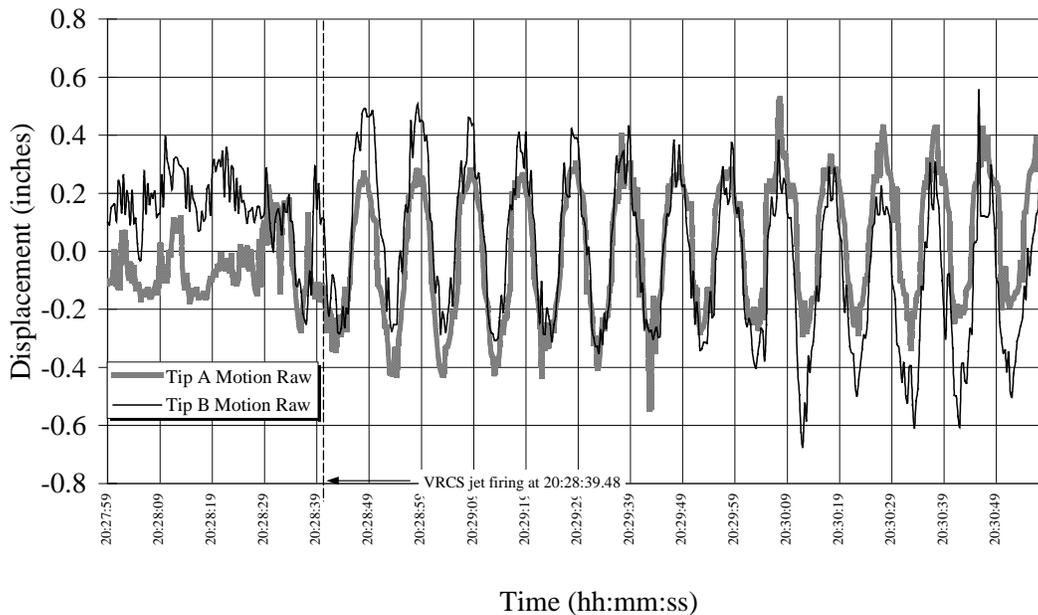
**Figure 6.4** Solar array tip displacement during the VRCS-induced solar array motion (Flight Day 3).

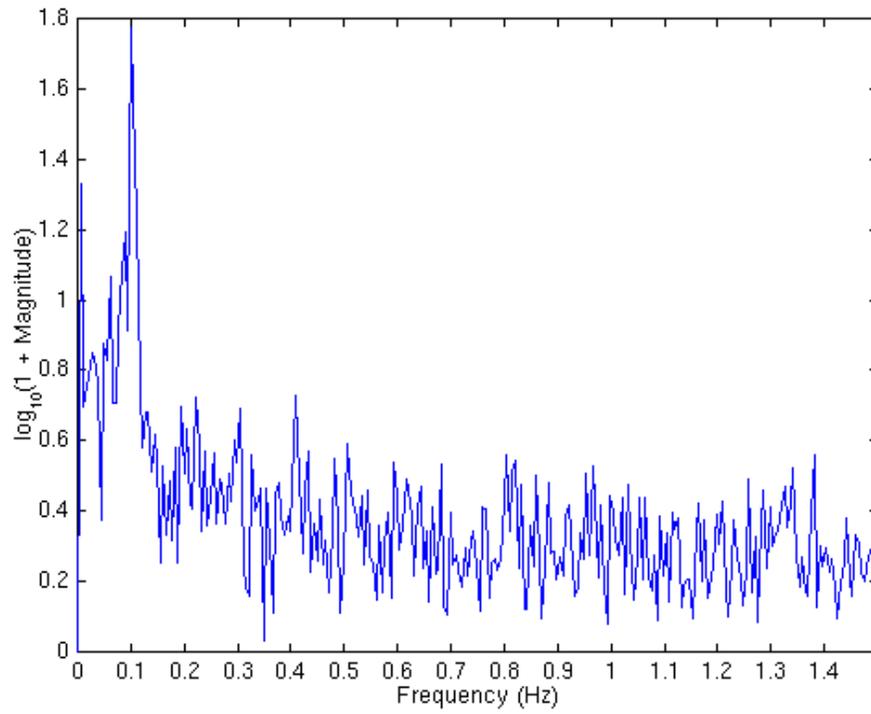
**Figure 6.5** Frequency plot for tip A from VRCS-induced motion.

The dominant frequencies are revealed in the plots of the log magnitude of the frequency response as a function of frequency for each tip. Figures 6.5 and 6.6 show plots for tips A and B. The dominant frequency of the array tip displacements is shown (large magnitudes) to be 0.1 Hz for both tips, which was the same frequency measured during the mission.

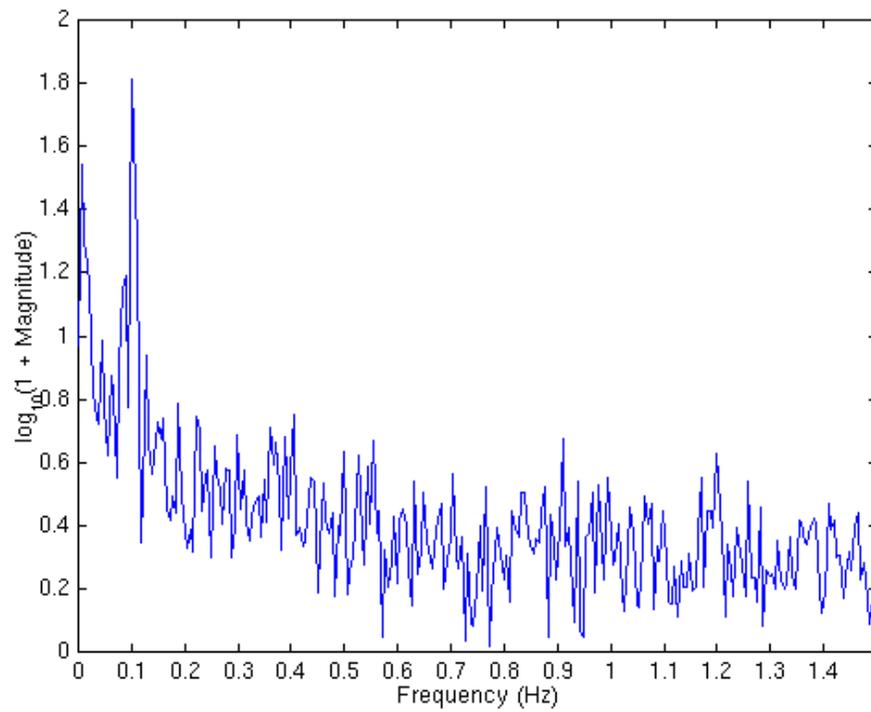
**Figure 6.6** Frequency plot for tip B from VRCS-induced motion.

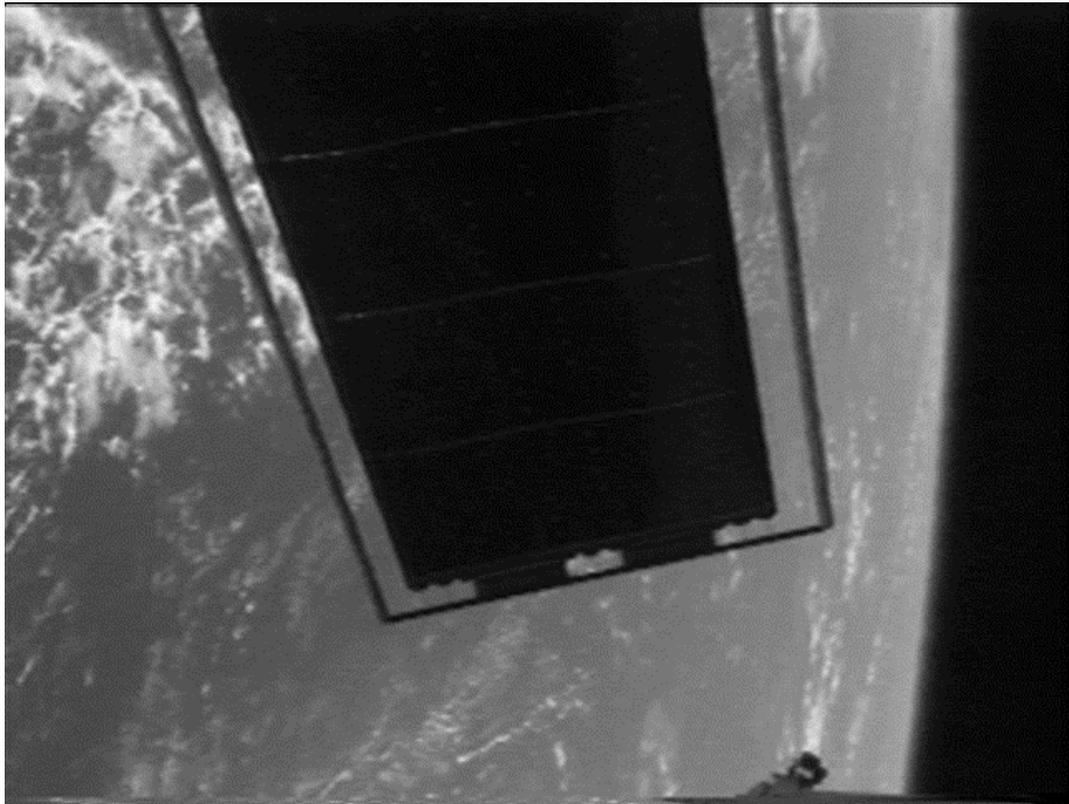
*Figure 6.7 View of +V2 solar array tips A & B from camera B during start of rotation.*

The solar array motion analysis for the HST rotation event on Flight Day 5 required a motion analysis to determine the time for the start and end of rotation. First, the array motion was analyzed from just before the start of rotation until several minutes after rotation began, such that a sudden change in the plot of array displacement vs. time would indicate the exact time that rotation began. Second, the array motion was analyzed from just before the end of rotation until several minutes after the end of the rotation event, so that a sudden change in the array displacement plot would indicate the exact time that rotation ended.

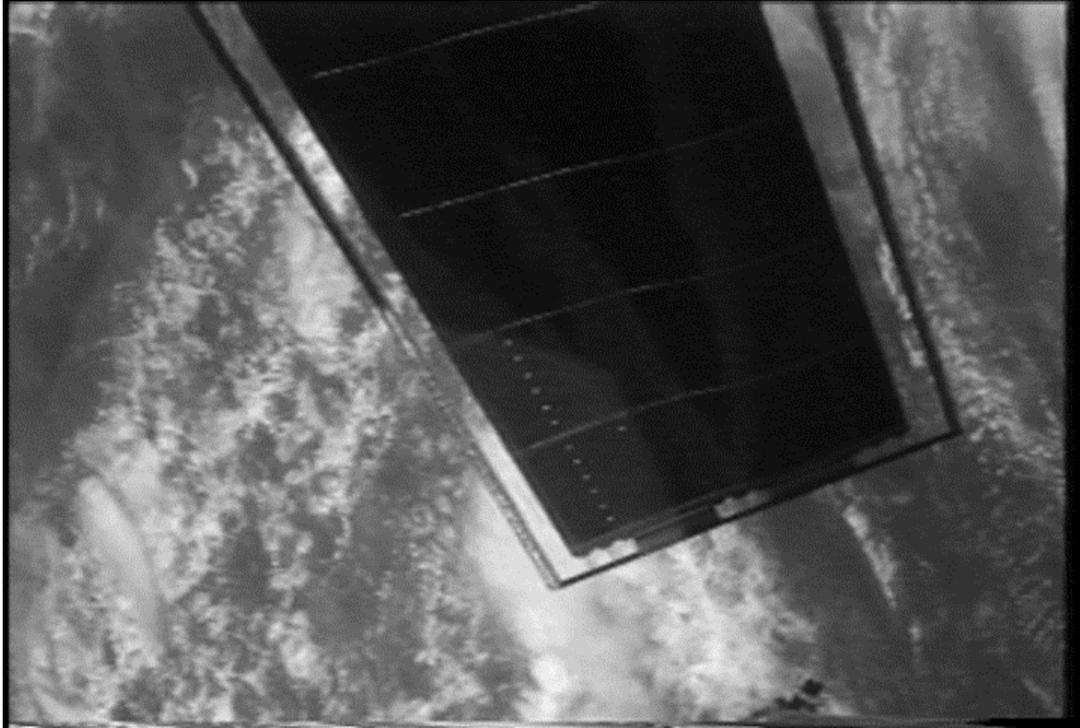
*Figure 6.8 View of -V2 solar array tips G and H from camera B at end of rotation.*

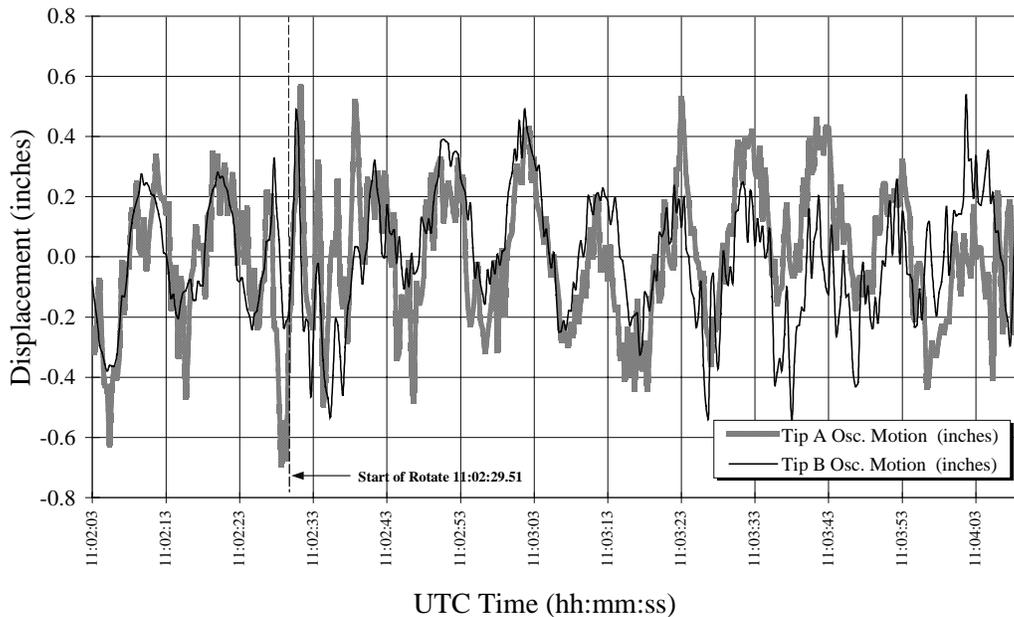
***Figure 6.9 Solar array tip displacement during start of rotate event (Flight Day 5).***

An approximately 2-minute video sequence showing the beginning of HST rotation on Flight Day 8 was analyzed. Camera B was used to image tips A (inboard) and B (outboard) during the start of rotation. The video sequence that was analyzed began at 11:02:02.85 UTC, which was just before the beginning of rotation, and ended at 11:04:09.51 UTC. Tip A was tracked using the line-tracking method because the point-tracking method could not remain fixed on the tip due to the background pattern change from the blackness of space to the blue/white of the Earth. The background for tip B did not change, and tip B was tracked with the point-tracking method. Tip A had a maximum peak-to-peak displacement of  $0.62 \pm 0.07$  inches at 11:03:02.18 UTC, and tip B had a maximum peak-to-peak displacement of  $0.64 \pm 0.07$  inches at 11:03:01.51 UTC. Both tips had a dominant frequency of approximately 0.1 Hz. Figure 6.9 shows the plot of the oscillatory displacement of the solar array tips as a function of time. The plot in Figure 6.9 represents a smoothing of the original data using a five-point moving average filter. Filtering of the data was necessary to remove high frequency noise in the motion tracking. Appendix G contains the raw, unsmoothed, displacement plot and the translational motion and frequency plots.

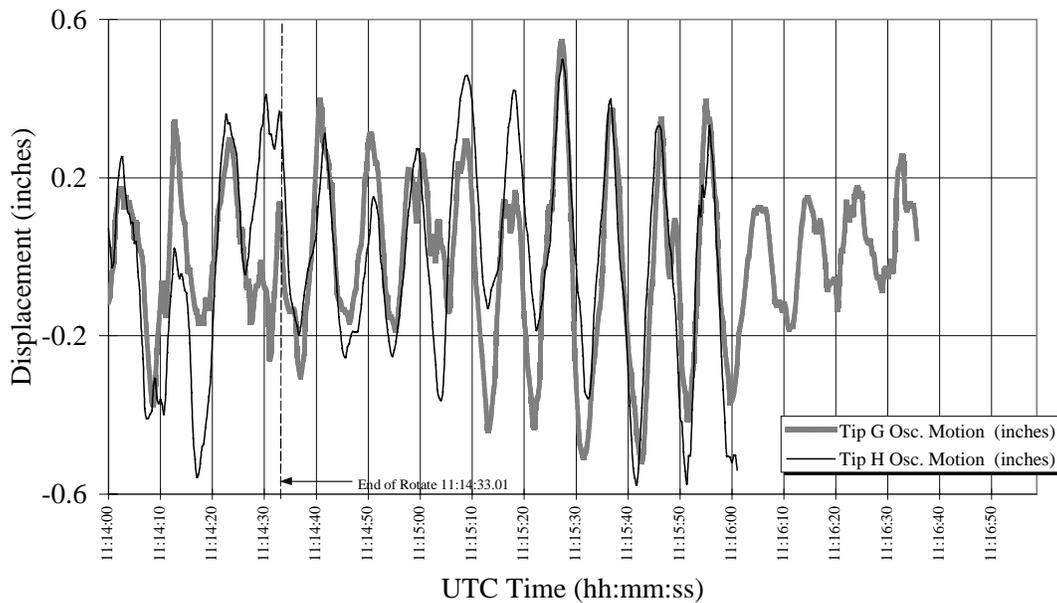
**Figure 6.10** Solar array tip displacement during end of rotate event (Flight Day 5).

An approximately 2.5-minute video sequence showing the end of HST rotation on Flight Day 8 was analyzed. Camera B was used to image tips G (inboard) and H (outboard) during the end of rotation. The video sequence began at 11:14:00 UTC, which was just before the end of rotation, and ended at 11:16:35 UTC. Tip G had a maximum peak-to-peak displacement of  $1.05 \pm 0.14$  inches at time 11:15:29.01 UTC with a dominant frequency of 0.1 Hz. Tip H had a maximum peak-to-peak displacement of  $0.97 \pm 0.11$  inches at time 11:15:38.35 UTC with a dominant frequency of 0.1 Hz. Both tips were tracked using the point-tracking method. Figure 6.10 shows the plot of the displacement of the solar array tips as a function of time. Filtering of the data was necessary to remove high-frequency noise in the motion tracking. Appendix G contains the raw displacement plot and the translational motion and frequency plots.

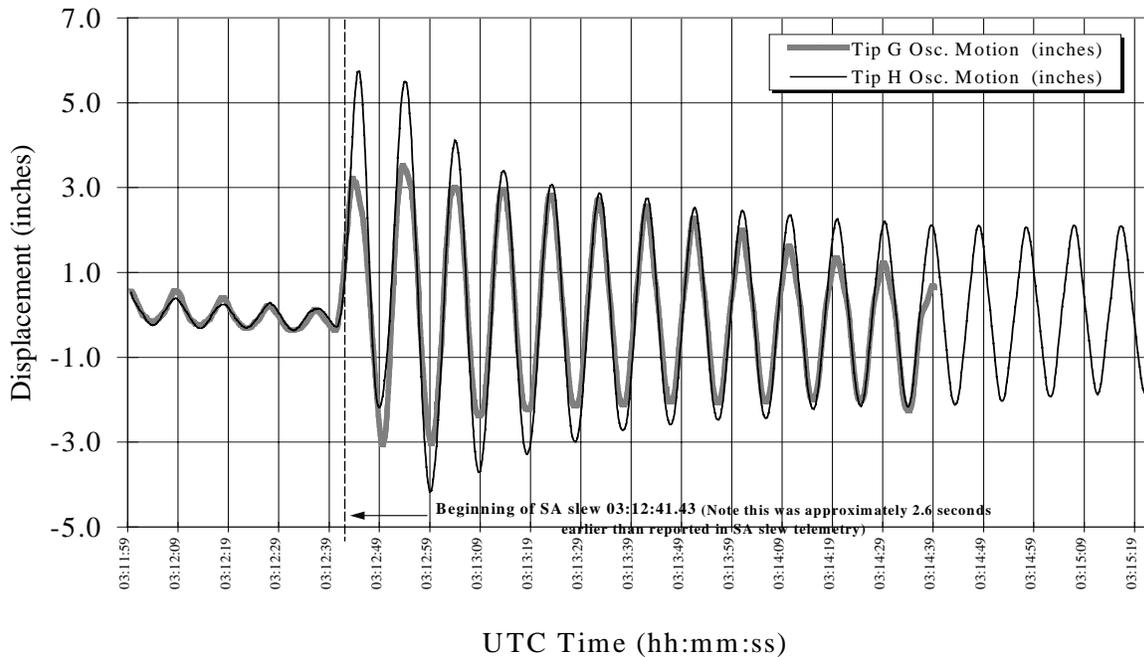
**Figure 6.11** Solar array tip displacements during airlock depressurization (Flight Day 8).

Figure 6.11 gives the plots of the displacement of the solar array tips and Appendix G contains plots of the displacement before the slew of the array was subtracted out. The plot in Figure 6.11 represents a smoothing of the original data using the five-point moving average filter. For the airlock-depressurization solar array displacement plot, the data had very little noise and smoothing was minimal. The plots of the raw tip displacements and frequency analyses are also in Appendix G. The maximum peak-to-peak displacement was  $9.66 \pm 0.41$  inches at time 03:12:53.77 UTC for tip H and  $6.53 \pm 0.37$  inches at time 03:12:53.43 UTC for tip G. The dominant frequency was approximately 0.1 Hz. Note that the background or base array motion was very evident before the airlock depressurization-induced slew. The peak-to-peak displacement of this background motion was approximately 0.2 inches and the frequency was 0.1 Hz. A clear damping of the tip displacement was observed for both tips. The displacement for tip G was measured for a shorter timeframe (170 seconds) than tip H (210 seconds), because a shadow passed over tip G, changing the background, and causing a loss of tracking. When the shadow passed over tip G, the change in lighting altered the pattern of pixel intensities surrounding the tip so much that the search pattern could no longer recognize the tip.

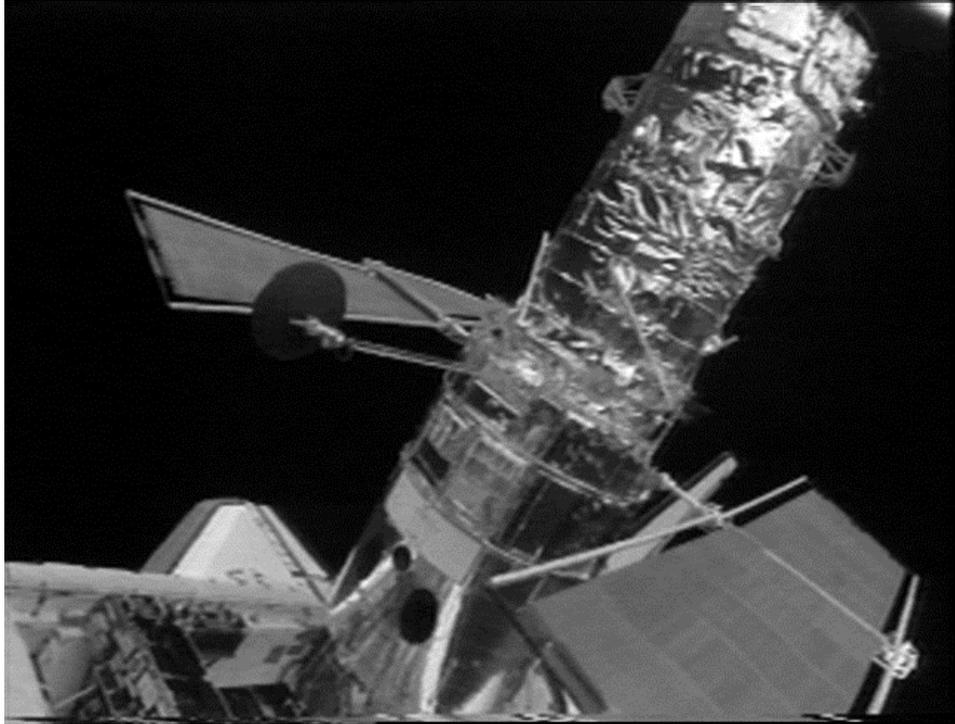
*Figure 6.12 View of -V2 solar array tips E and F from the RMS elbow camera during beginning of pivot.*

Like the analysis of solar array motion during the rotation on Flight Day 5, the analysis of the array motion during the HST pivot event on Flight Day 8 was a two-step process. First, the array motion was analyzed from just before the beginning of pivot until several minutes after pivot. The video was analyzed just before the pivot so that a sudden change in the plot of array displacement vs. time would indicate the exact time that pivot began. Second, the array motion was analyzed from just before the end of pivot until several minutes after the end of the pivot event. For the conclusion of the pivot, the video was analyzed just before the end of pivot so that the sudden change in the array displacement plot would indicate the exact time that pivot ended.
