NASA/TP-98-201793

# **Photogrammetric Assessment of the Hubble Space Telescope Solar Arrays During the Second Servicing Mission**

## **Final Report**

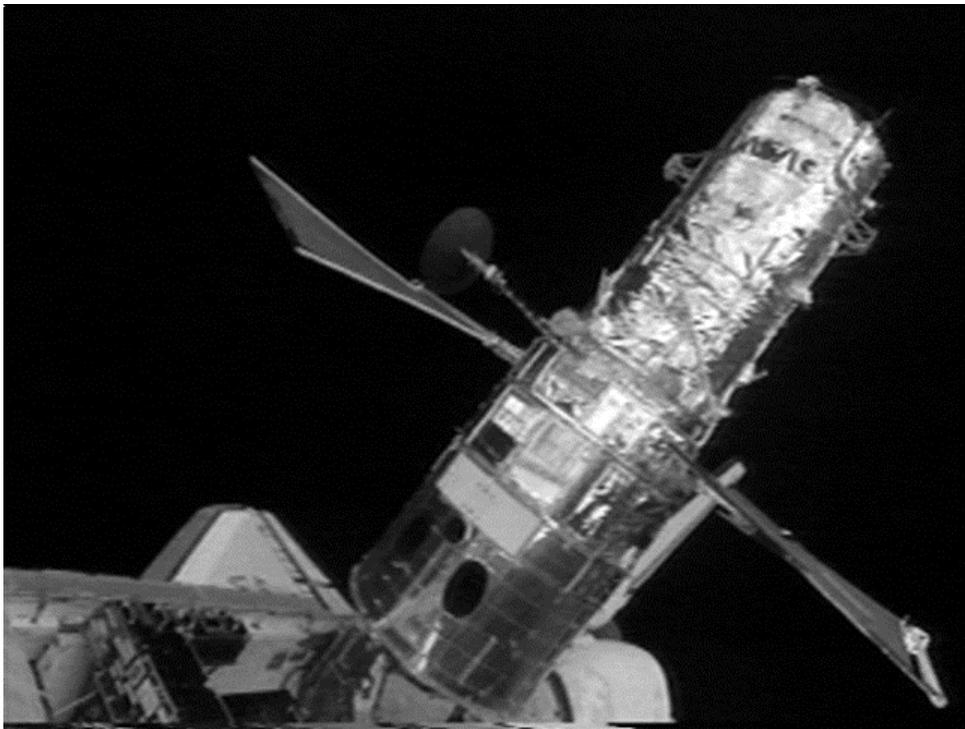
*Figure 6.13 View of -V2 solar array tips E and F from the RMS elbow camera during end of pivot.*

Like the analysis of solar array motion during the rotation on Flight Day 5, the analysis of the array motion during the HST pivot event on Flight Day 8 was a two-step process. First, the array motion was analyzed from just before the beginning of pivot until several minutes after pivot. The video was analyzed just before the pivot so that a sudden change in the plot of array displacement vs. time would indicate the exact time that pivot began. Second, the array motion was analyzed from just before the end of pivot until several minutes after the end of the pivot event. For the conclusion of the pivot, the video was analyzed just before the end of pivot so that the sudden change in the array displacement plot would indicate the exact time that pivot ended.

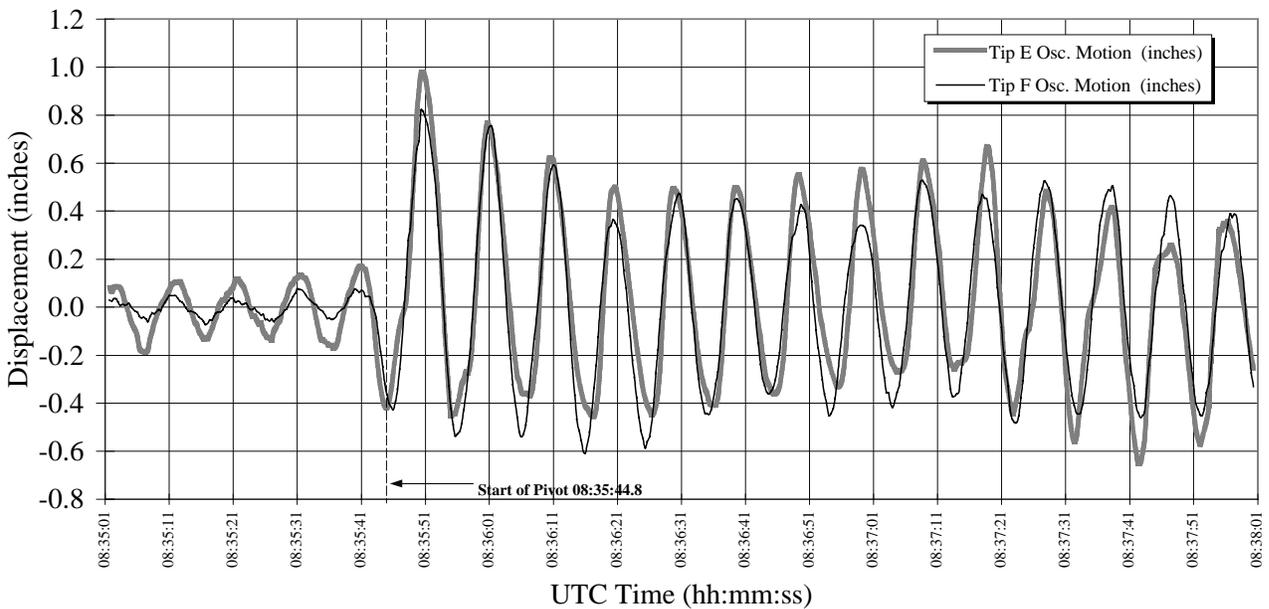
***Figure 6.14 Solar array tip displacements during start of pivot event (Flight Day 8).***

Figure 6.14 gives the plots of the displacements of the solar array tips as a function of time, and Appendix G contains plots showing the displacements before the translational correction. The plots in Figure 6.14 represent a smoothing of the original data using the five-point moving average filter. The raw displacement plots and the frequency plots are also in Appendix G. The maximum peak-to-peak displacement for tip E was  $1.43 \pm 0.14$  inches at 08:35:50.46 UTC while the maximum peak-to-peak displacement for tip F was  $1.36 \pm 0.21$  inches at 08:35:50.13 UTC. The dominant frequency for both tips was 0.1 Hz. Again note that the background motion had a peak-to-peak displacement of approximately 0.2 inches with a 0.1 Hz frequency.

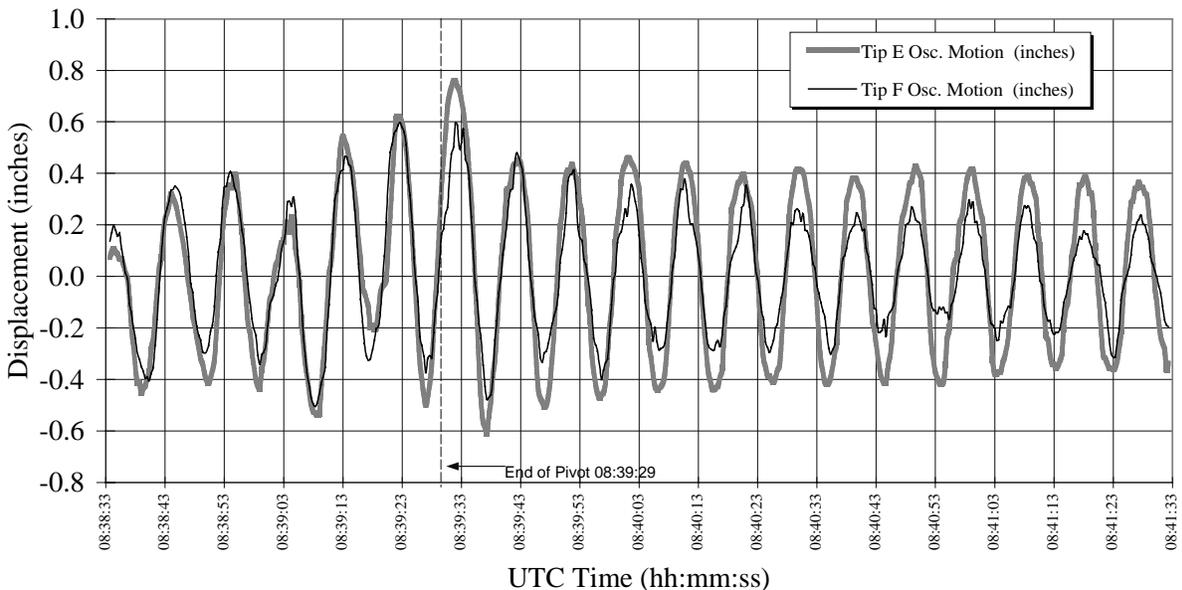
**Figure 6.15** Solar array tip displacements during end of pivot event (Flight Day 8).

A 3-minute video sequence showing the end of HST pivot on Flight Day 8 was analyzed. The video sequence began at 08:38:33.0 UTC, which was just before the end of the pivot and ended at 08:41:33.0 UTC. As with the start of pivot, the RMS elbow camera was used to image tips E (inboard) and F (outboard) during the end of the pivot. Figure 6.15 gives the plots of the displacements of the solar array tips, and Appendix G contains plots showing the displacements before the translational correction. Figure 6.15 represents a smoothing of the original data using a five-point moving average filter. The raw displacement plots and the frequency plots are also included in Appendix G. The maximum peak-to-peak displacement for tip E was  $1.37 \pm 0.13$  inches at 08:39:32 UTC and the maximum peak-to-peak displacement for tip F was  $1.07 \pm 0.29$  inches at 08:39:32.00 UTC. Both maximum displacements occurred just as the pivot operation ended. The dominant frequency for both tips was 0.1 Hz. The accuracy for measuring the tip displacement for tip F was less than for tip E. This can be clearly seen in the raw displacement plots, with tip F being noisier. The cause for the poorer tracking for tip F was not readily apparent in viewing the imagery. No significant lighting or background changes were observed.

The tip displacements for the end-of-pivot data were noisier than those for the beginning of pivot. The lighting appeared to be stable with no noticeable shadows moving through the view. The cause for the increased noise in the data was not determined.

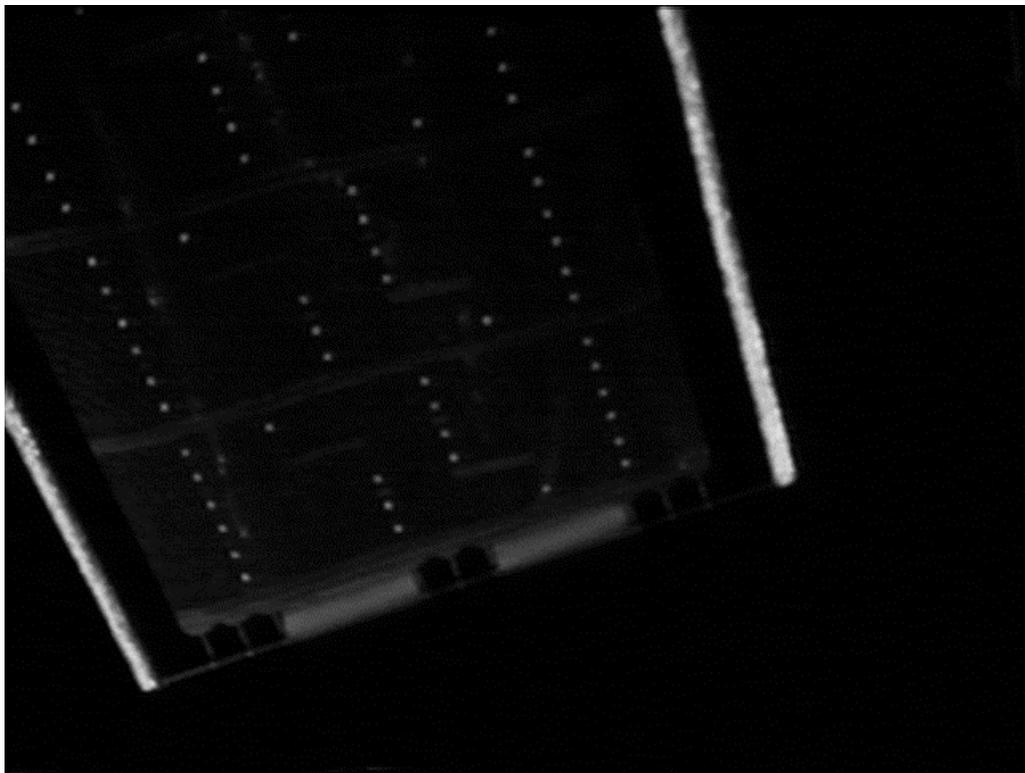
*Figure 6.16 View of +V2 solar array tips A and B from camera B during reboost on Flight Day 8.*

A 3-minute video sequence showing the HST during reboost on Flight Day 8 was analyzed. This was the fourth and last reboost of the mission occurring at UTC 049:10:26 and lasting for 20 minutes. Camera B was used to image tips A (inboard) and B (outboard) during the reboost. Tip A had maximum peak-to-peak displacement of approximately  $1.0 \pm 0.05$  inches at 10:30:06.04 UTC, while tip B had a maximum peak-to-peak tip displacement of  $1.09 \pm 0.06$  inches at 10:30:06.04 UTC. Both tips had a dominant frequency of approximately 0.1 Hz. Figure 6.17 gives the plots of the displacements of the solar array tips and Appendix G contains the raw displacement plots and the frequency plots. Figure 6.17 represents a smoothing of the original data using the five-point moving average filter. The video quality was excellent with steady lighting, no background changes, and no shadows moving through the view. The tracking was very accurate with little noise observed.

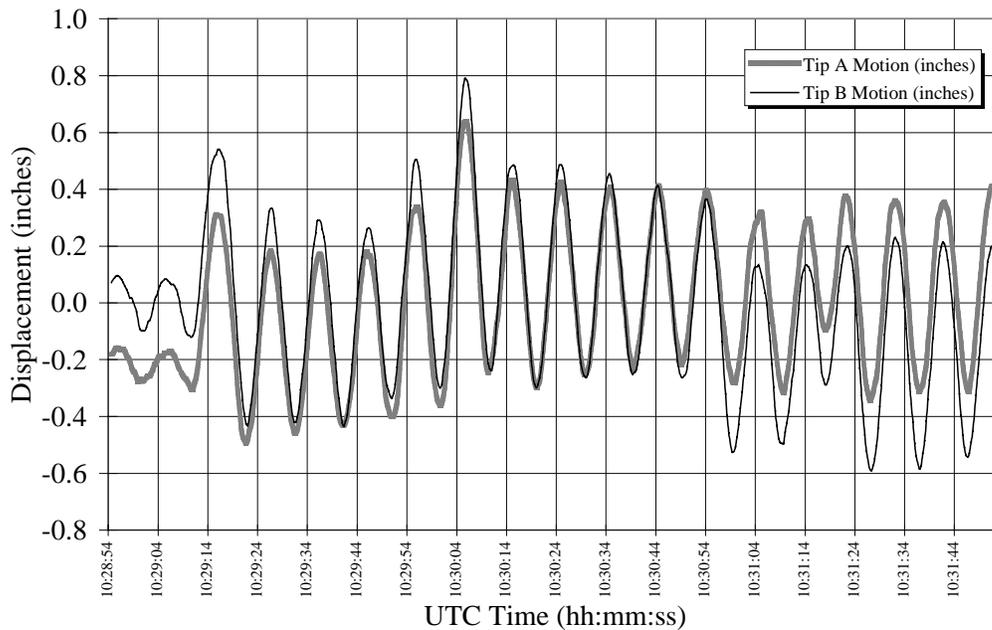
**Figure 6.17** Solar array tip displacements during reboost (Flight Day 8).

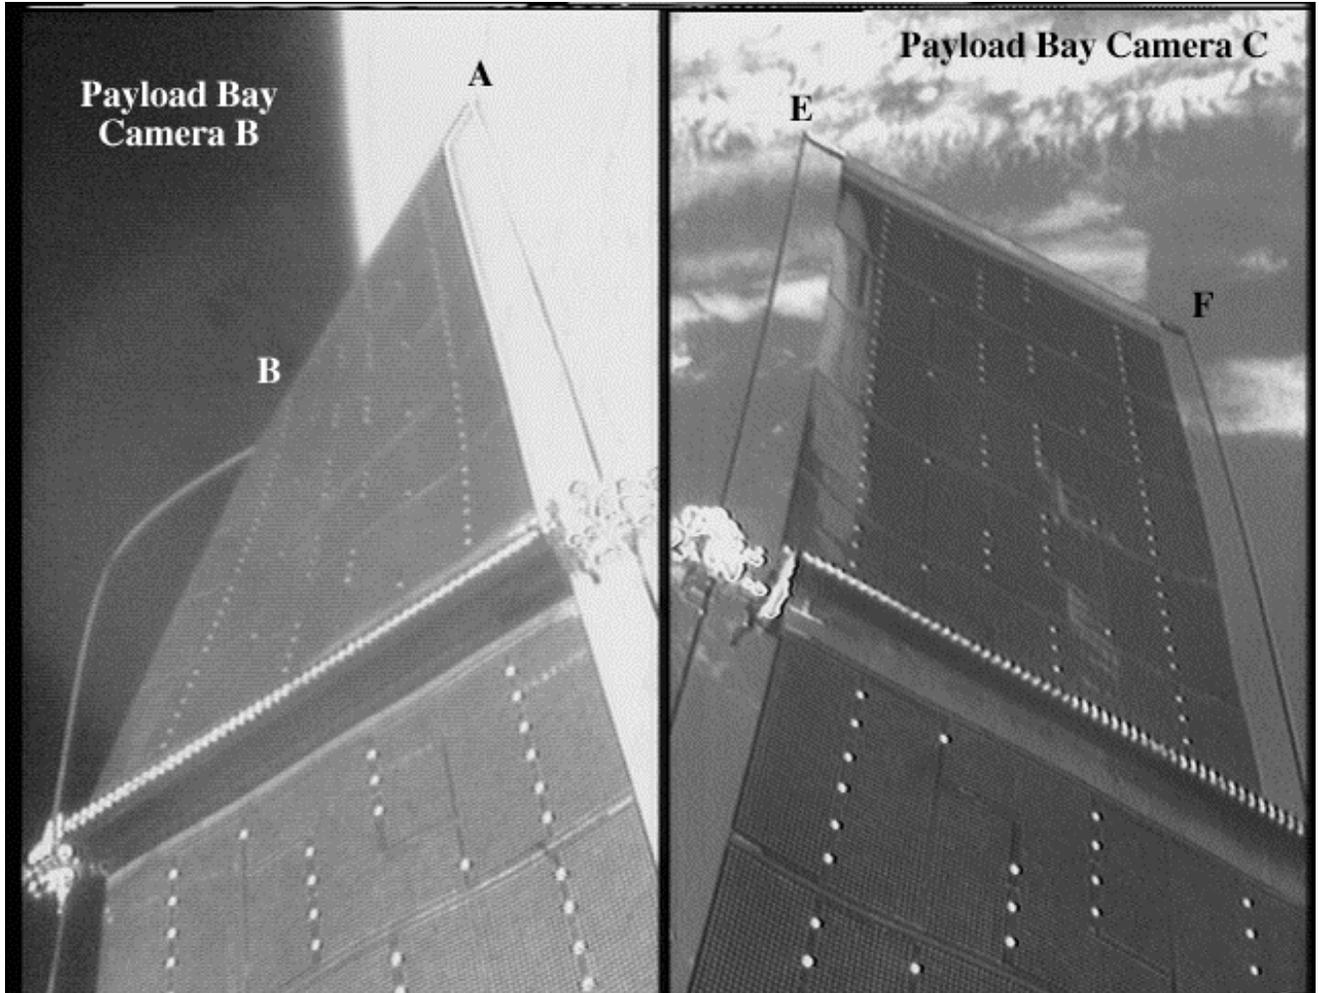
*Figure 1: Frame of video from Servicing Mission 1 used in proof-of-concept analysis.*

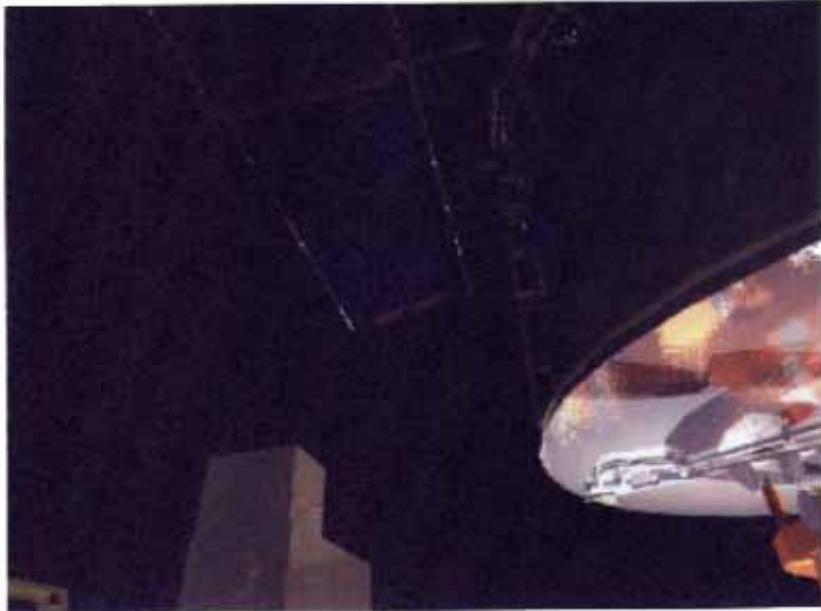
**Camera B (CTVC) View  
of Solar Array Edge A/B**

*Low light levels will introduce noise into the camera image, thus interfering with the camera view of the solar array edge.*

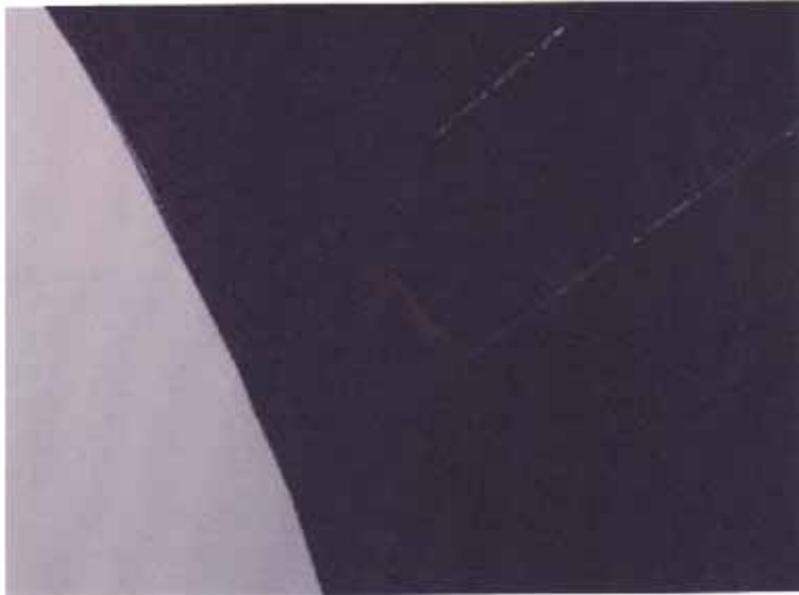
Camera B (CTVC) View  
of Solar Array Edge C/D

*Low light levels will introduce noise into the camera image, thus interfering with the camera view of the solar array edge.*

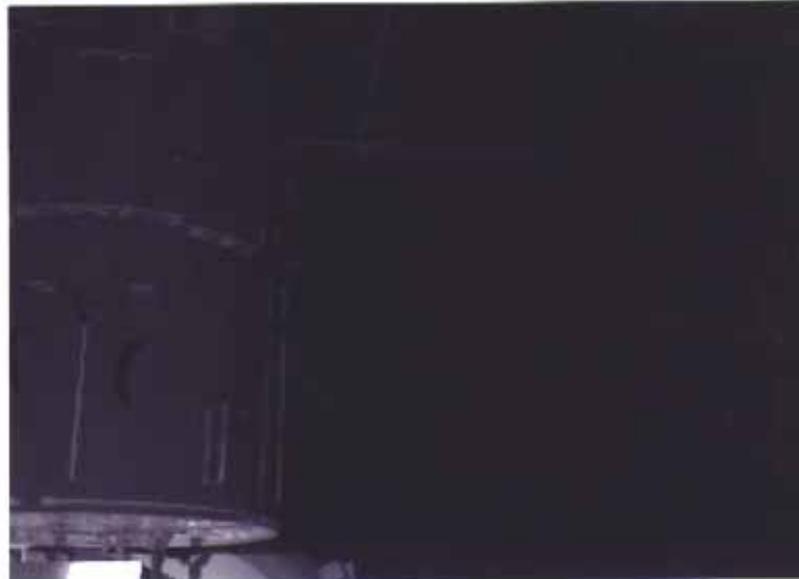
Camera A (MLA) View  
of Solar Array Edge C/D

*MLA capabilities of viewing in low light levels allow for the viewing of the solar array edge at night.*

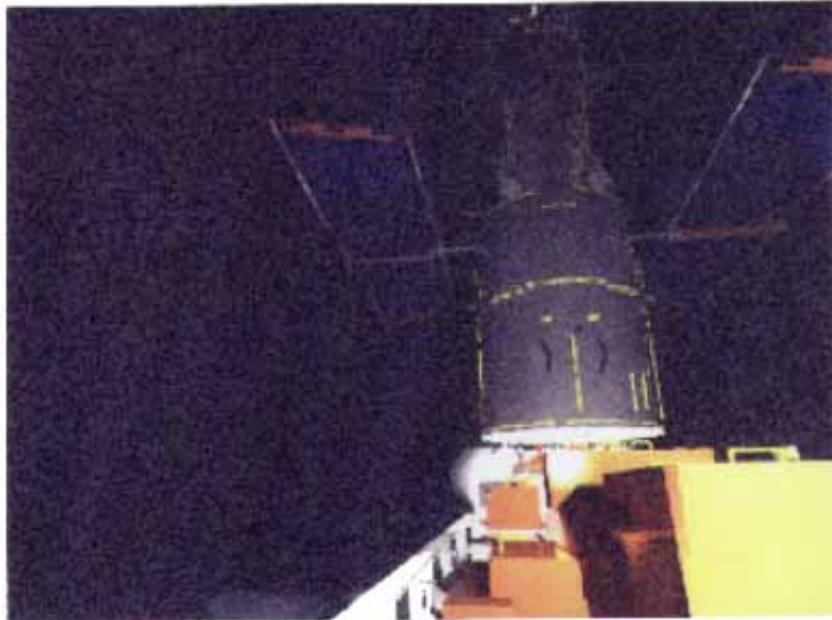
**Camera D (CTVC) View  
of Solar Array Edge G/H**

*Low light levels will introduce noise into the camera image, thus interfering with the camera view of the solar array edge.*

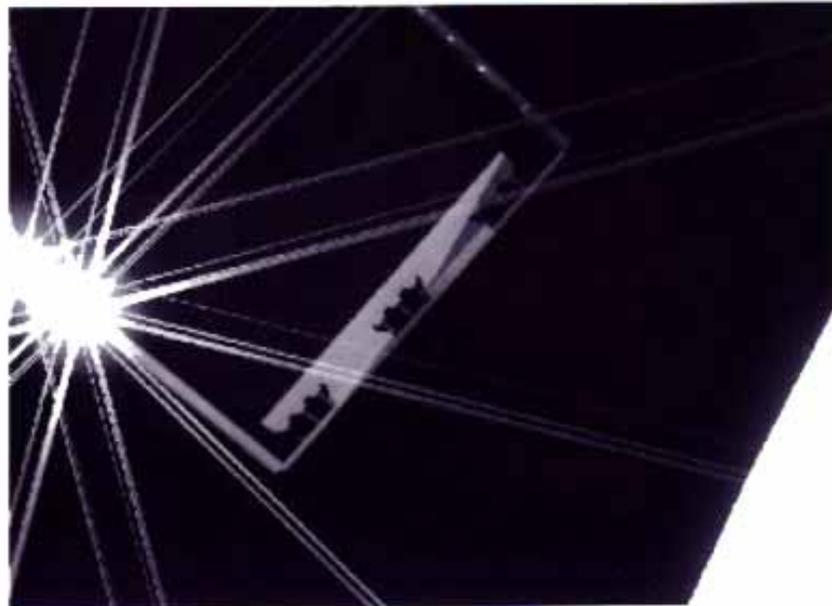
**Camera C (MLA) View  
of Solar Array Edge G/H**

*MLA capabilities of viewing in low light levels allow for the viewing of the solar array edge at night, though specular reflection of the lights off of the bismems will cause some scattering of the light in the lens.*

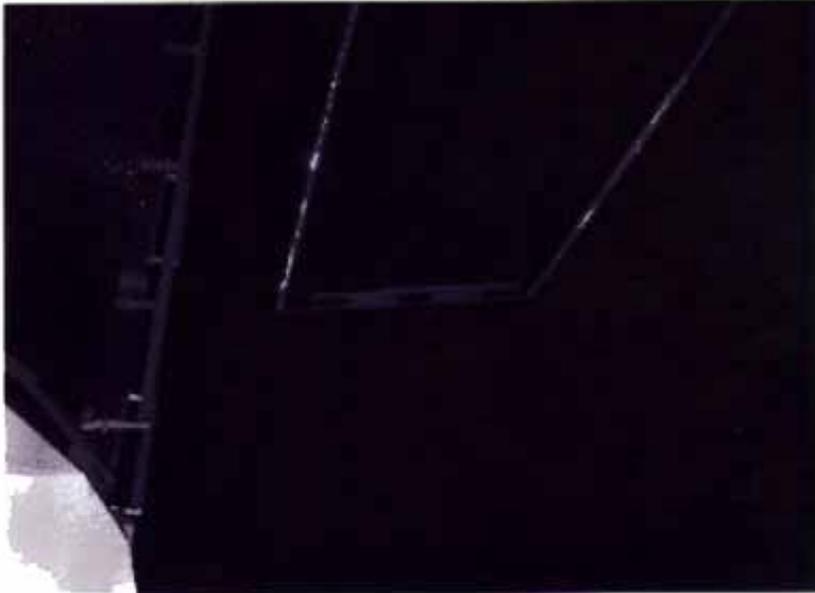
Camera C (MLA) View  
of Solar Array Edge E/F

*MLA capabilities of viewing  
in low light levels allow for  
the viewing of the solar  
array edge at night.*
